# The stability of the strata overlying the mined-out areas of the central Witwatersrand

by F. G. HILL\*, Pr. Eng. B.Sc. (Min. Eng.), M.A. (Juris), Hon. Ph.D., Hon. Ll.D., Hon. F.S.A.I.M.M., Hon. F.S.A.I.P.M., M.I. Mech. E., M.I.M.M.

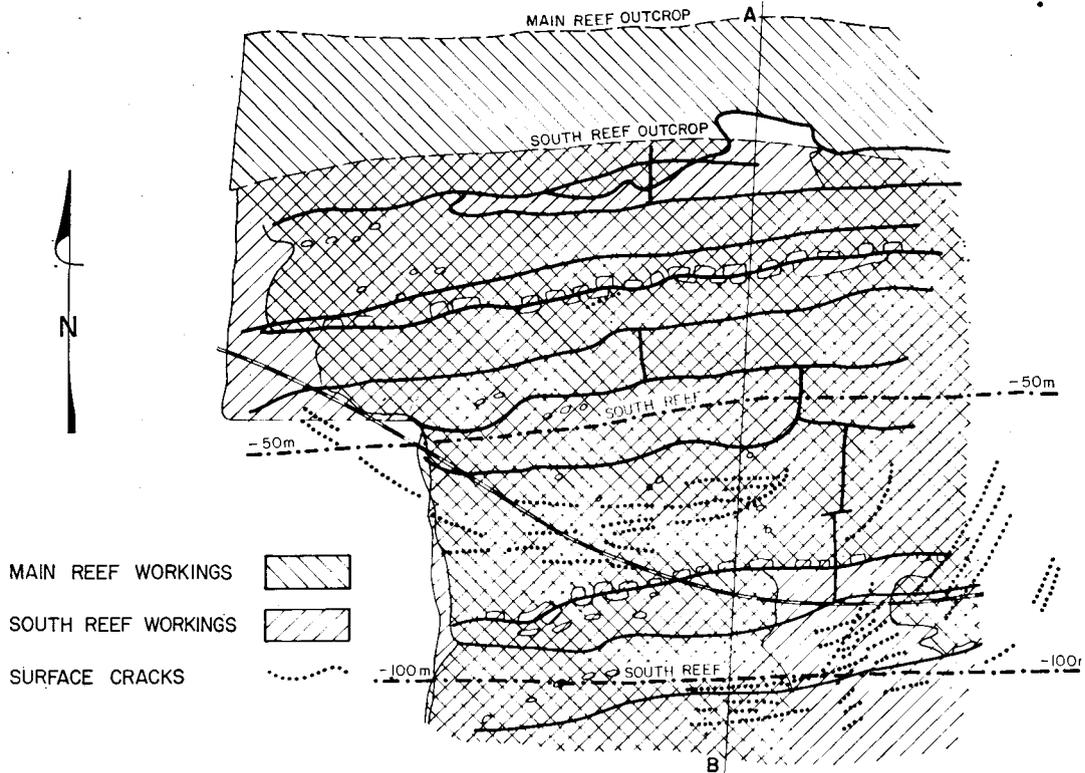
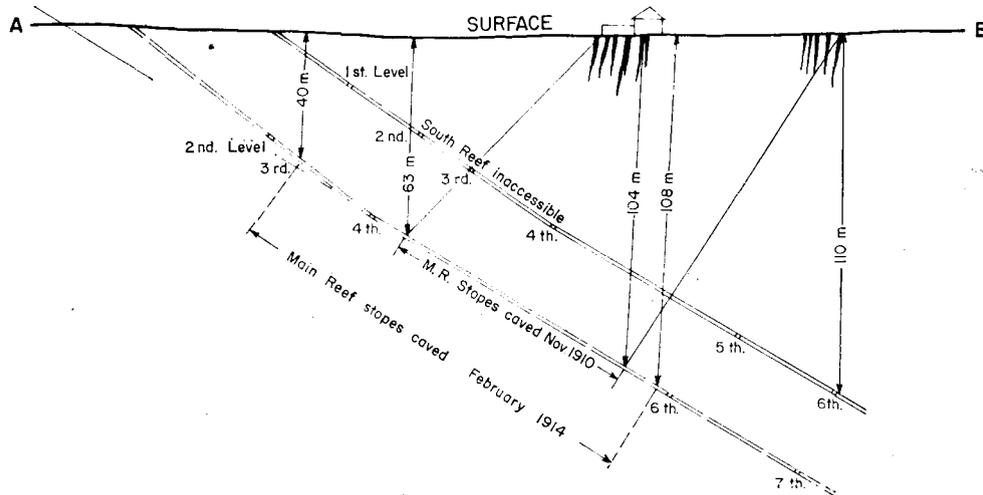
Fig. 1—Plan of the underground workings at Durban Roodepoort Deep, showing the positions of surface cracks

Fig. 2—Section through A-B of Fig. 1, showing the depth of the workings and the positions of the surface cracks

In February 1914 a collapse took place in the stopes and caused a number of cracks on surface with widths in some places of as much as 3¼" [90 mm]. There are signs along the affected zone of settlement greater than 1" [25 mm]. The ground . . . appears to have moved northwards to the extent of 3¼" [90 mm] as evidenced by the pulling apart of the flooring boards of a store which had been affected by the cracks.

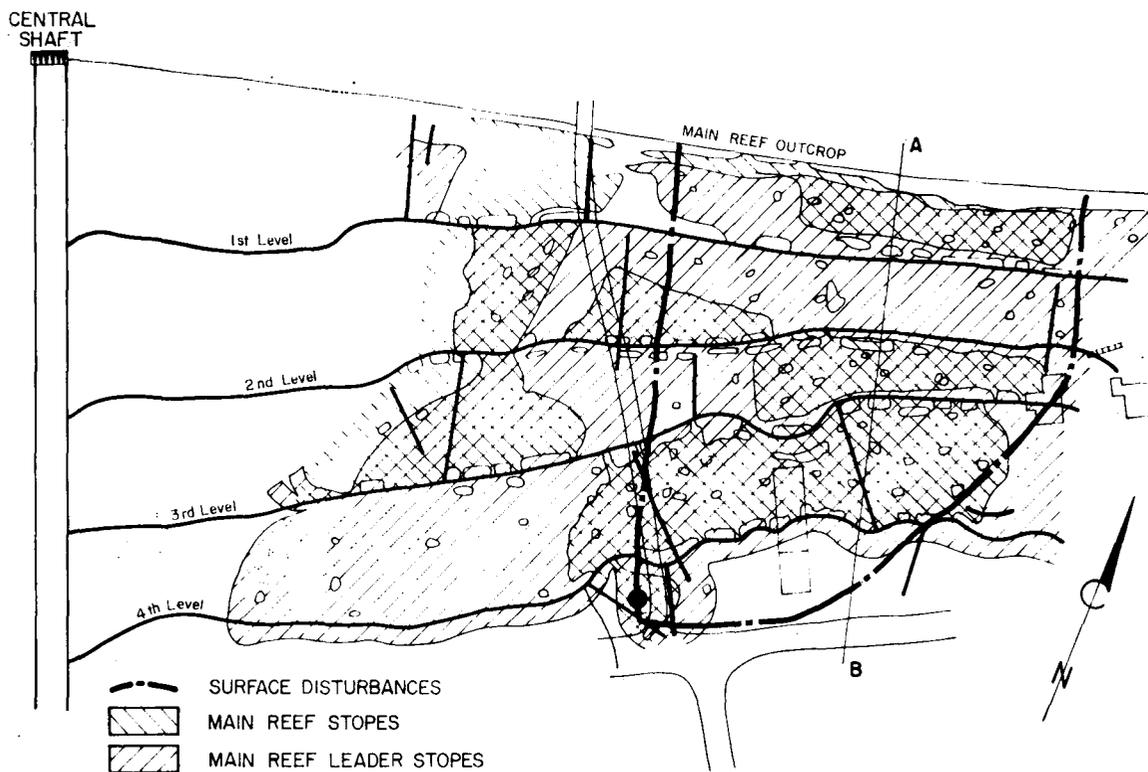
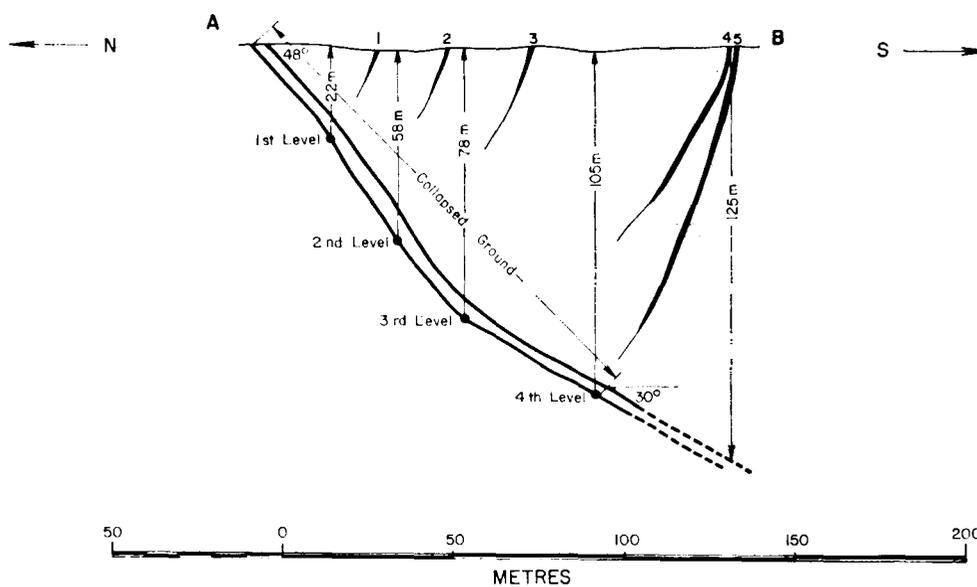
Fig. 3—Plan of the underground workings at New Kleinfontein, showing the positions of surface disturbances

Fig. 4—Section through A-B of Fig. 3, showing the depth of the workings and the positions of the surface cracks

*New Kleinfontein.* Figs. 3 and 4 show a plan and section respectively of the underground workings at the New Kleinfontein Mine (in the Benoni district, 30 km east of Johannesburg) as at July 1906. These successive surface cracks occurred as the working depths increased. To be noted is the decrease of dip with depth.

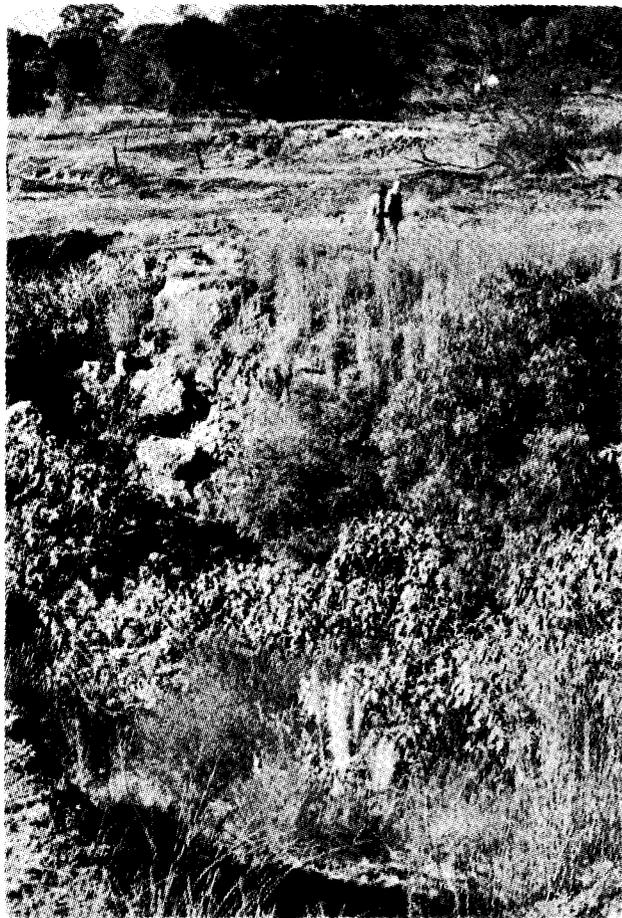
Fig. 7—Collapsed hangingwall at an outcrop of the reef, Waverley Mine

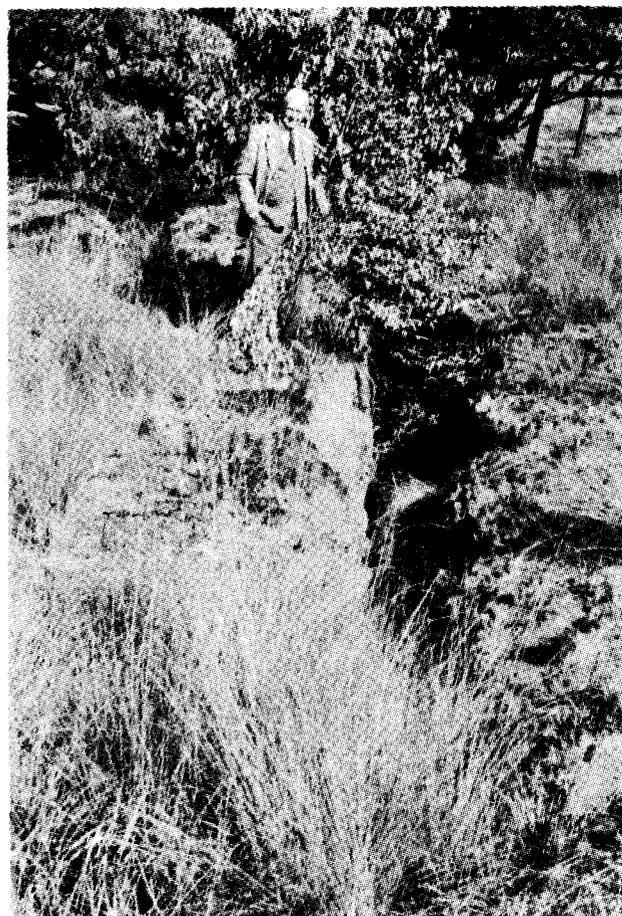
Fig. 8—Surface crack in the hangingwall of the reef outcrop shown in Fig. 7

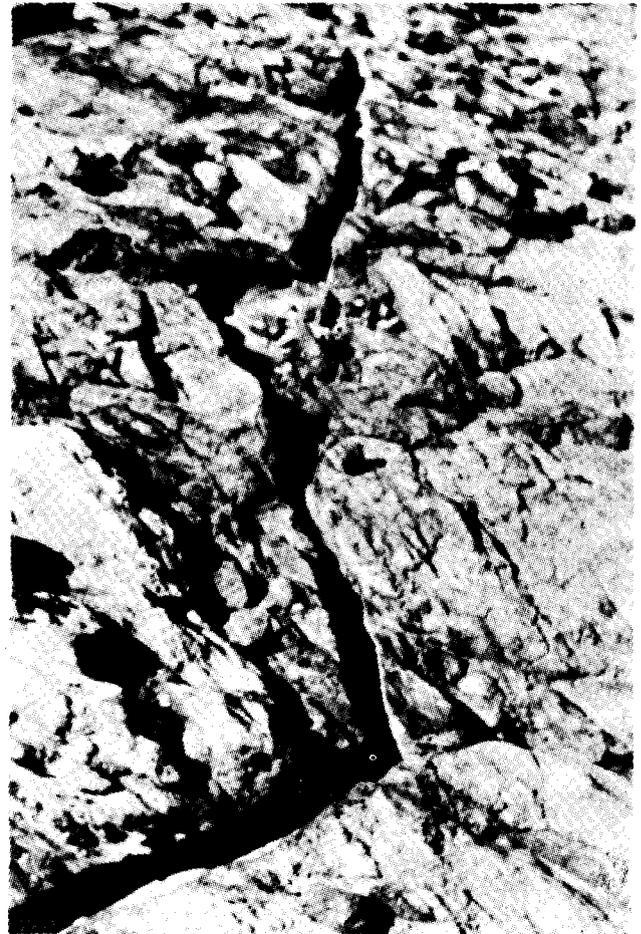
Fig. 10—Surface crack in hangingwall of the outcrop reef shown in Fig. 9

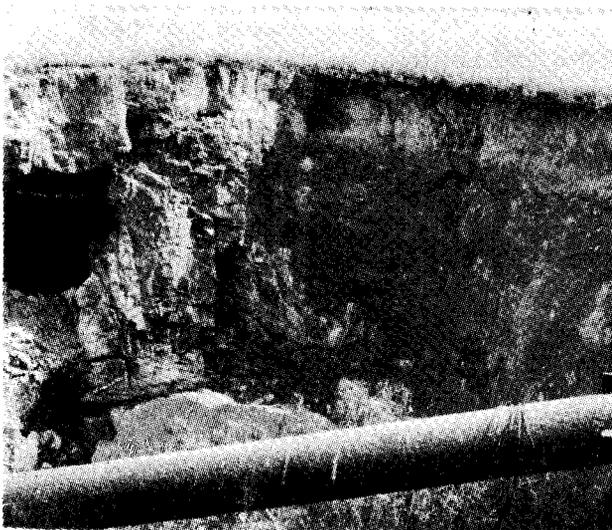
Fig. 12—Collapse of sidewalls of an outcrop stope, Van Ryn Estates (note unsafe bridge above the stoped area)

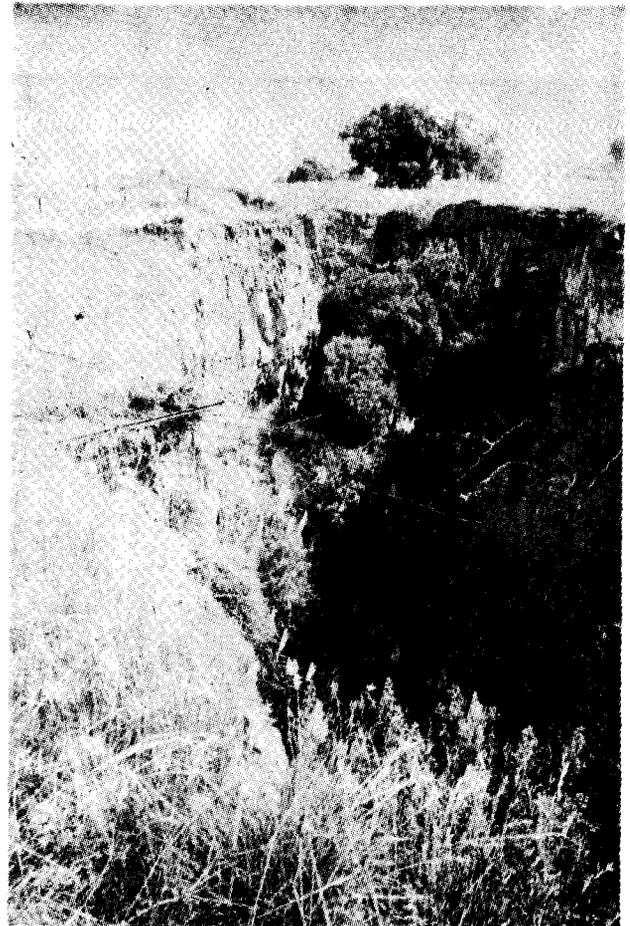
Fig. 13—Extensive collapse of sidewalls of a stope, Van Ryn Estates

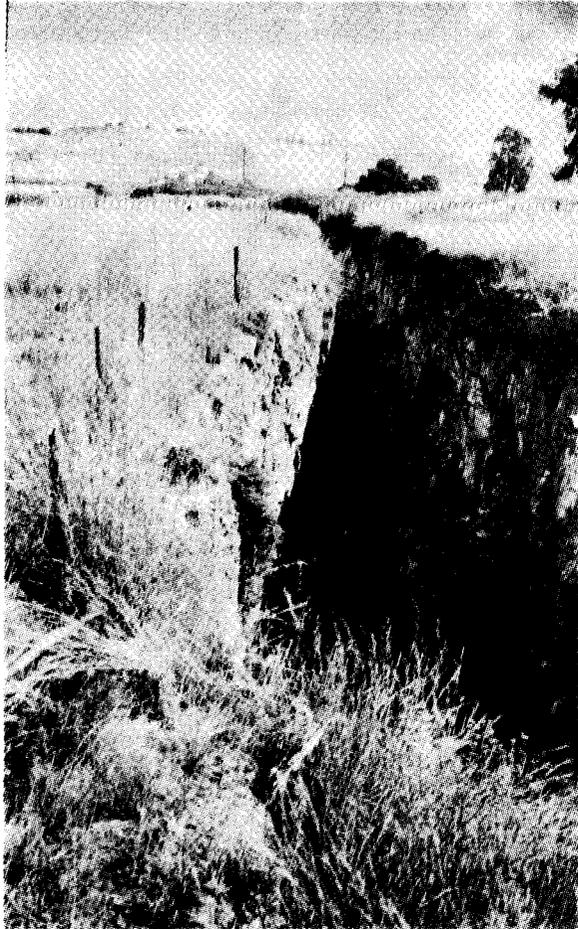
Fig. 14—Widening of slope due to slabbing away of hanging-wall and footwall rock, Van Ryn Estates

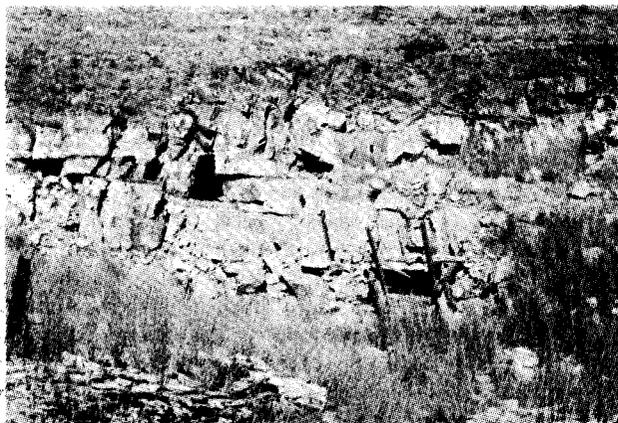
Fig. 15—Fractured hangingwall overlying worked-out stopes, New Modder

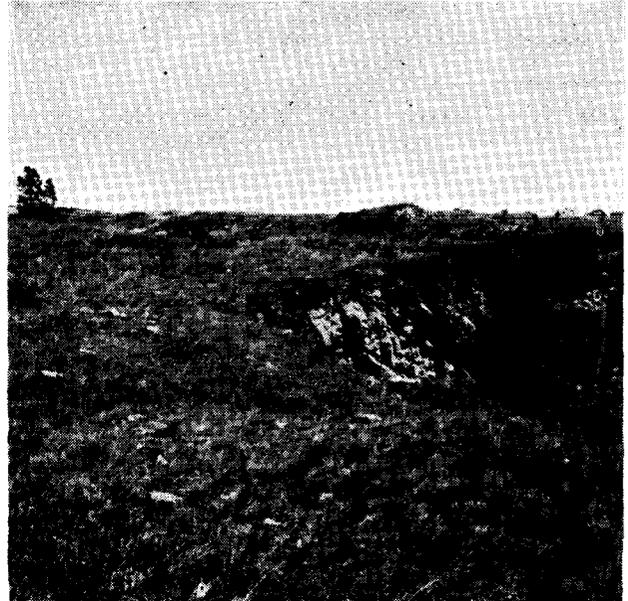
Fig. 16—Sinkhole in the hangingwall strata shown in Fig. 15

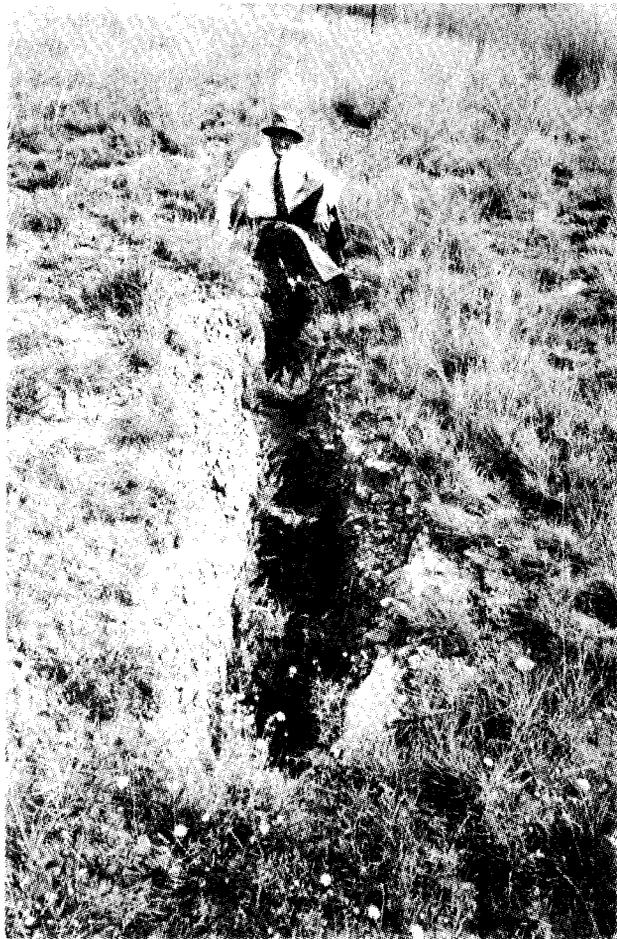
Another example of surface cracks is to be found at New Kleinfontein, as shown in Fig. 22. In this case, however, numerous reefs with a large combined stoping

width had been mined, and the closure towards the worked-out reefs was so great that it caused the large tension crack shown.

Fig. 22—Surface crack resulting from the mining of a number of superimposed reefs, New Kleinfontein

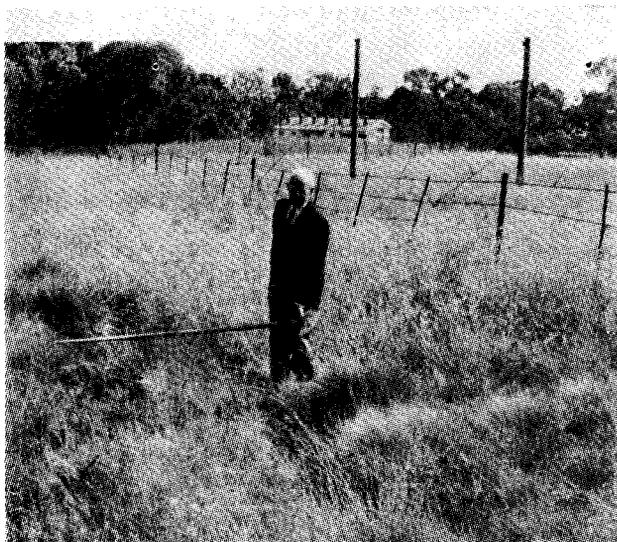
Fig. 27—'Step' fracture with a length of about 100 m and a 'step' of about 0,4 m, Rand Leases

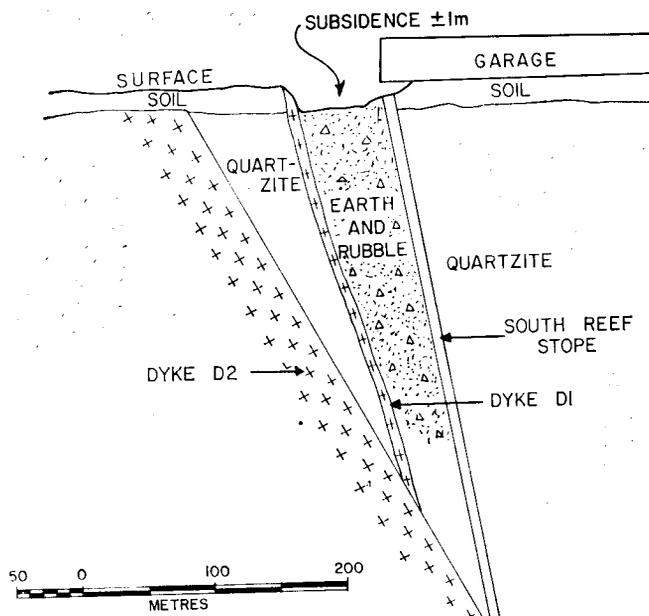
Fig. 28 is a cross-section at the site of the subsidence. The dykes shown in the sketch lie in the footwall of the mined-out South Reef, which has a dip of some 80°. The tendency would be for the wedge to slide down the slippery slope of the soft, weathered dyke, and this is in fact what happened. In the words of Mr Immelman, the

Fig. 28—The subsidence of a wedge of ground between a dyke in the footwall and a worked-out stope, City Central

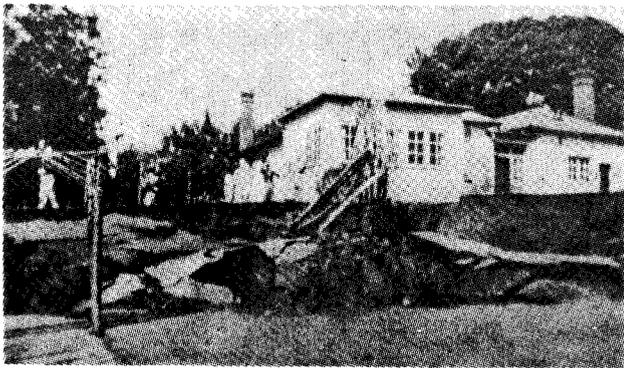
That collapses of this nature could cause considerable damage is clear from Fig. 30: three houses in the area had, in fact, to be demolished. Similar occurrences, and for the same reasons, have occurred elsewhere on the Witwatersrand, and indicate that caution is necessary in the assess-

Fig. 30—Surface rupture caused by the collapse of the wedge of ground depicted in Fig. 29, Nourse Mines

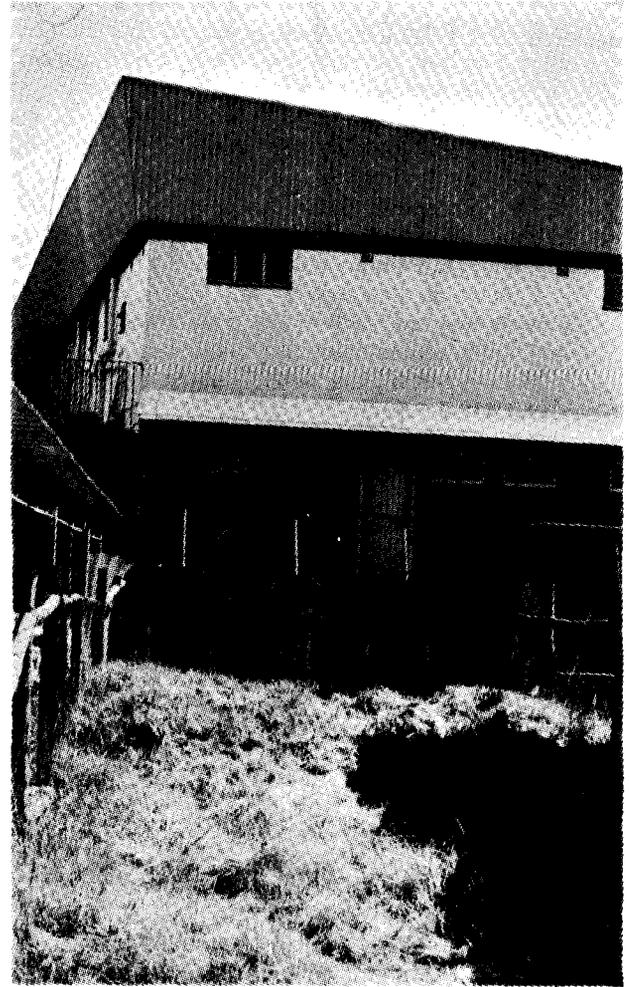
Fig. 65—A sinkhole occurred at the edge of this building (building A in Fig. 69) in 1972 but caused no damage

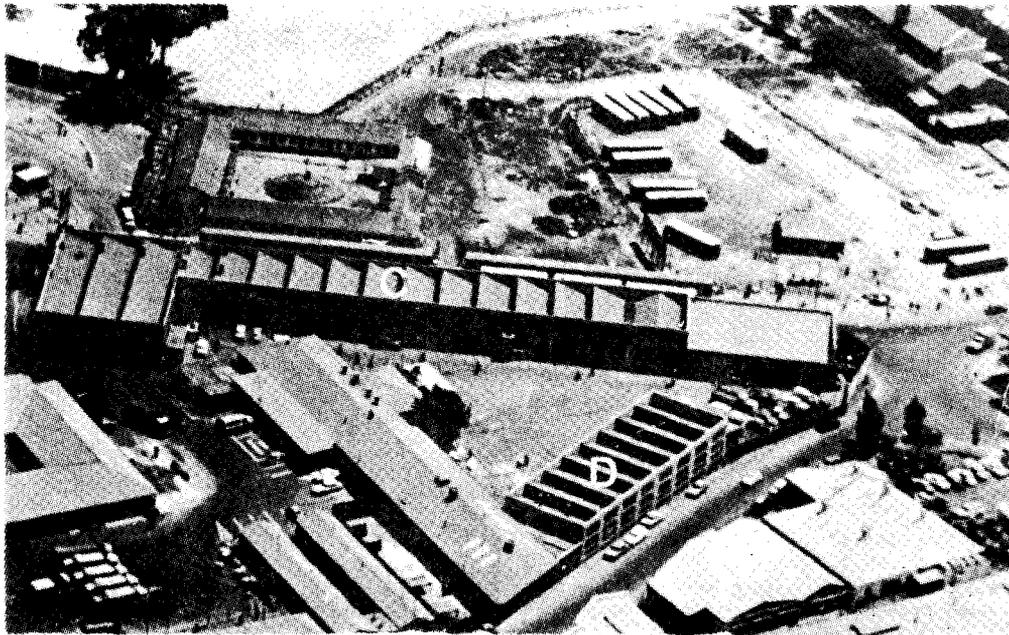
Fig. 68—Despite straddling the Crown Ferreira dyke, these buildings (C and D in Fig. 69), which were erected over 40 years ago, have been unaffected by differential movement of the surface
