A major mud push occurred on the 870 m production level, scraper drift block cave at Dutoitspan diamond mine in November 2011, during which it is estimated that more than 4 400 m³ of mud engulfed the west cave. The production level was successfully evacuated during the mud push with no loss of life or injury to personnel, thanks largely to mine employees being well trained in and adhering to on-mine mud rush evacuation procedures. All access to the west cave was lost as a result of the mud push. Clean-up operations are currently under way to regain access to the production level, to establish the extent of damage to scraper drifts and equipment, and to evaluate what remedial works may be required to resume production. The magnitude of the Dutoitspan mud push necessitated a detailed investigation into the key contributing factors leading up to the incident, which are discussed in this paper. Mud rush mitigation measures in place on scraper drift block caving operations at Dutoitspan, Bultfontein, and Wesselton diamond mines in the Kimberley area are critically reviewed. Recommendations are furthermore made for enhanced mitigation based on mud rush risk profiles derived for different

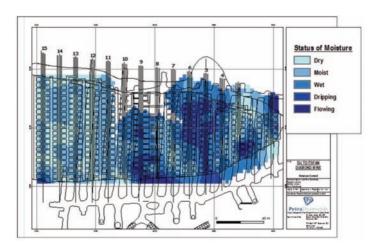
Figure 6-Moisture conditions on 870 Lvl, October 2011

Despite these sources of water ingress, the October 2011 moisture condition plot for 870 Lvl in Figure 6 shows that the West Cave was relatively dry compared to the East Cave, except for water inflows at the host rock/pipe contact in the front of Drift 15.

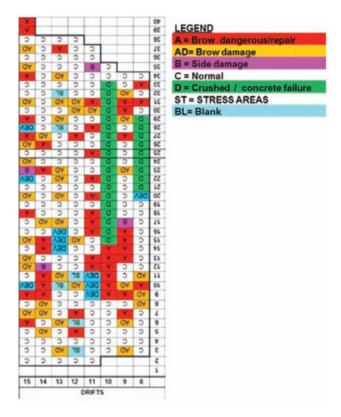
Figure 9—Structural condition of West Cave drawpoints by November

The structural condition of drawpoints in the West Cave in November 2011 is schematically presented in Figure 9. This plot shows why draw shifted towards the front of the cave in the latter half of 2011, with badly damaged drawpoints (A-class drawpoints) in Drifts 11, 14, and 15 making it impossible to draw the central and back portions of these drifts. This resulted in severe isolated draw from the front of the cave and from Drifts 12 and 13, which were still in reasonably good condition compared to the other drifts in the West Cave.

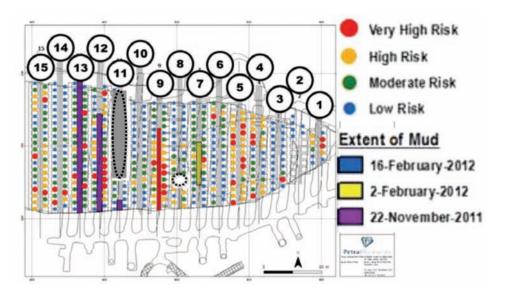
Figure 10-Mud rush risk plot for Dutoitspan 870 Lvl

Figure 10 shows very high mud rush risk potential in the front part of the West Cave as well as in Drifts 12 and 13 where the November 2011 mud push occurred, in Drift 9 where the 2005 mud rush occurred, and in Drifts 1, 4, and 5 as well as in the back of Drift 6 in the East Cave where mud rushes and pushes have occurred in the past. It furthermore indicates a very high mud rush risk potential in the central portion of Drift 7, which is where a small mud push developed in early February 2012, about 3 months after the November 2011 mud push in the West Cave. A smaller mud

push, which occurred mid-February 2012 in Drift 8, however, was not 'predicted'.

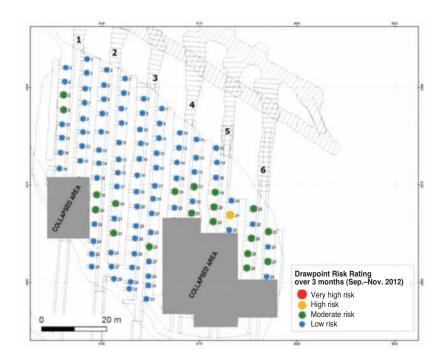
Figure 11 - November 2012 mud rush risk plot for Bultfontein 845 Lvl

As an example, Figure 11 gives the 3-month moving average mud rush risk scores for Bultfontein 845 Lvl for November 2012. The plot indicated a high risk score at Drawpoint 21 in Drift 5. A review of the draw control data showed that this was a badly damaged drawpoint (or A-class drawpoint) from which more than 300 scoops of material was drawn during November 2012, which equated to a relatively high rate of draw compared with draw from many other drawpoints in the cave. A draw control decision was therefore made to repair Drawpoint 21 and to limit draw from this area to reduce the risk score for this drawpoint to a more acceptable level.
