Davidsen, J.E. and Honstad, M. Tap-hole maintenance and management on furnace 10 at Eramet Norway Porsgrunn The Southern African Insitute of Mining and Metallurgy

Synopsis

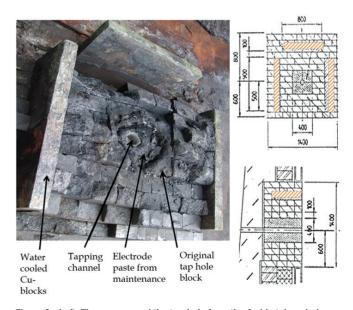
During the relining in 2010 the tapping block on the A-side was removed in a single piece. Figure 3 shows a picture of the inside of the tap-hole, with the original tapping block largely intact. One can clearly see both the tapping channel with the regular plugging paste, as well as the area where the tapping block has been worn away and replaced by electrode paste, as indicated by arrows. This is assumed to be sufficient proof of the effect of the regular maintenance with hot electrode paste. Figure 3 also show that the water-cooled Cu blocks have helped to keep the carbon blocks in place by reducing the movement due to thermal expansion and contraction, preventing infiltration of slag and alloy in the area.

Figure 3—Left: The area around the tap-hole from the A side taken during the relining in 2010. The tapping channel with the plugging paste, the electrode paste used for maintenance, and the original tap-hole block are all visible and indicated with arrows. Right: Original drawings of the tap-hole, showing the dimensions of the Cu blocks and ta-hole block. All dimensions in millimetres

The practice of maintaining the tap-hole channel with electrode paste at furnace 10 was started in 1988. The idea behind the procedure is to inject a carbon-based material which is stronger and more wear-resistant than the normal plugging paste. Electrode paste in the form of 'A clump', a now discontinued product delivered by Elkem Carbon, was originally used for the purpose.

The procedure was established of using hot electrode paste for closing the furnace one tap on each side every week. Due to the electrode paste having a significantly higher softening point than the regular plugging paste, the paste has to be preheated prior to injection. The preheating is done at 60–70°C in a closed cabinet for two to three hours. As electrode paste emits fumes during heating, the cabinet is connected to the same off-gas suction system used to collect the tapping fumes. The heated paste is then loaded into the mud gun, and used to close the tap-hole 'as normal'. The mud gun is kept in front of the tap-hole for 15 minutes after closing in order to allow the electrode paste to start baking. To allow for proper baking of the electrode paste in the tapping channel the next two taps are performed on the opposite tap-hole.
