Investigation of the mechanism for fire-side corrosion in coal-fired boilers in South Africa

Furnace wall tubes from 600 MW subcritical boilers at three coal-fired power stations were sampled and the fireside deposits examined to determine the mechanism of fireside corrosion. This involved an in-depth investigation into the morphology and composition of the fireside deposits and the conditions of the furnace that enable this type of attack. SEM-EDS analysis revealed high concentrations of oxygen, iron, and sulphur, QEMSCAN and XRD analyses identified the presence of Fe_3O_4 , Fe_2O_3 , FeS , and FeS_2 . Differential thermal analysis showed thermal activities at temperatures of 500–600°C, 900–1100°C, and 1100–1250°C, which are associated, respectively, with FeS_2 oxidation to FeS and Fe_2O_3 , at 475–525°C, formation of aluminosilicates at 925–1100°C, and melting of FeS around 1190°C. The absence of sodium and potassium eliminates the contribution of molten alkali sulphates to the corrosion. The consistent coexistence of iron sulphide and iron oxide is indicative of the substoichiometric conditions in the furnace, while the detection of pyrite suggests that the coal is not complete

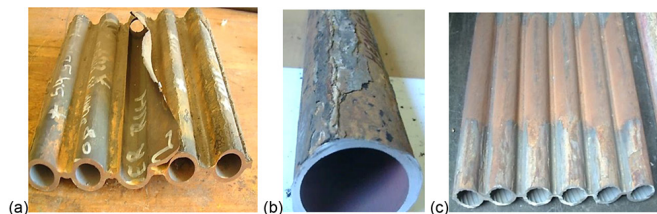
The hard and thick sintered deposits with loosely bonded ash on the fireside of the tubes from the three power stations are shown in Figure 3. The deposit thicknesses were a maximum of 0.975 mm, 0.6 mm, and 0.57 mm for stations A, B, and C respectively. Wall thinning was observed on the cross-sections of the tubes, with the fireside generally showing significant thinning and the cold side exhibiting a uniform wall with minimal thinning. Figures 4 and 5 show the localized wall thinning on the fireside of tubes from stations A and C at the location encompassing a 120° angle of the tube circumferentially (referred to as the 10 o'clock and 2 o'clock positions). One of the ruptured tubes from Station A is shown in Figure 3a. This tube failed due to significant wall thinning and excessive build-up of pressure.

Figure 3—Furnace wall tubes from (a) Station A, (b) Station B, and (c) Station C, showing the fireside deposit. Ruptured tube from Station A is shown in (a)

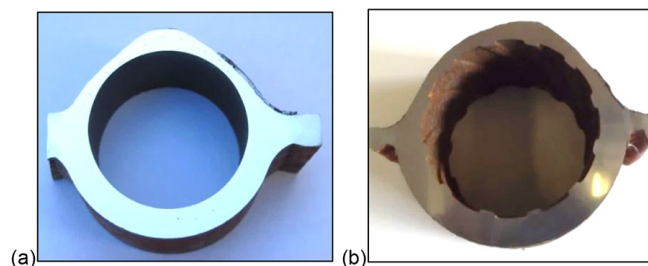
The wall thickness measured on the fireside of Station A tubing varied from 0.1 to 4.93 mm. This implies that the tubes with the original wall thickness of 5.6 mm experienced wall losses ranging from approximately 11.9 to 98.2%. Station C, having tubes, with original wall thickness of 7.5 mm and remaining wall

Figure 5—Cross-section specimens of tubing from (a) Station A and (b) Station C showing localized wall thinning on the fireside

thicknesses of 2.92 to 3.4 mm, experienced relatively lower wall loss, estimated at 45.2 to 65.33%.

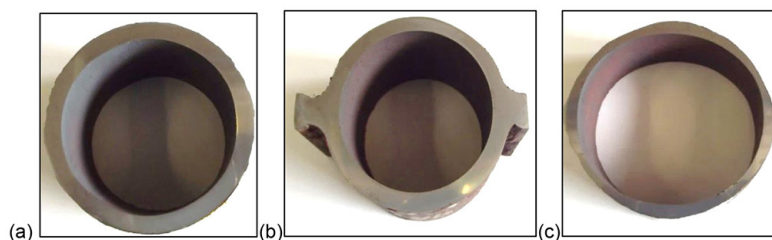
Tubes from Station B showed different features compared to stations A and C. Unit 1 tubes revealed general wall thinning around the circumference. Unit 8 showed wall thinning only on the fireside. Unit 3, on the other hand, showed a completely different picture; inconsistent wall thinning was observed on both the fireside and non-fireside as shown in Figure 6. Observations on tubing from Station B suggest that in addition to fireside corrosion, there may be other forms of attack taking place. Different fireside deposits were also observed on Station B tubing. Units 1 and 3 had hard and thin sintered brown deposits, whereas unit 8 had loosely bonded grey ash deposits. The wall thickness of the tubing from Station B ranged from 1.76 to 5.54 mm. Based on a 6 mm installed wall thickness, the highest wall thinning was measured at 68.57%.

Figure 6—Cross section specimens of Station B tubing showing (a) uniform wall thinning on fire- and cold sides of unit 1, (b) wall thinning on fireside of unit 8, and (c) inconsistent wall thinning around the tube of unit 3

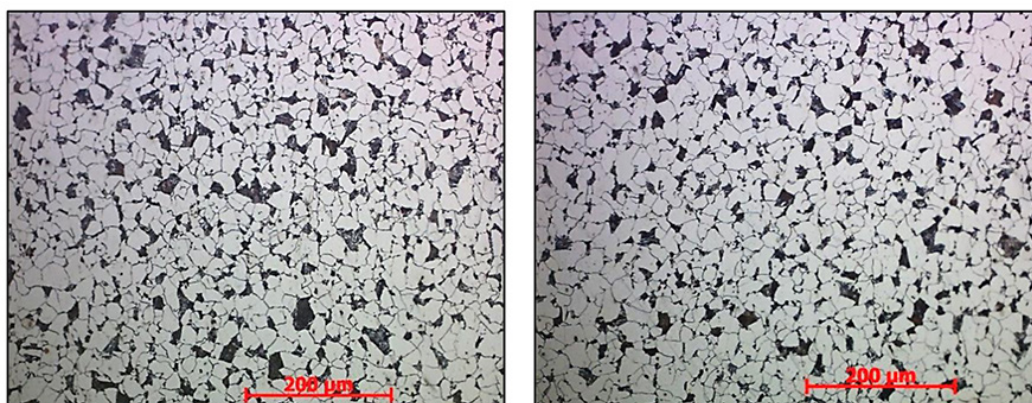
The microstructures observed on tubing samples from the three power stations were the same on both fireside and cold side, as shown in Figure 7. They consisted of well-spheroidized and degenerated carbides, still grouped in the original pearlitic pattern, in a ferrite matrix. A spheroidized microstructure is typical of service-exposed 16Mo3 and A106 Grade B tubing operating at moderately elevated temperatures. A similar appearance between the fireside and cold side indicates that the flame-exposed (fire-) side of the tubing was not significantly hotter than the casing (cold) side.

Figure 7—Microstructure of sidewall tubing from Station A on (left) fireside, and (right) cold side

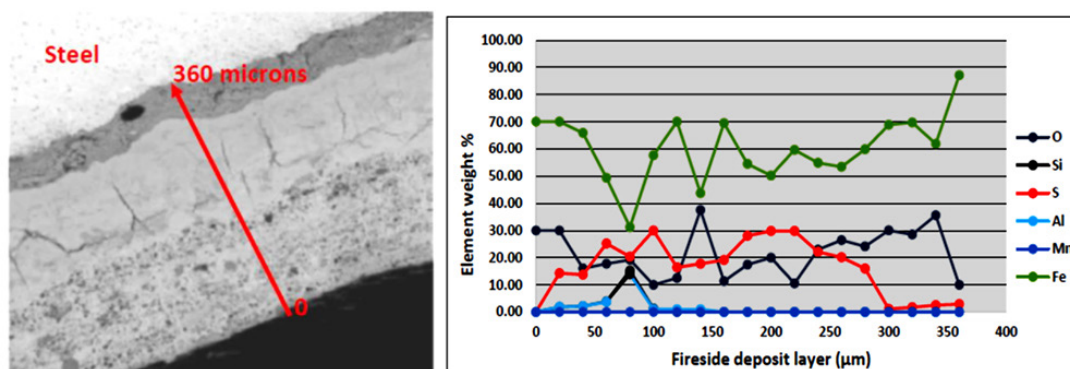
Figure 8—Unit 3 of Station A showing Fe-O rich inner layer, moderate Fe-S and Fe-O middle layer, and Fe-S, Fe-O, and fly ash outer layer

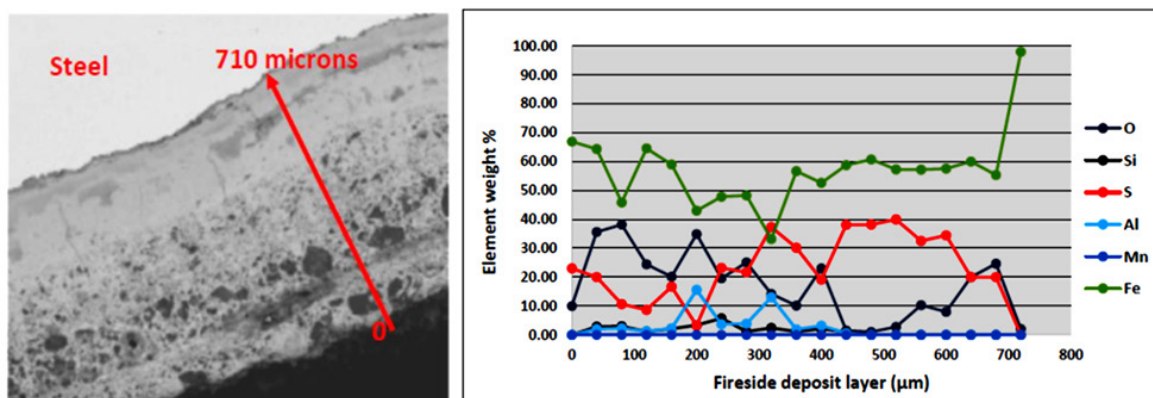
Figure 9—Unit 1 of Station A showing Fe-O rich inner layer, Fe-S middle layer, Fe-S and Fe-O outer layer with particles of fly ash and unburned coal

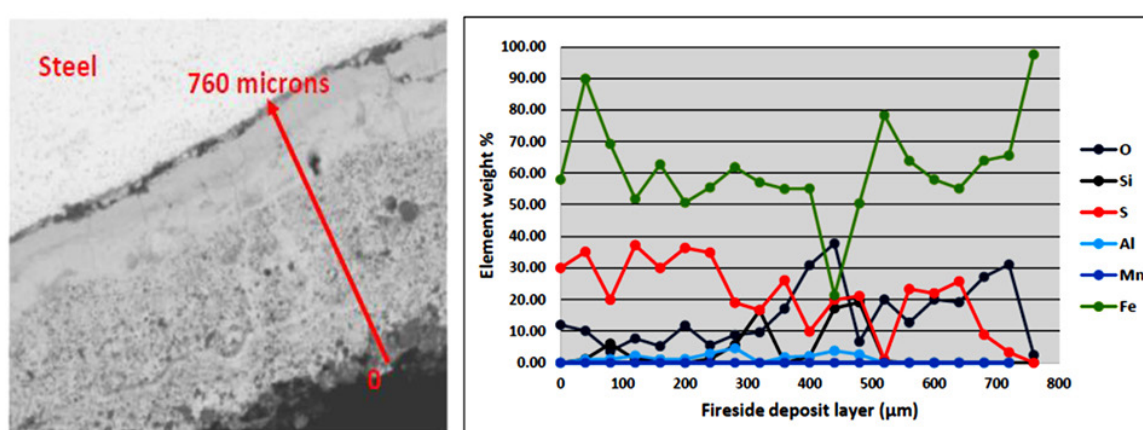
Figure 10—Unit 4 of Station A showing Fe-O rich inner layer, Fe-S rich middle layer, Fe-S/Fe-O outer layer with fly ash particles

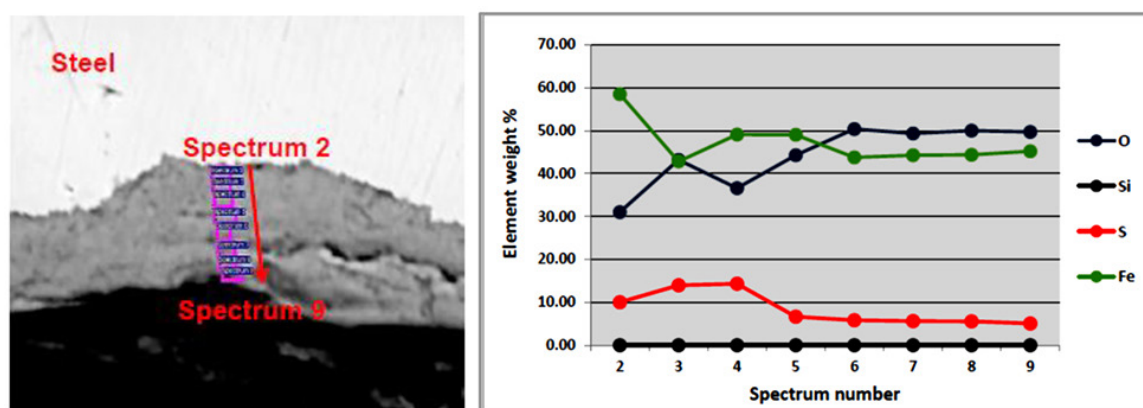
Figure 11—Unit 8 of Station B showing Fe-O rich inner layer with moderate S, and Fe-O rich outer layer with low concentration of S

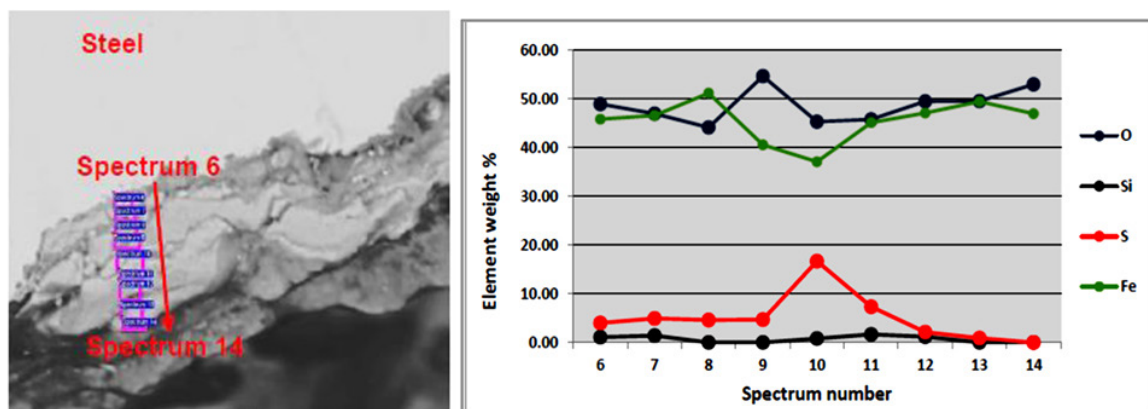
Figure 12—Unit 3 of Station B showing Fe-O rich inner and outer layers with low S, and Fe-O rich middle layer with higher levels of S

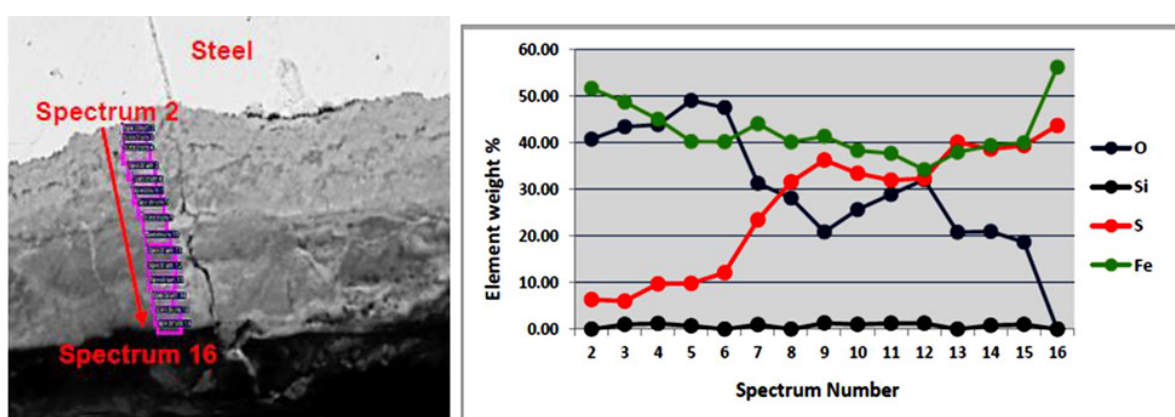
Figure 13—Unit 1 of Station B showing Fe-S rich inner and middle layers with low O, outer layer rich in Fe oxide with higher levels of sulphur and fly ash

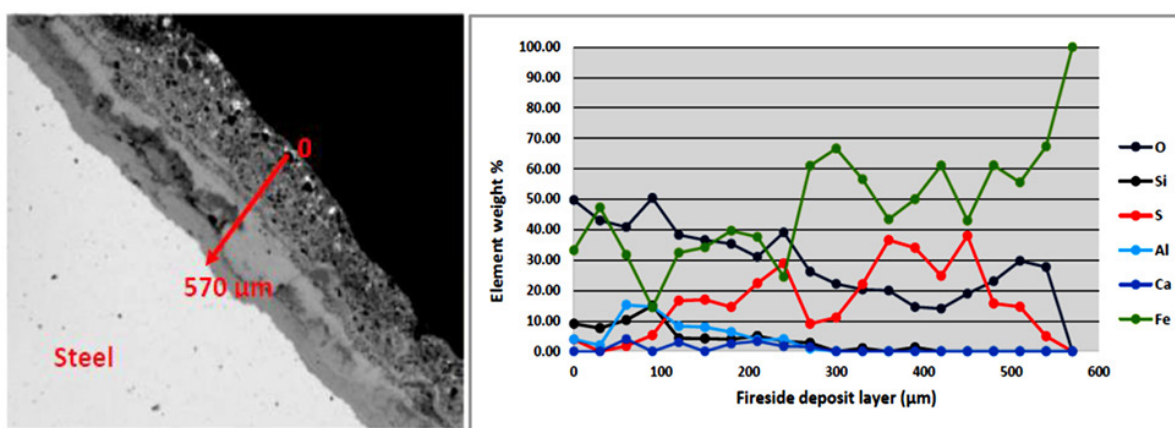
Figure 14—Unit 4 of Station C showing Fe-O rich inner and outer layers and moderate levels of Fe-O and Fe-S in the middle layer. High concentration of fly ash in the outer layer

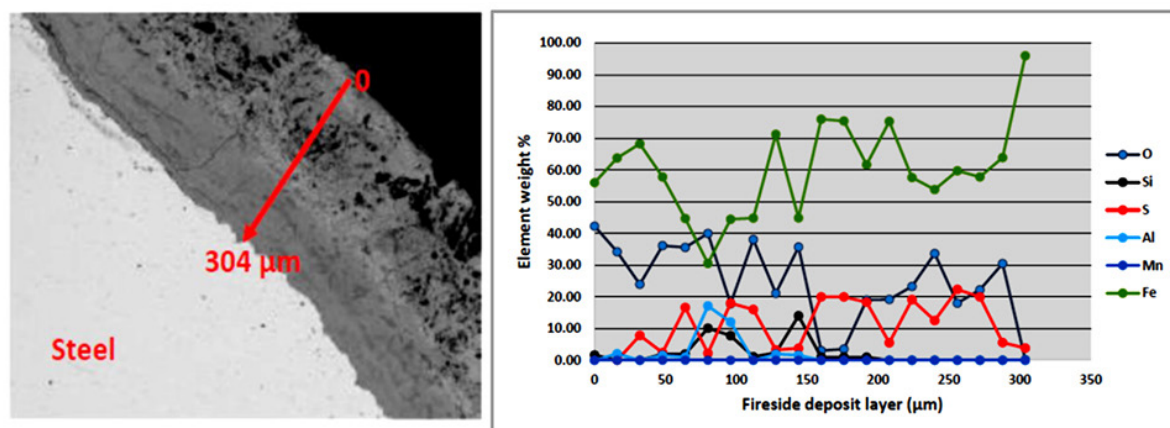
Figure 15—Unit 6 of Station C showing Fe-O rich inner and outer layers, low levels of S, and Fe-O/Fe-S middle layer. Low levels of fly ash particles in the outer layers
