# Stabilisation of Highwall Instability Using Numerical Modelling and Statistical Analysis for Open Pit Mining

**Middindi Consulting (Pty) Ltd**  
Rock Engineering Geotechnics Geology

Rising concerns after highwall failure led to an urgent detailed assessment as increasing fractures and block movement developed at the failed highwalls crest and is close to a public road, approximately 100m.

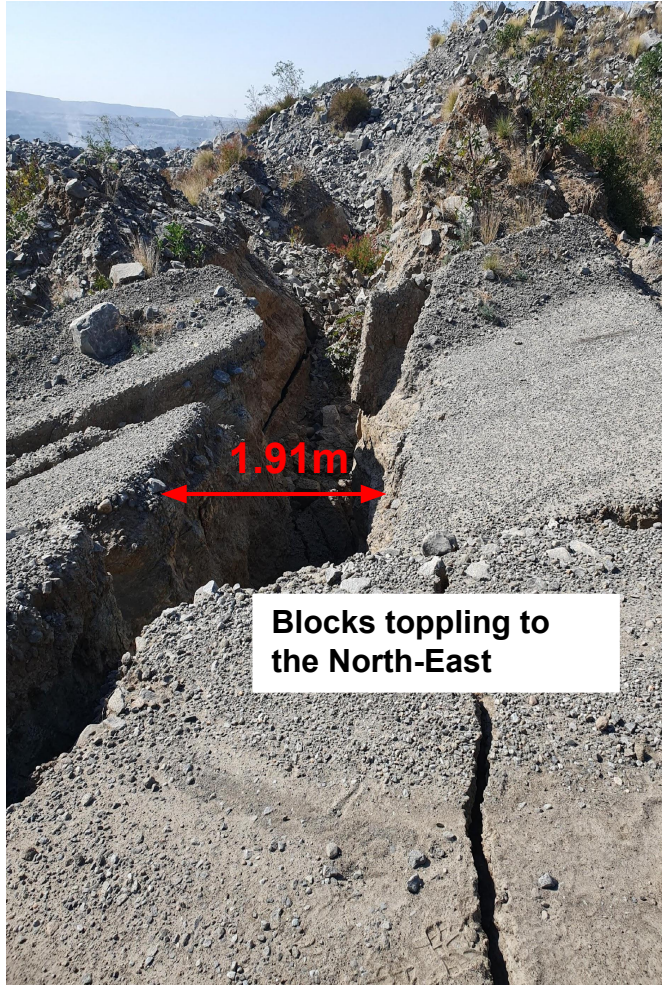
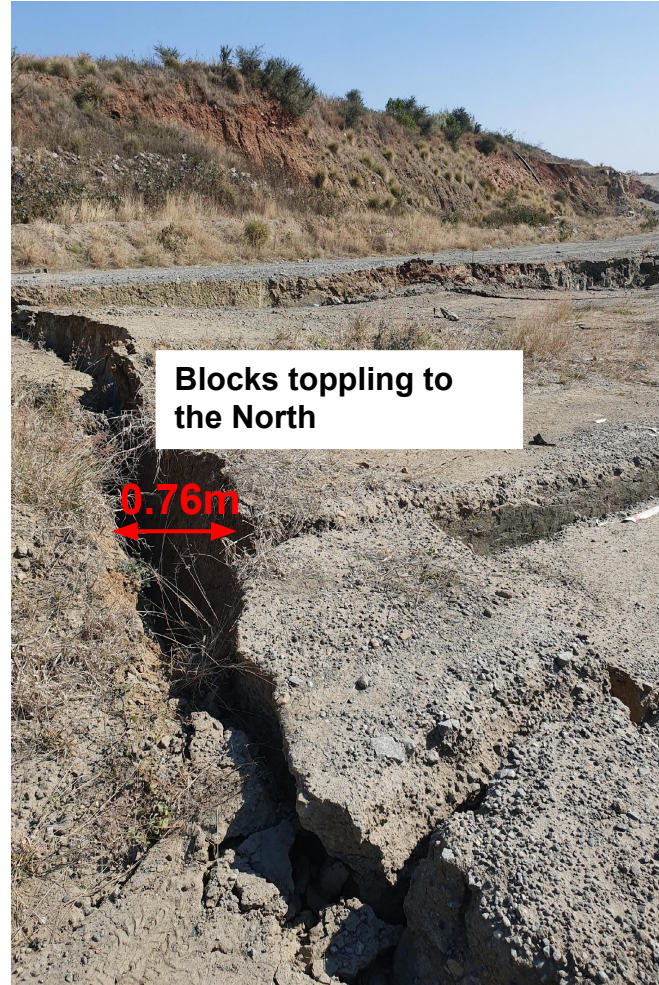
# Site Inspection & Initial Observations

- A site inspection was conducted to assess reported tensile cracks and ground displacement along the south-western crest of the East Pit.
- Prominent open cracks (tension cracks) in ground surface.
- Cracks follow a stepped path in multiple directions.
- Significant block separation and vertical displacement.
- Block toppling/sliding evident.
- Ground displacement visible along crest and surface.

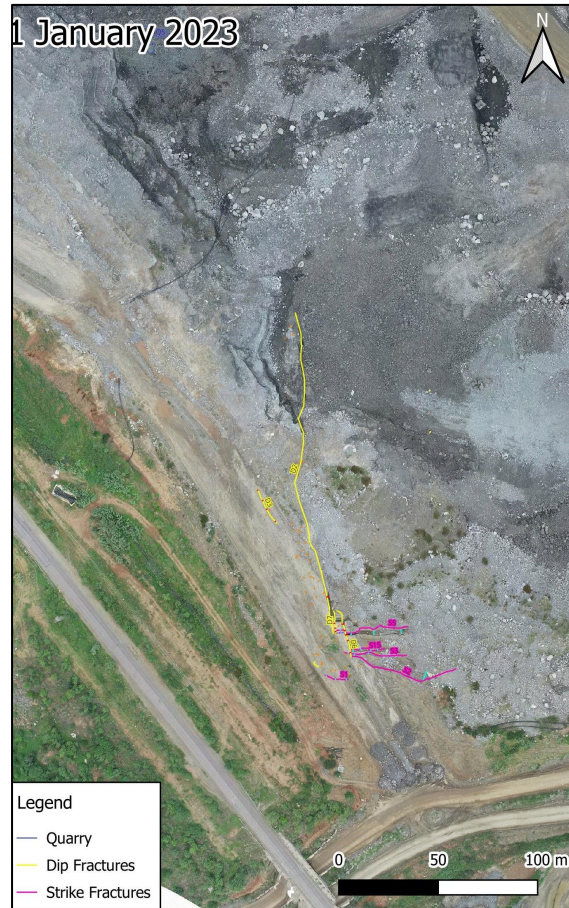
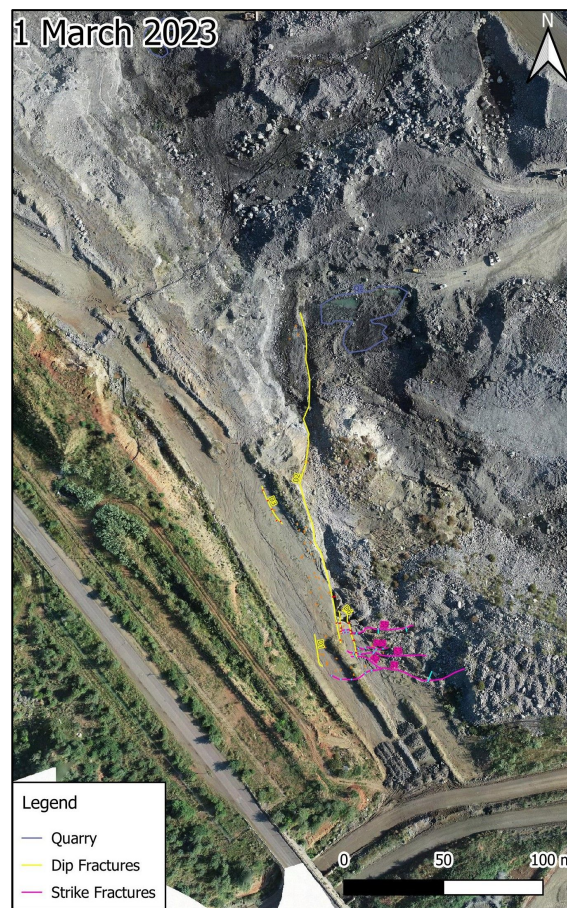
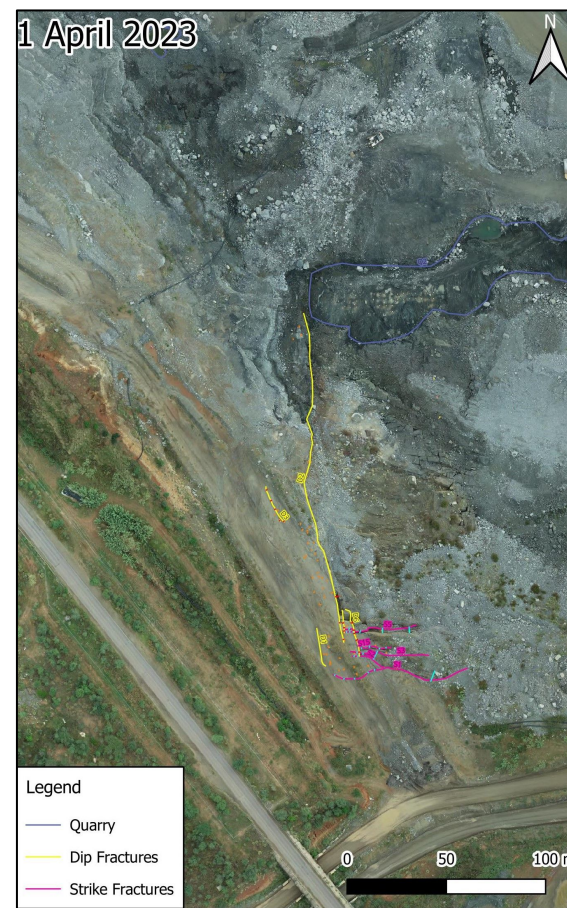
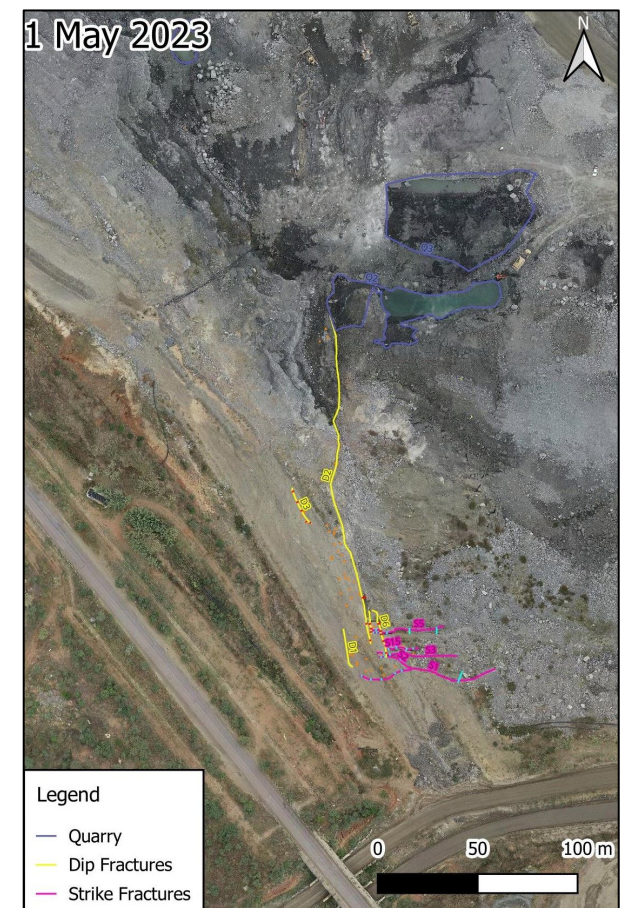
# Progression: 1 January 2023 to 1 May 2023

- Fracture propagation analysis using aerial photographs captured over a six month period.
- A total of 10 Dip fractures, 15 strike fractures, and 28 radial fractures were observed and analysed using QGIS.

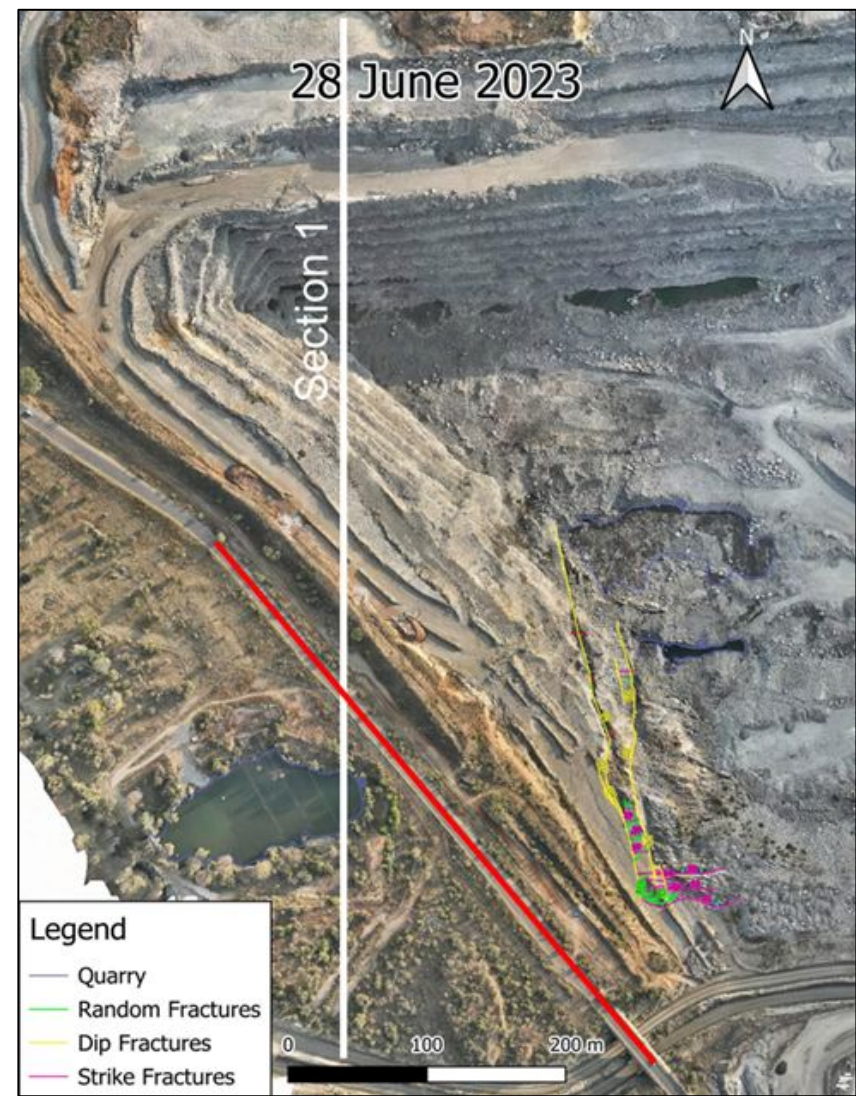
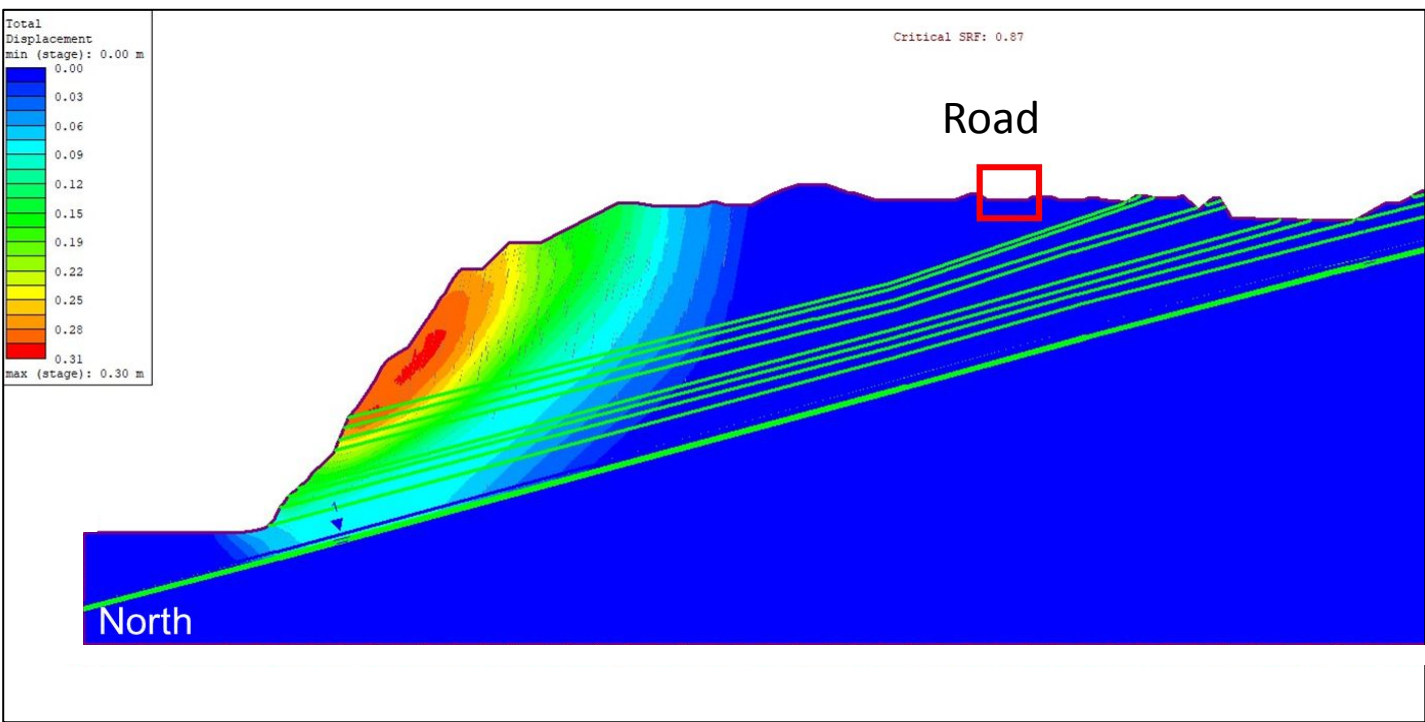
# Risk to public road (NS Section 1)

| SRF | 0.87 |
| Total Displacement | 0.31m |

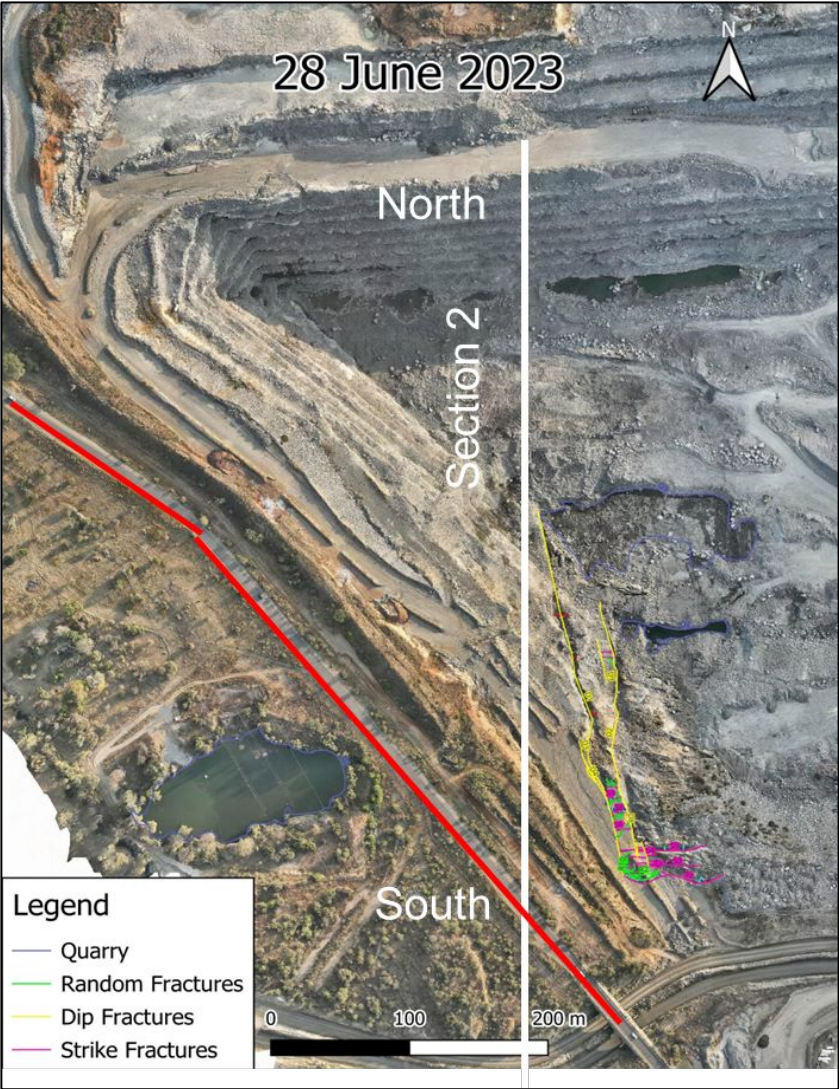
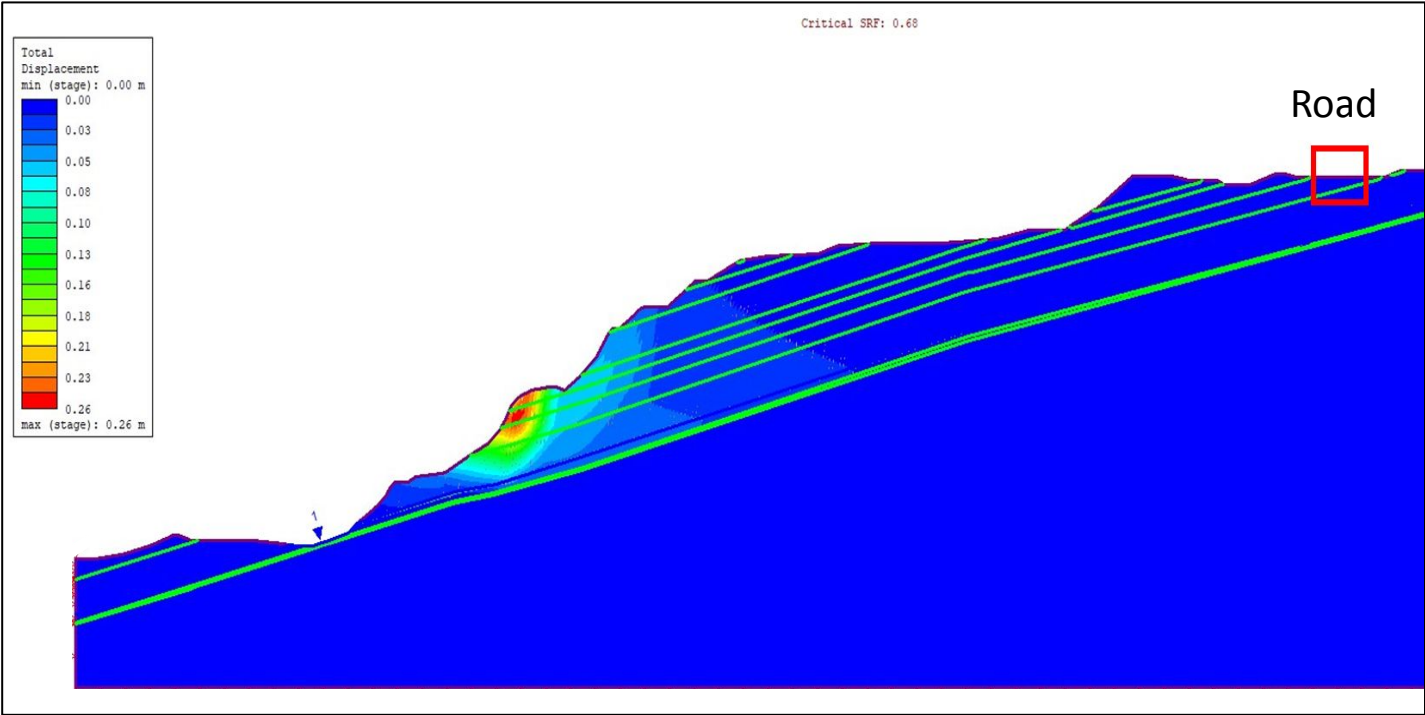
# Risk to public road (NS Section 2)

SRF

0.68

Total Displacement

0.26m

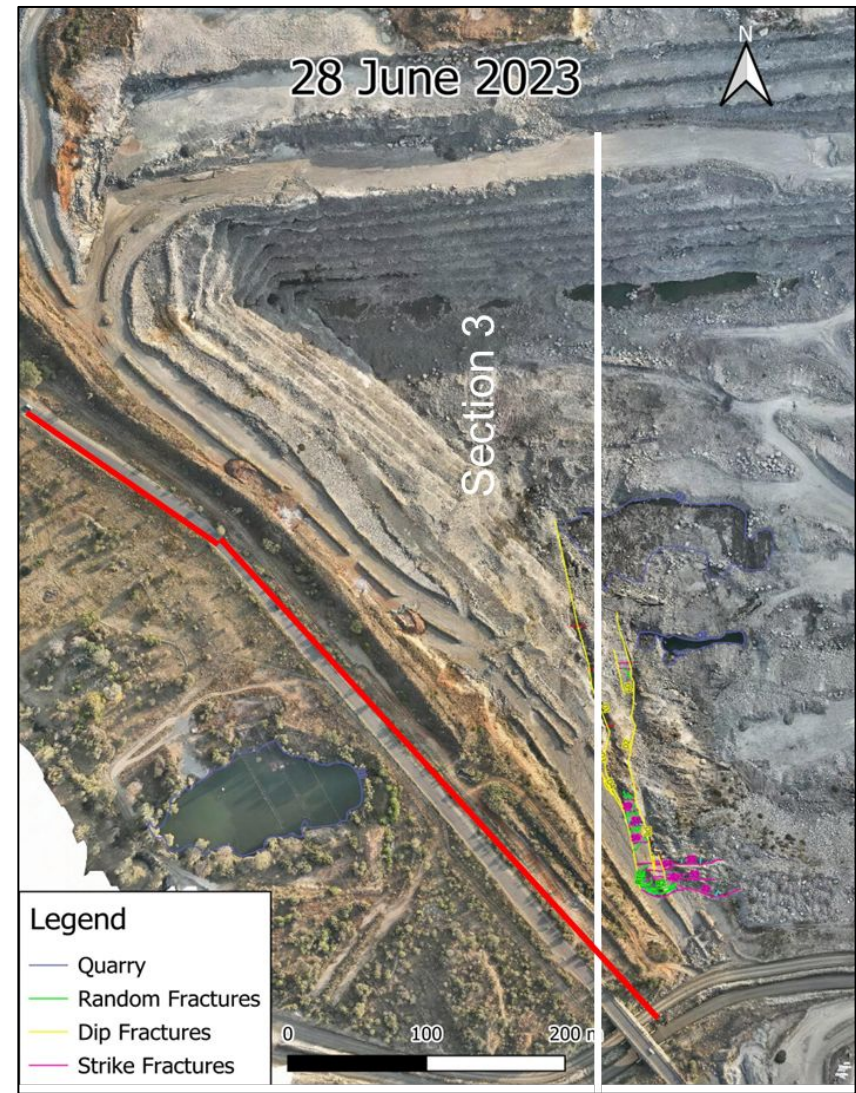
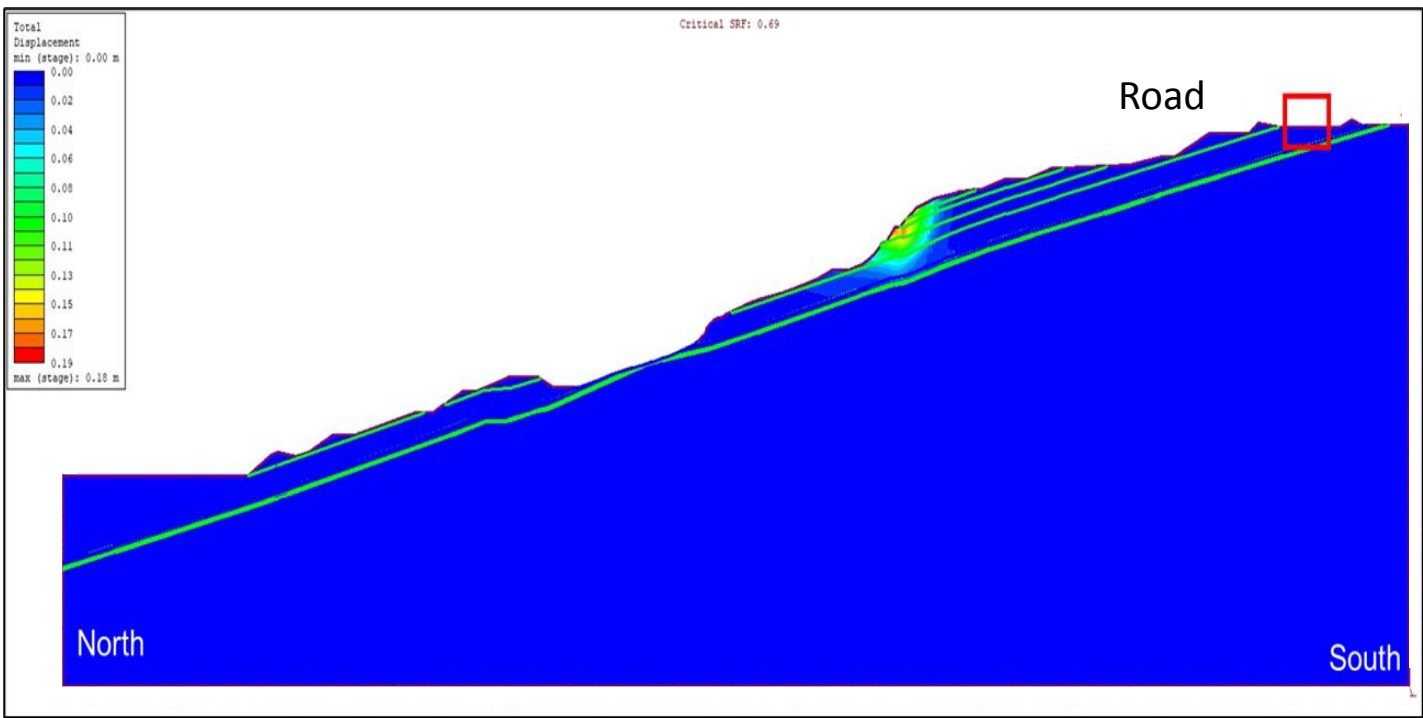
# Risk to public road (NS Section 3)

SRF

0.69

Total Displacement

0.19m

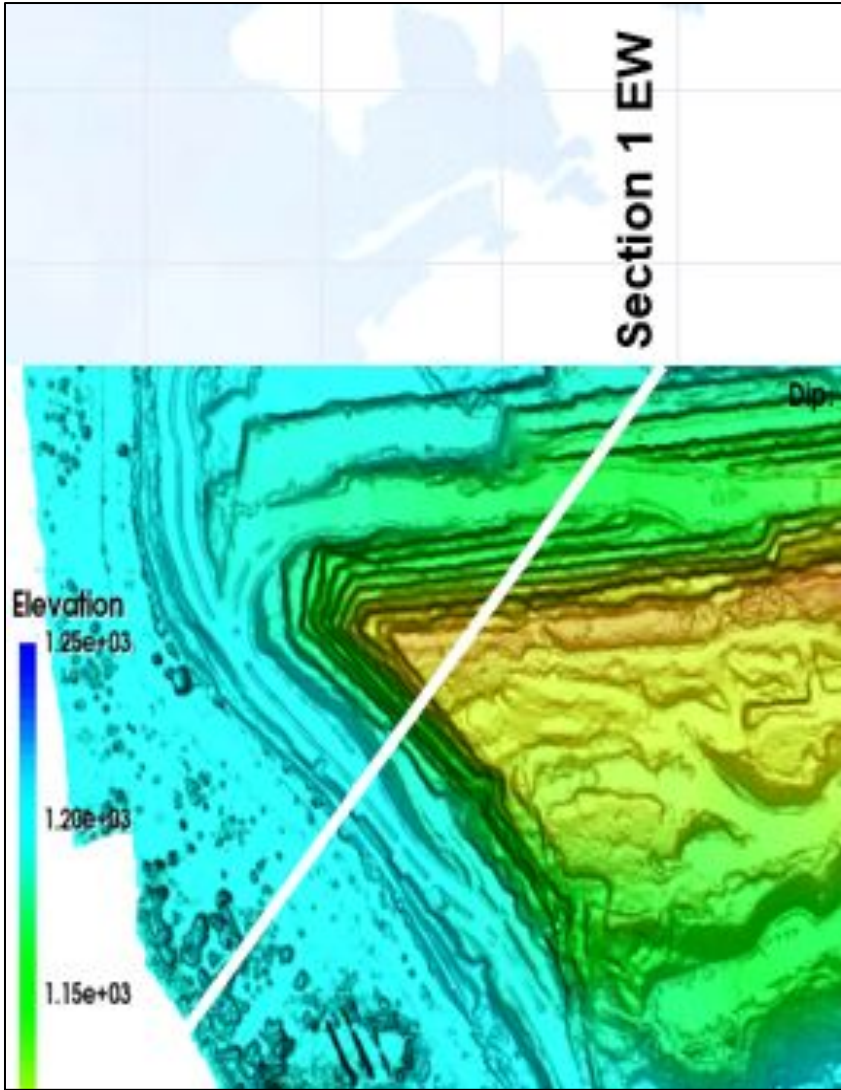
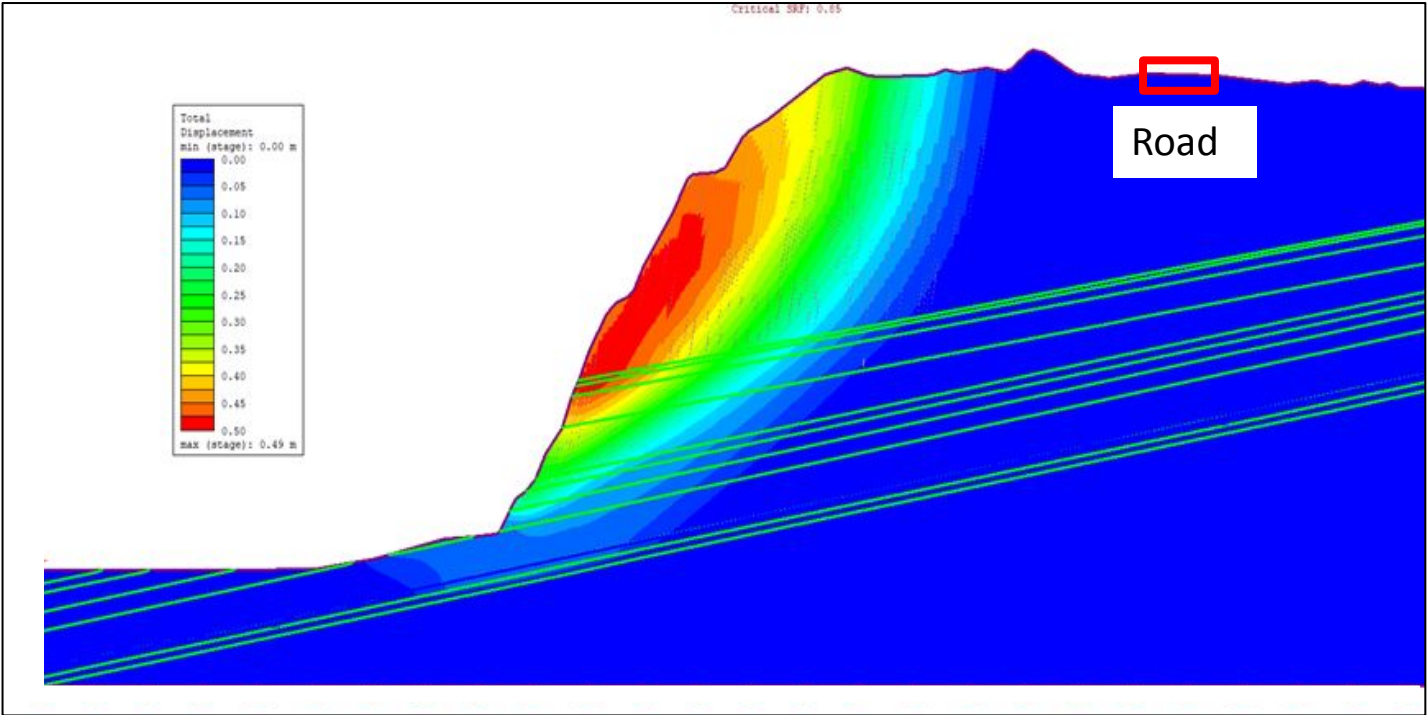
# Risk to public road (EW Section 1)

SRF

0.85

Total Displacement

0.49m

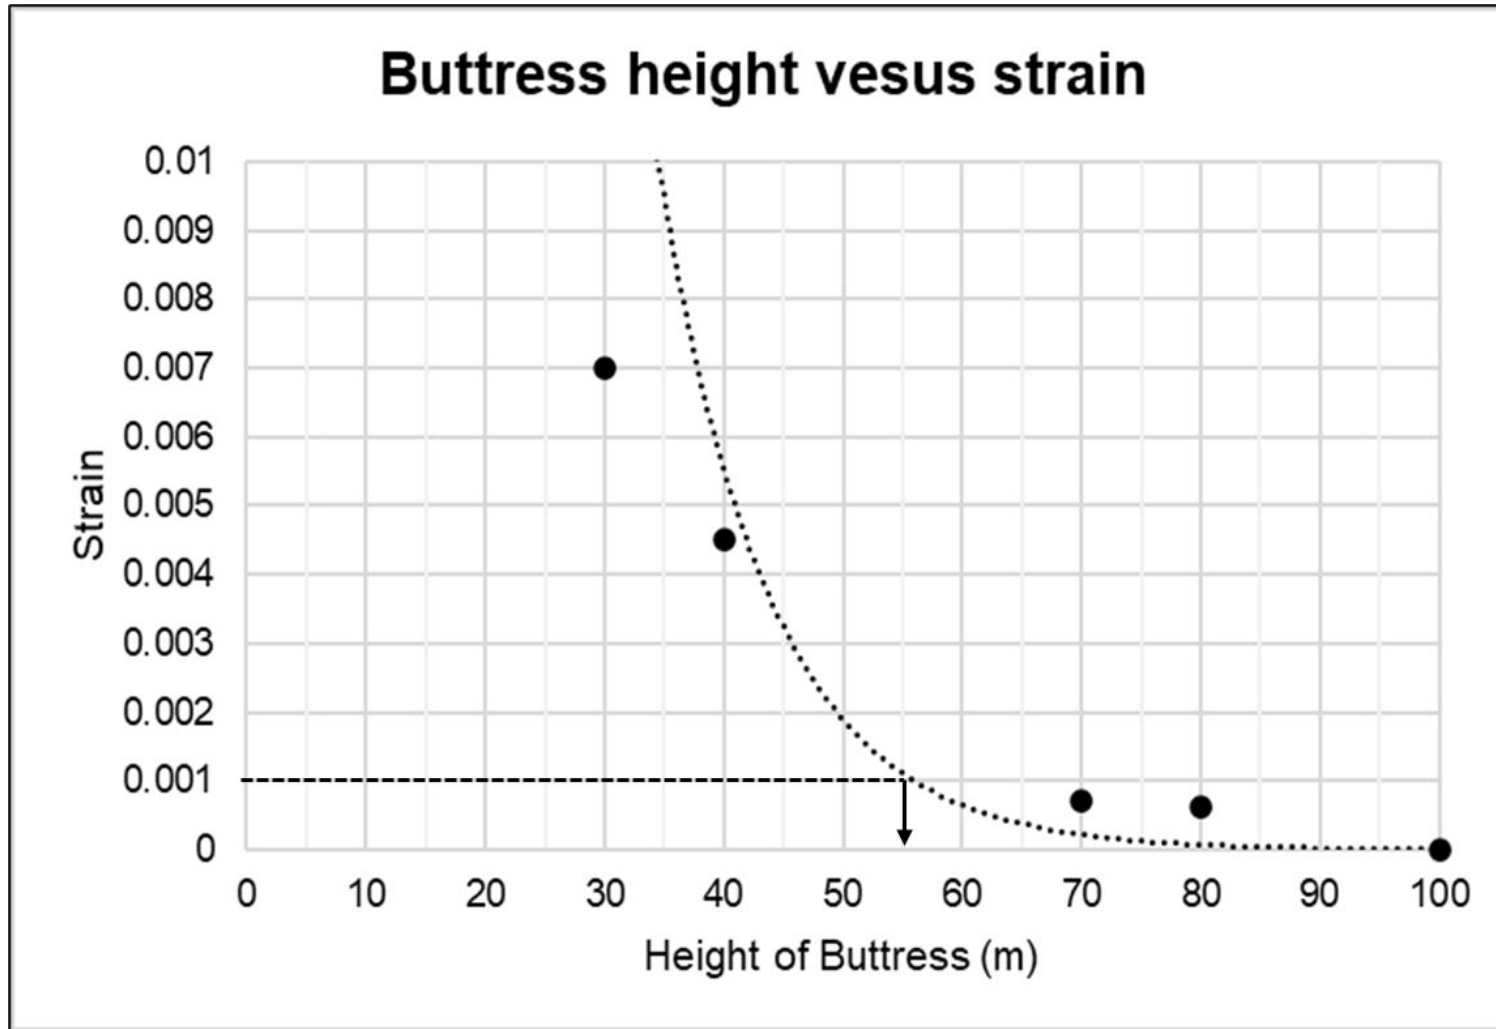
# Height of Buttress Across Highwall

- The West Highwall spans approximately 579 m in width.
- A strain cut-off of 0.001 was used, as this represents the industry standard for allowable strain limits.

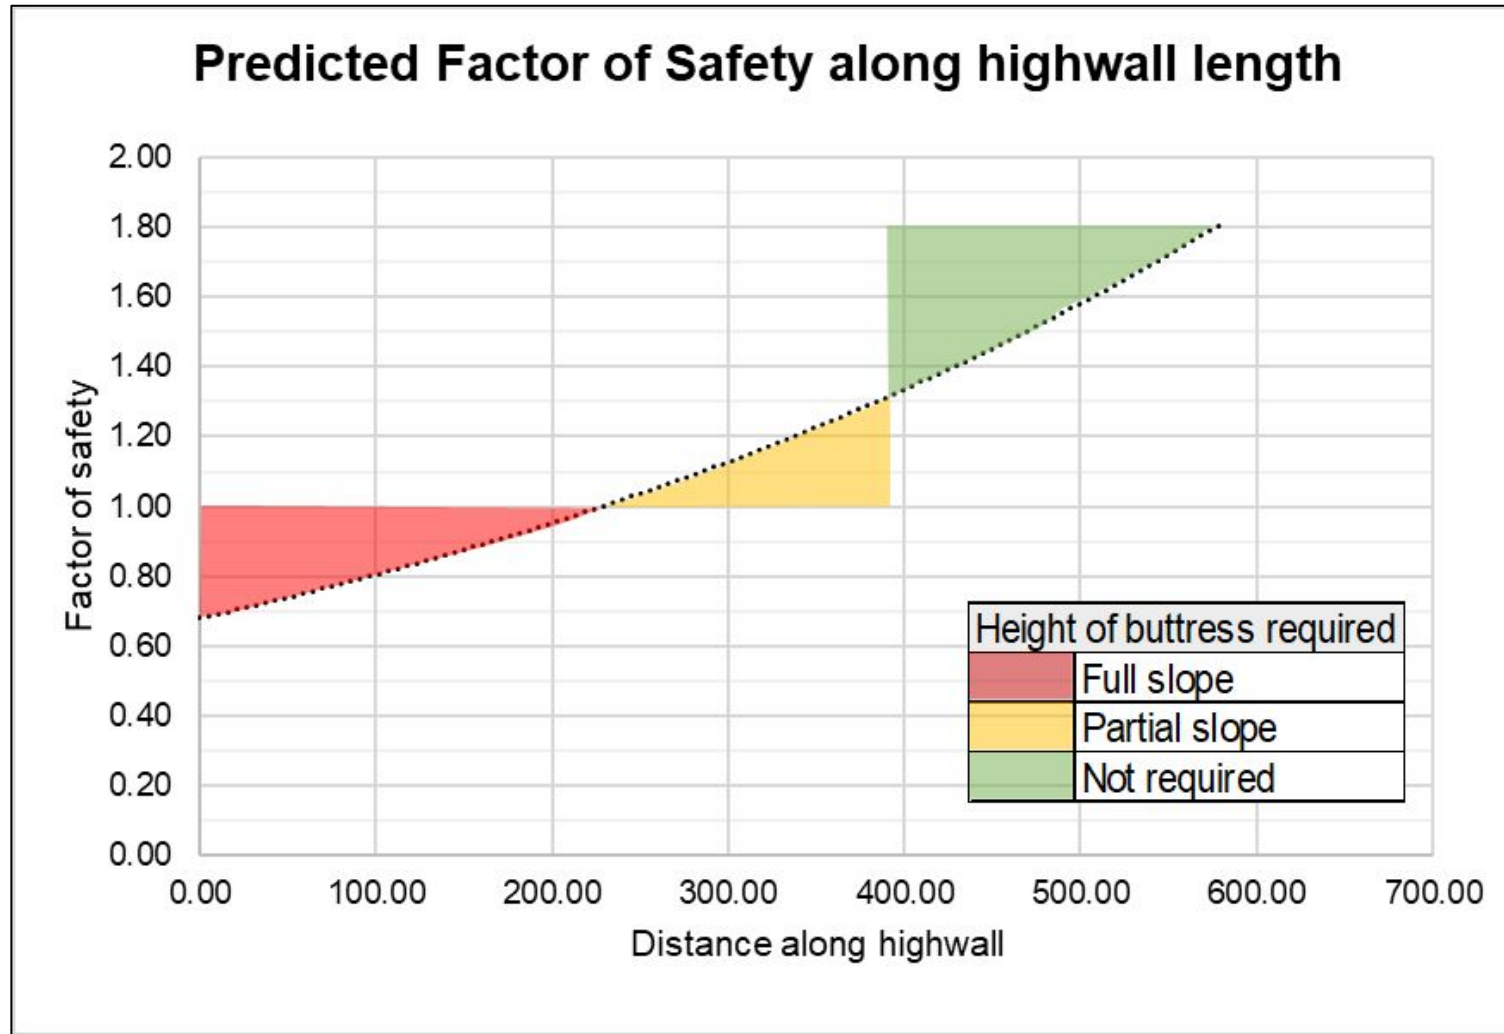
# Length of Buttress Across Failed Highwall

- Our analysis showed that for the first 227m, the West Highwall shows a SF below 1 (red).
- Between 227m and 395m, there is a zone of potential weakness (yellow) .
- Beyond 395 m, no buttressing is needed, allowing for a gradual slope decline.
