# Characterization of firebricks used in copper smelting furnaces of the 19th century, Atacama, Chile

Characterization of firebricks used in copper smelting furnaces of the 19th Century, Atacama, Chile.

Journal of the Southern African Institute of Mining and Metallurgy, vol. 123, no. 7, pp. 343–348

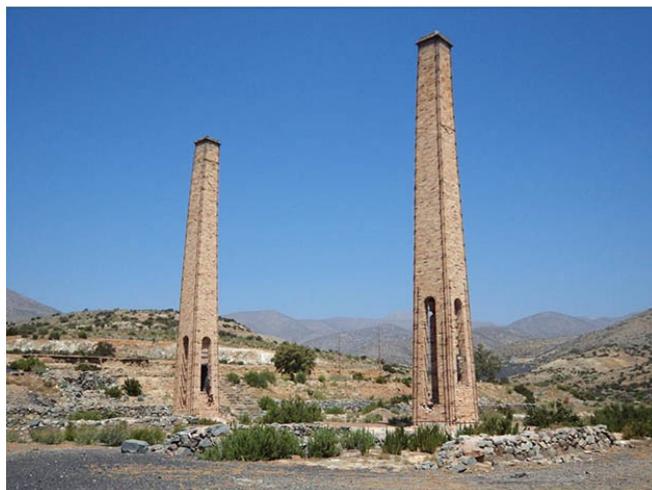
Few vestiges of copper smelting remain today, and these remnants could totally disappear in the future. Figure 1 shows the ruins of a smelter, with only the chimneys remaining standing. These chimneys, the only examples of their kind, have been declared a National Monument of Chile, in the category of Historical Monument (Consejo de Monumentos Nacionales de Chile, 1996).

Figure 1—Torres de Labrar in the commune of Freirina, declared a National Monument of Chile (Consejo de Monumentos Nacionales de Chile, 1996 Consejo de Monumentos Nacionales de Chile, 2021)

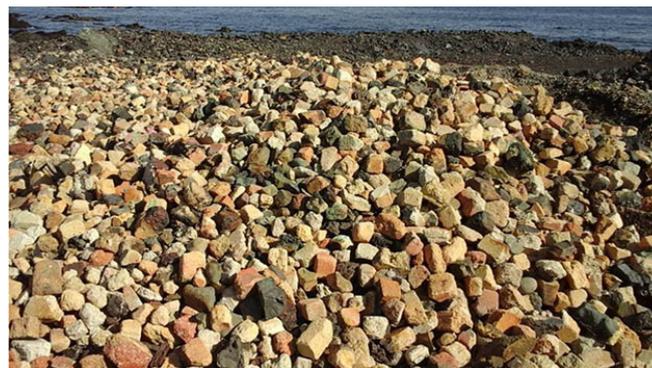
Among the residues found in the abandoned mining settlements are a great variety of refractory bricks that were used in the copper smelting furnaces, which are mostly broken, with the manufacturers’ names partially or totally missing (see Figure 2). Until now, no studies have been reported that characterize these bricks. The objective of this research was to characterize 10 different types of refractory bricks (Figure 3), using various laboratory techniques to determine the chemical and mineralogical composition, mechanical resistance by a non-destructive method, the density, and in addition to identify the manufacturers. The results of this study can contribute to the knowledge of these materials that are a significant part of the Chilean mining and metallurgical heritage.

Figure 2—Pile of refractory bricks on a copper dump at the coast

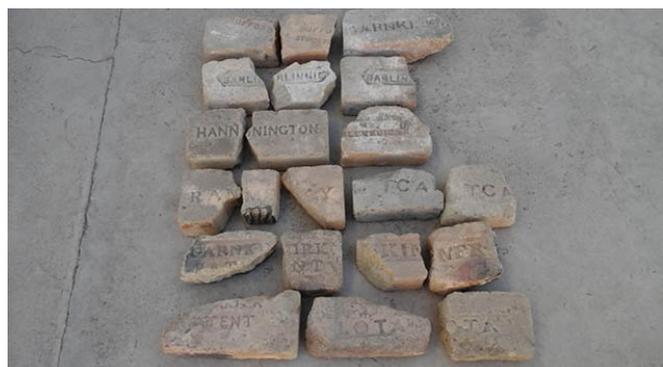
Figure 3—Refractory bricks studied

assumed that these were widely used bricks. Of the total samples, only 10 different types were selected and bearing the following manufacturer's marks: Barlinnie, Garkirk, Garkirk Patent, Glenboig, Hannington, Lota, Ramsay, Rufford Stourbridge, Skinner, and Tcarr.

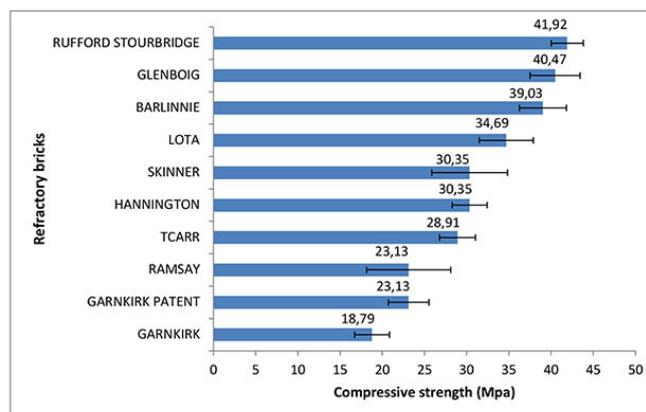
The results of the compressive strength tests of the bricks are presented in Figure 4. The maximum values were obtained for the Rufford Stourbridge and Glenboig bricks, at 41.92 MPa and 40.47 MPa, respectively, while the minimum values were for Garnkirk at 18.79 MPa. The strength of the Ramsay and Garnkirk Patent bricks was 23.13 MPa.

Figure 4—Average compressive strength of refractory bricks measured with Schmidt hammer

The difference in compressive strength observed between the different bricks would be related to the compaction method of the fresh clay mortar before firing. On the other hand, the compressive strength values can be related to the apparent densities shown in Table II, from which it can be deduced that bricks with a low apparent density have a higher porosity, which adversely affects the final strength. On the other hand, bricks may have suffered from microcracking due to thermal shock. Refractory materials are formulated to withstand rapid changes in temperature without fracturing. However, when subjected to repeated cycles of heating
