# Risk-based slope design: Insights from the Thabazimbi failure

by M. Bester<sup>1</sup>, T. Dlokweni<sup>2</sup>, I. Basson<sup>3</sup>, C. Koegelenberg<sup>3</sup>

Bester, M., Dlokweni, T., Basson, I., Koegelenberg, C. 2025. Risk-based slope design: Insights from the Thabazimbi failure. *Journal of the Southern African Institute of Mining and Metallurgy*, vol. 125, no. 8, pp. 421–436

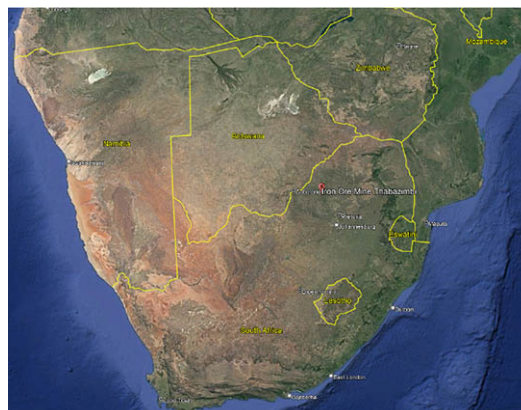
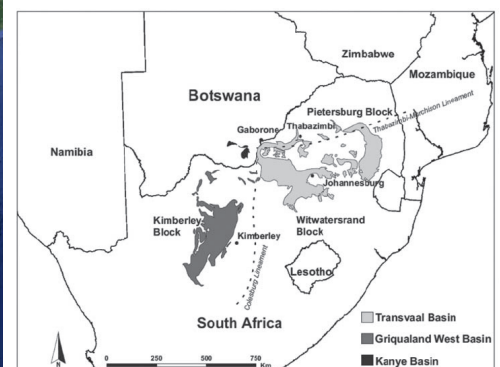
Figure 1—Location of Thabazimbi Iron Ore Mine and the distribution of the Transvaal Supergroup

Thabazimbi ("mountain of iron" in Setswana) Mine has been operating since 1932 and is currently in the closure phase. It is situated approximately 250 km north of Johannesburg in the Limpopo Province of the Republic of South Africa (Figure 1). Thabazimbi mine primarily produced high-grade haematite ore (more than 62% iron (Fe) content), which is particularly low in contaminants and sold exclusively to ArcelorMittal South Africa. The Thabazimbi area has a recorded mean annual precipitation (MAP) of 645 mm, of which 90% falls between October and April. The area is characterised by high peak temperatures, with daily maximum temperatures that may rise above 40 °C in summer.

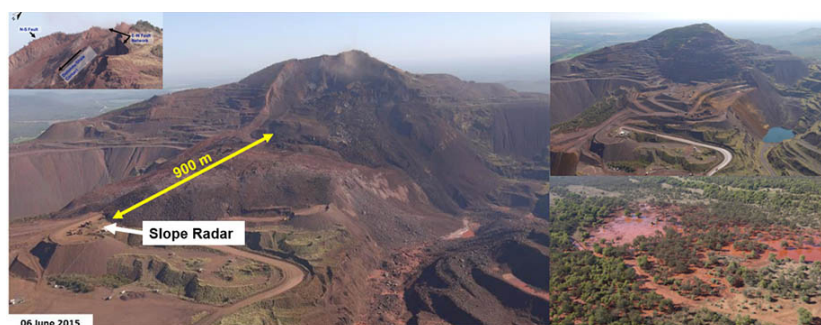
Figure 29—Slope failure showing run out distance and the area from where approximately 280 000 m<sup>3</sup> of water was ejected

- **Saturday, 6 June 2015:** Failure occurred at 02:45 with a run-out of approximately 900 m in less than 5 minutes (Figure 29). The anisotropic nature of BIF—characterised by steeply dipping bedding on the western side, and therefore non-daylighting in the slope—contributed significant strength to

the entire BIF rock mass. This strength allowed a buildup of stress at the toe of the failure surface. It is inferred that the accumulated stress triggered the violent nature of the failure, which also accounts for the extensive run-out distance. It may also be inferred that, had the BIF featured daylighting bedding (weaker orientation), failure would likely have shown movement at the toe earlier and exhibited slower movement, akin to the earlier Kumba West failure (a slow moving smaller failure that occurred earlier).
