FIRST QUANTUM  
MINERALS LTD

# Running A Successful 4 Acid plant year Campaign

# Kansanshi Mine

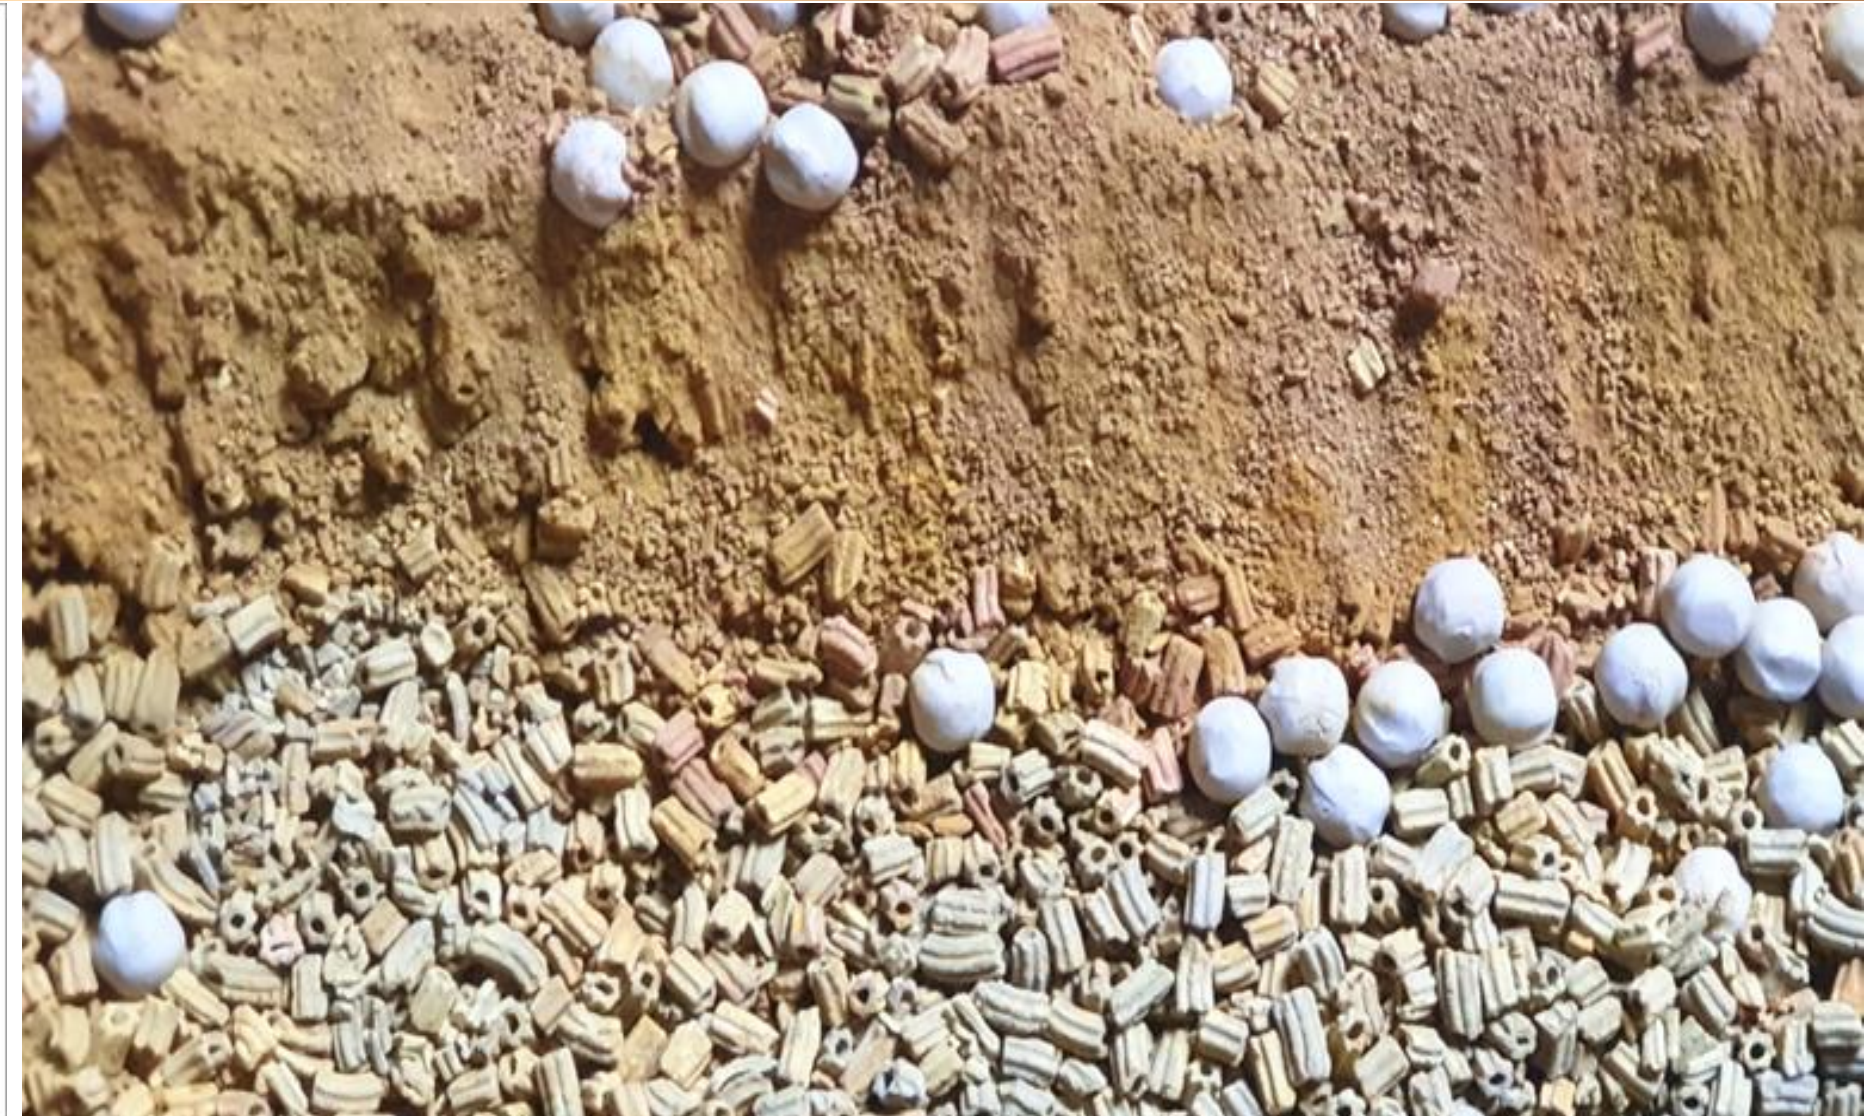
# Bed 1 pressure drop and Catalyst screening

- Fast pressure drop rise in bed 1
- Dust layer on top 100 -200 mm catalyst.
- Elimination process - Dust, Moisture, Poisons
- Samples results indicated slightly elevated levels of impurities than design. Si, F, High SO<sub>2</sub>.

| Campaign No. | Time of Stoppage | Campaign Duration [Months] | Reason for Stoppage | Beds screened | Changes implemented | Achievement |
|---|---|---|---|---|---|---|
| 4 | Jun 2020 | 12 | Unplanned stoppage - High $\Delta P$ in Bed 1 | Bed 1 | Introduced dust protection catalyst on top layer<br>Put new catalyst type on top of Bed 1 | Bed 1 $\Delta P$ reduced to 1.0 kPa from 5.0 kPa |

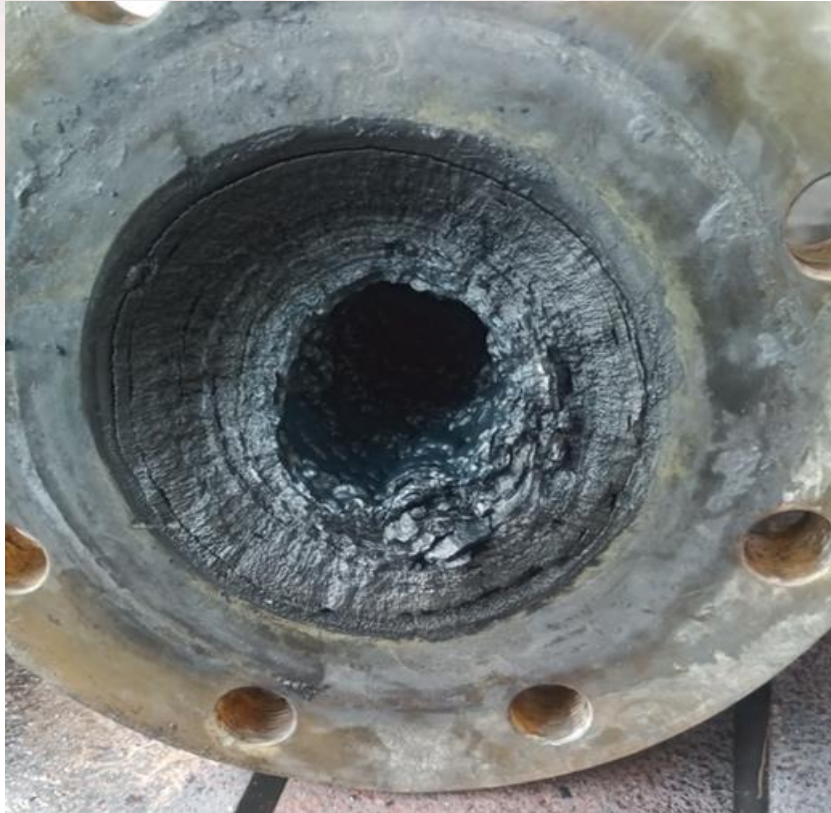
*Quench tower circulation pipes blocking*

- Gradual build-up
- High Selenium content
- Requires frequent cleaning

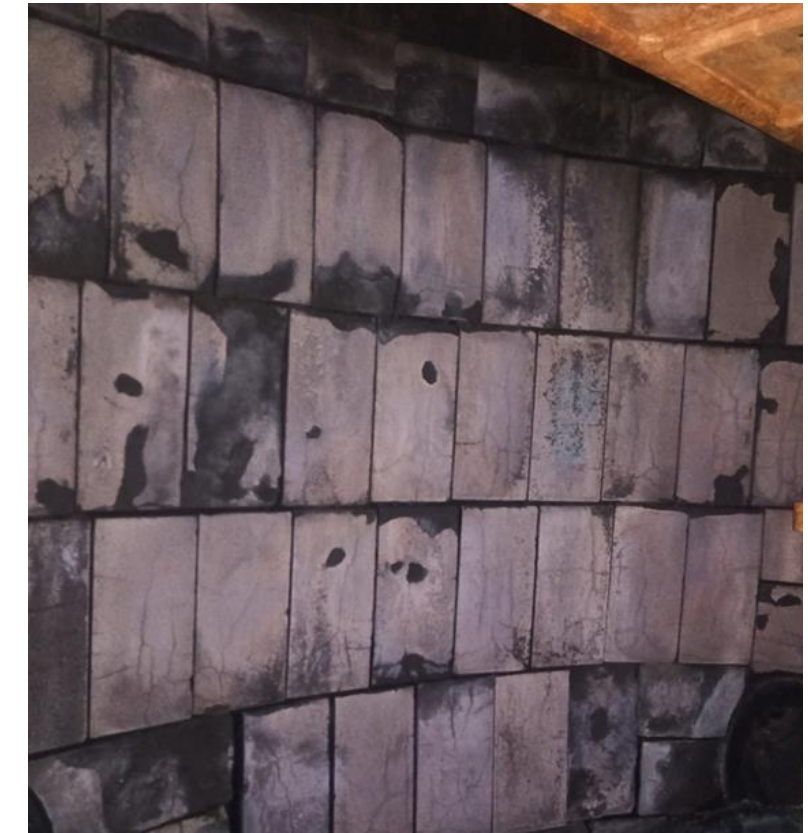
*Scrubber bricks spalling*

- Carbon bricks above quench nozzles
- mostly localised

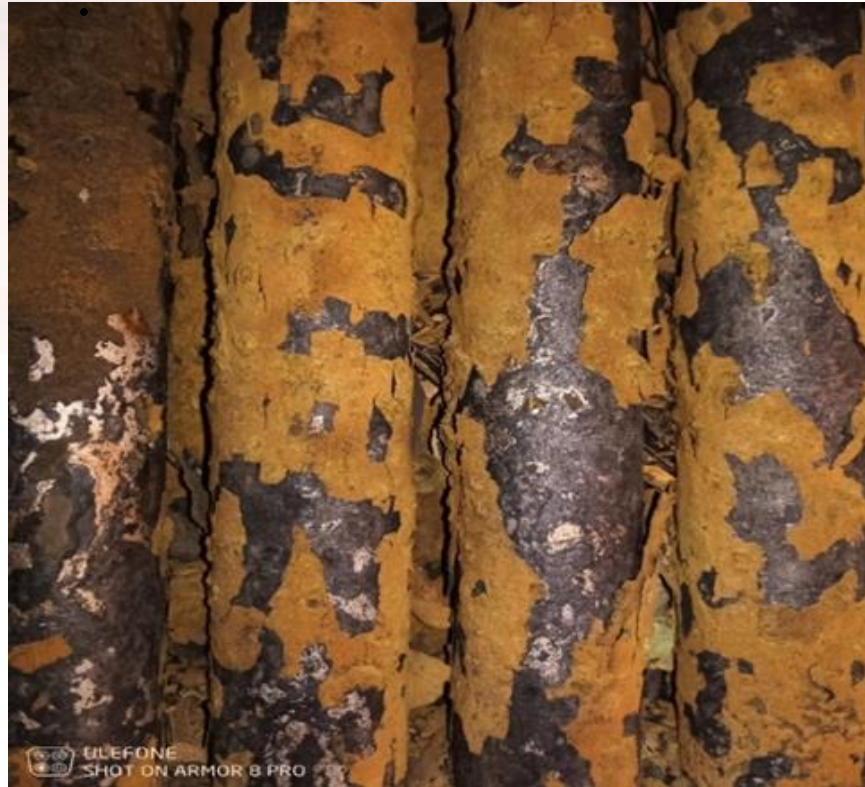
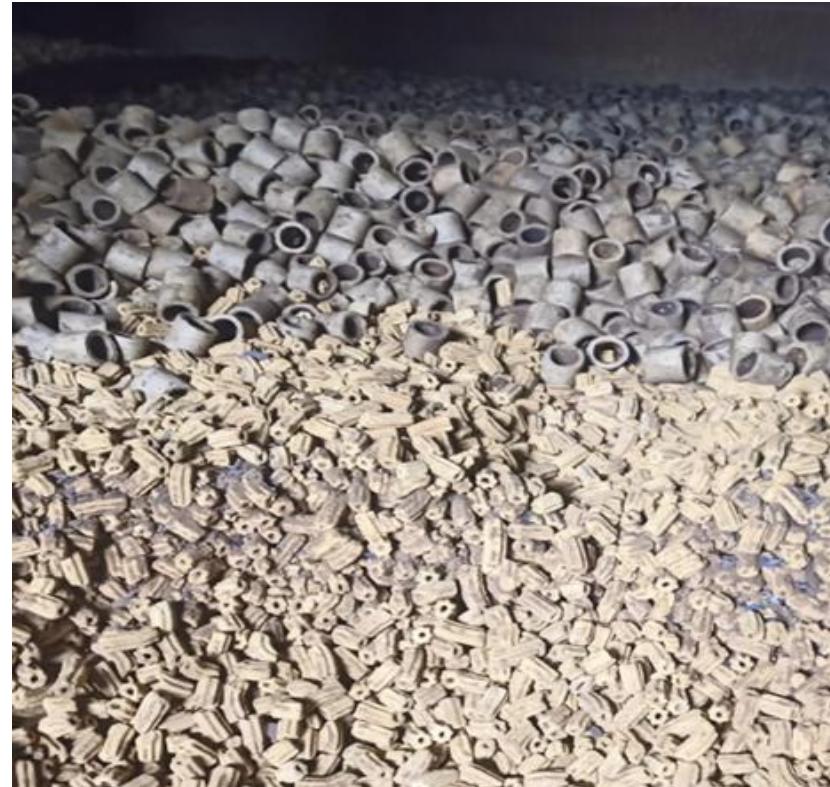
## *Hot heat Exchanger*

- Metal loss on the tubes.
- High  $\Delta P$  across heat exchanger
- Deposit on bed 2 surface
- Difficult to clean

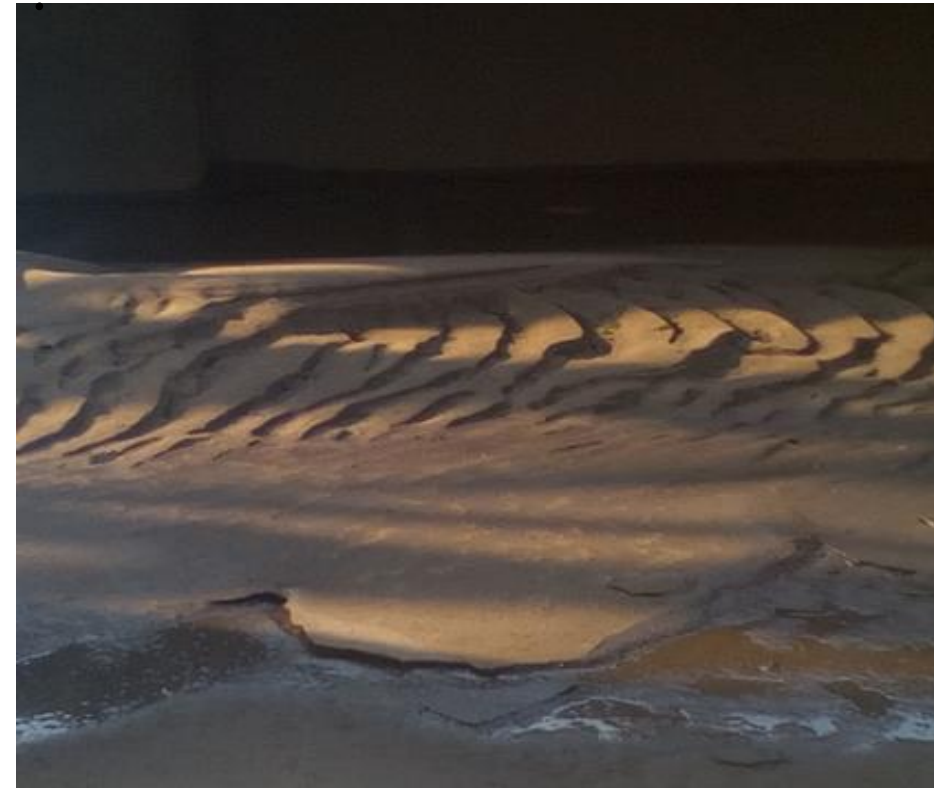
## *Silt in cooling tower*

- Silt depositing in cooling tower
- Cause under-deposit corrosion in acid coolers
