# Characterisation of the reworked residual norite in the Rustenburg Region of South Africa

# Why this matters – GISTM & TSF stability

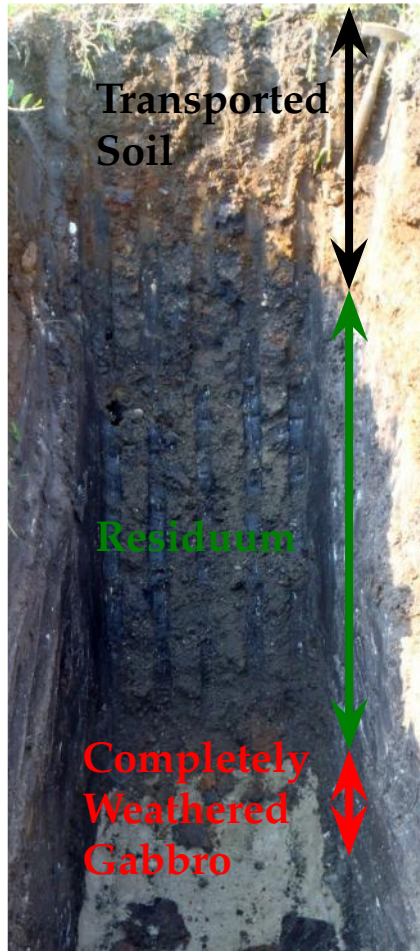
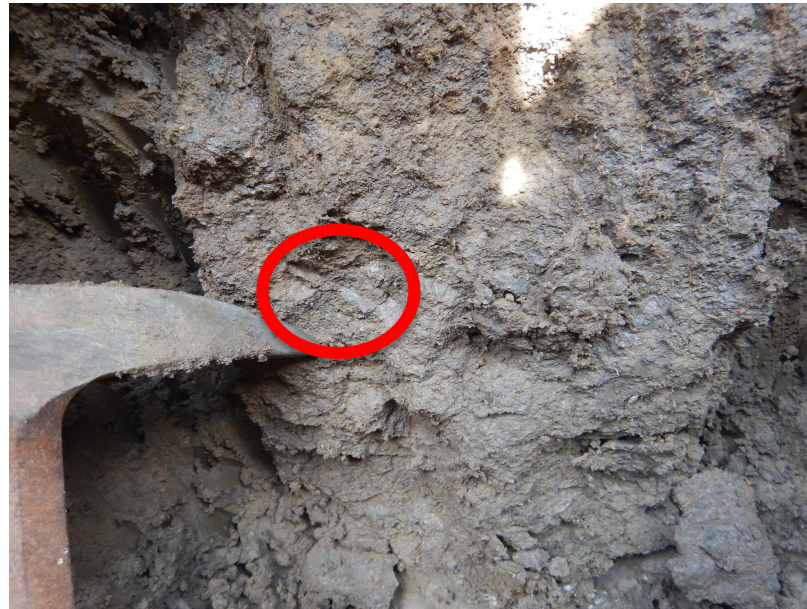
Due to the high swell and shrinkage potential, remulching is common which results in the presence of slickensides. These planes are not aligned and non-continuous which is characteristic of residual soils
