# Cross-Calibrated In-Situ Shear Strength of Gold Tailings

from CPTu, Vane Shear, and NorSand Modeling

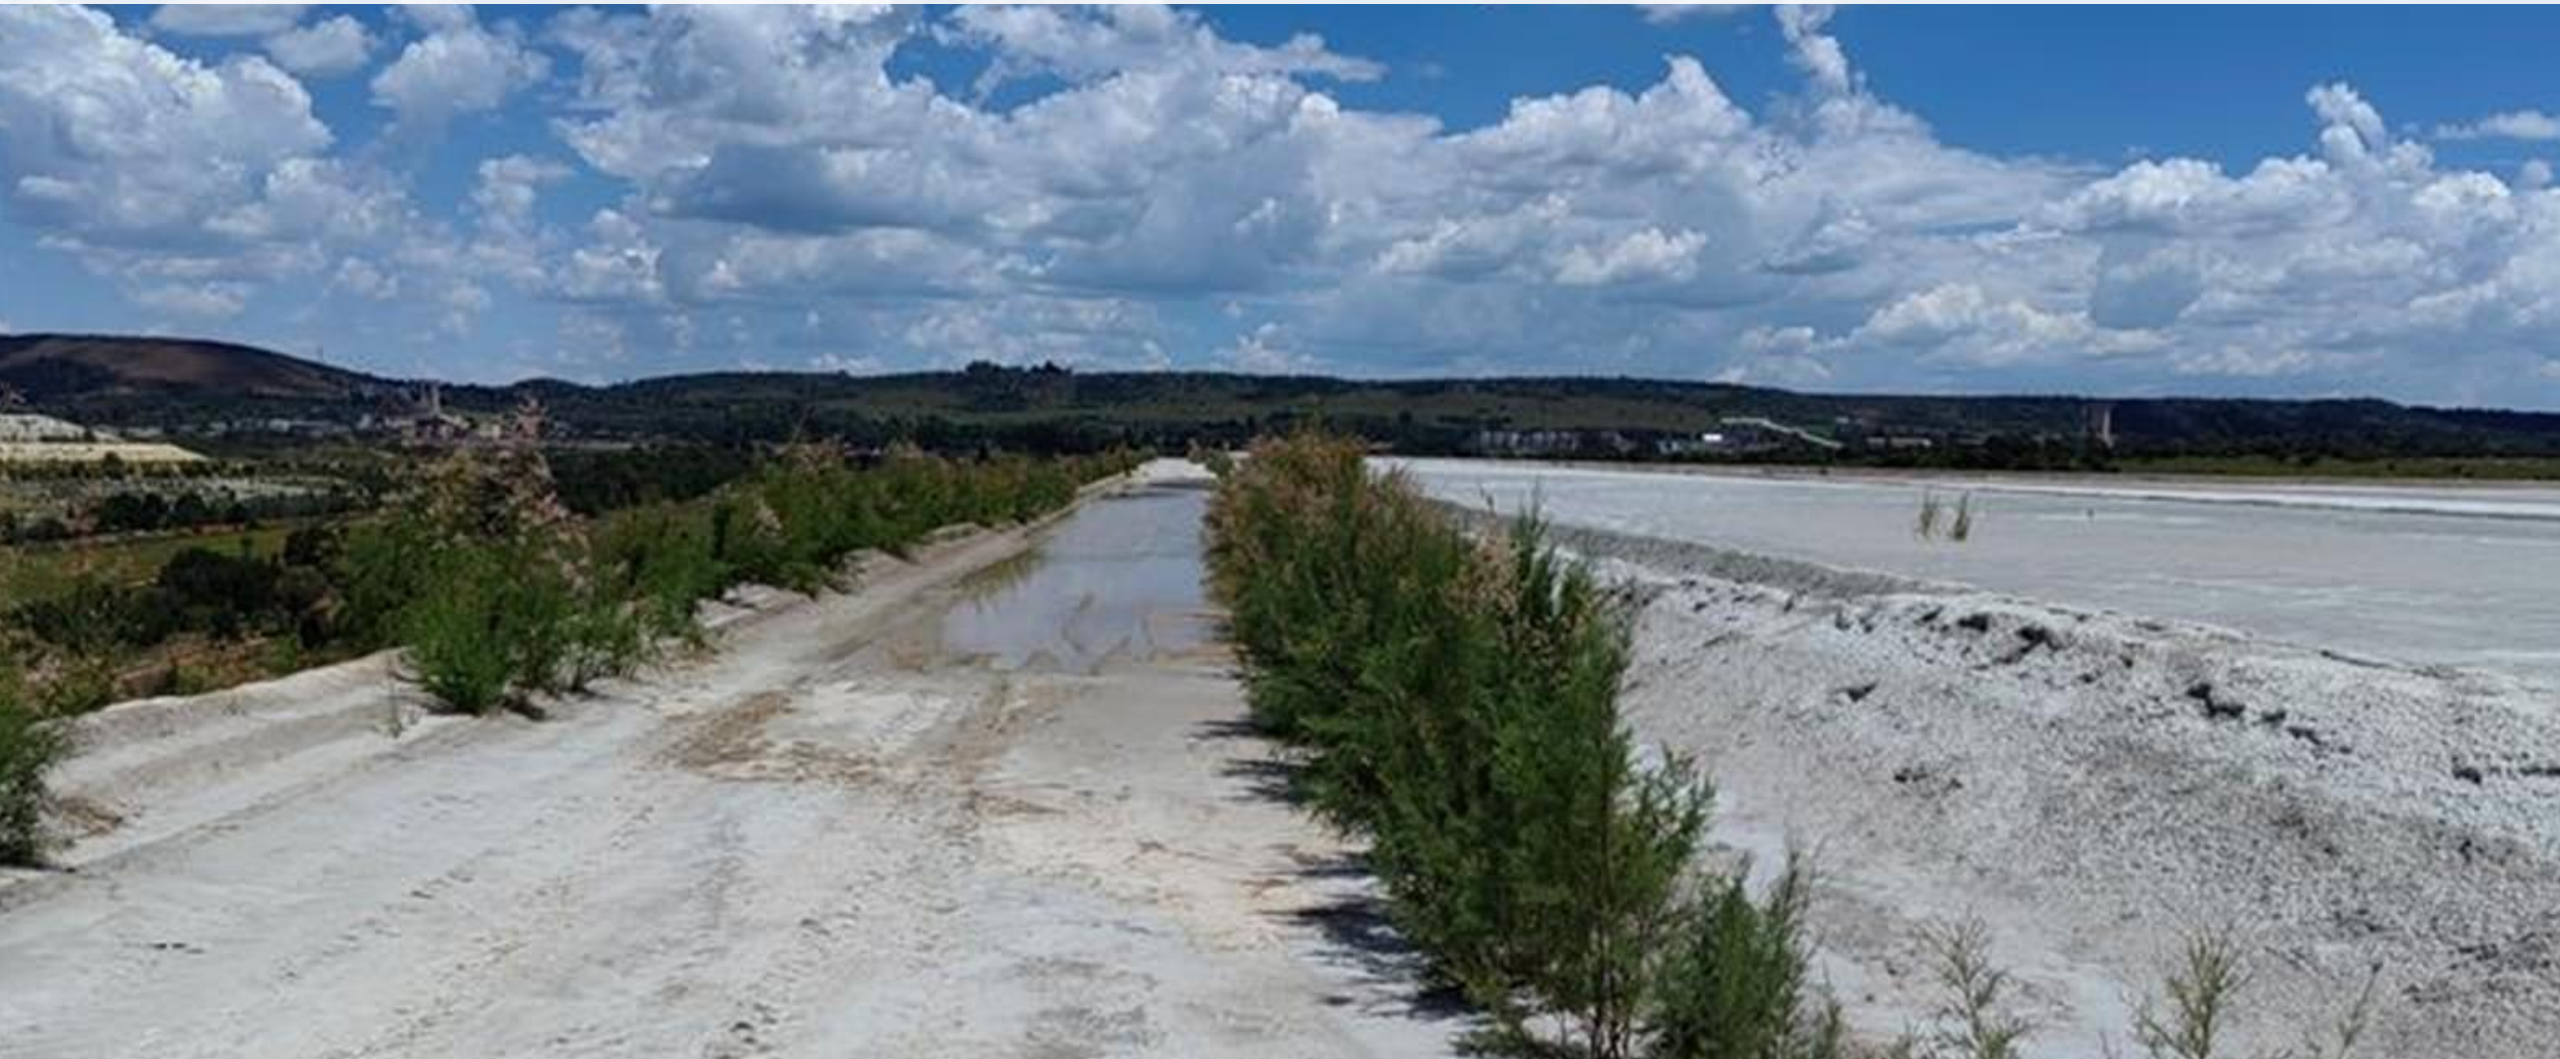
## Investigation Scope

- Gold TSF, South Africa
- **31 Vane Shear Test (VST)**
- 36 CPT Positions
- 8 cross-sections
- Max height: 50 m

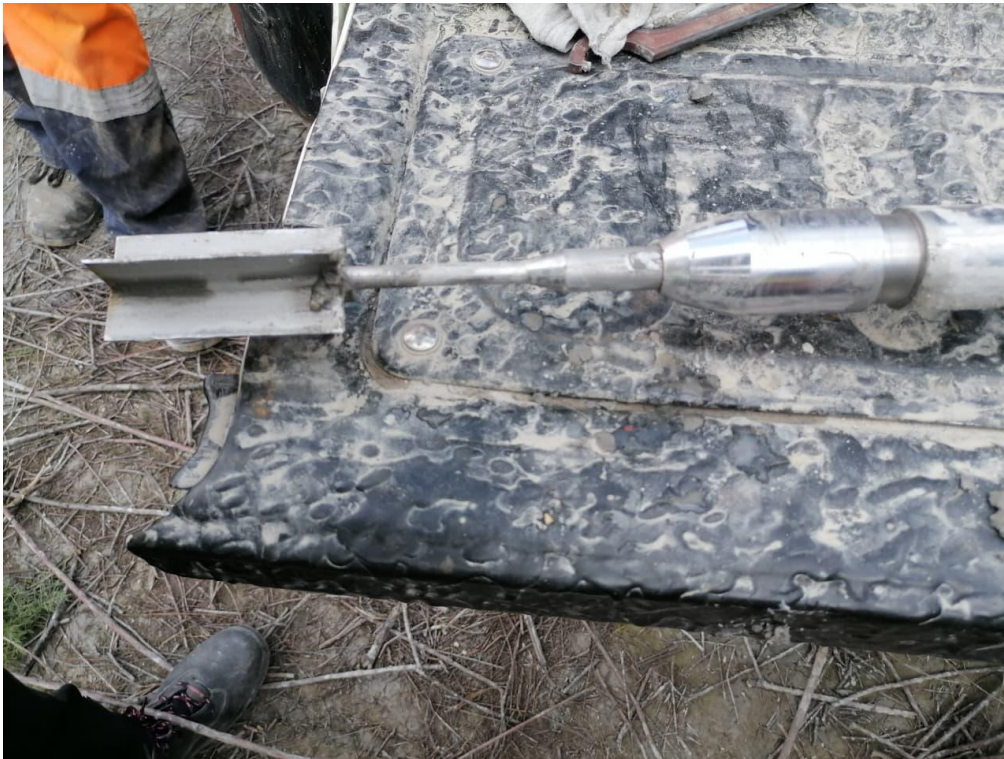
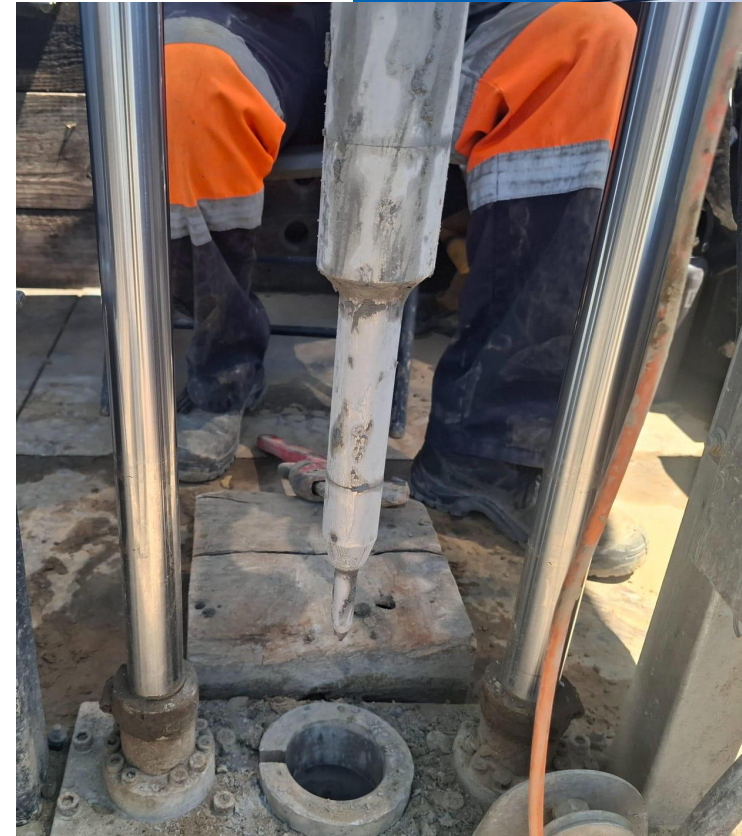
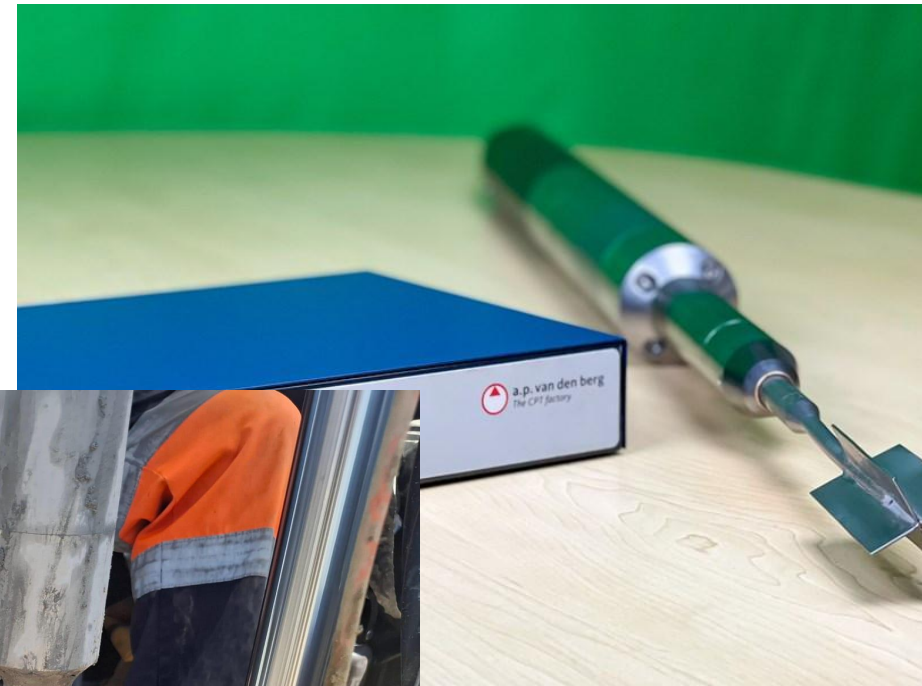
## Vane Shear Testing

- Equipment: AP van den Berg, 40×100mm, 4-blade

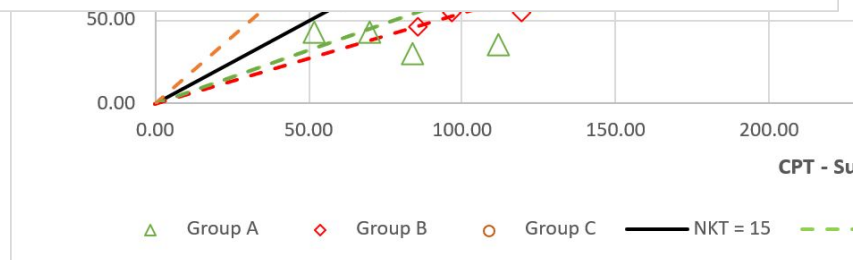
## Calibrated Nkt From Regression

| | n | Average $S_u/p'$ | Deviation from<br>Triangulated Mean |
|---|---|---|---|
| CPT (Nkt = 23.1, calibrated) | 10 | 0.24 | -4% |

Site-specific  $N_{kt} = 23.1$  validated through:
