# **AfriRock Symposium**

## ***Crush Pillar Design for High-Stress Mining Environments***

***Bryan Watson***

***22<sup>nd</sup> July 2025***

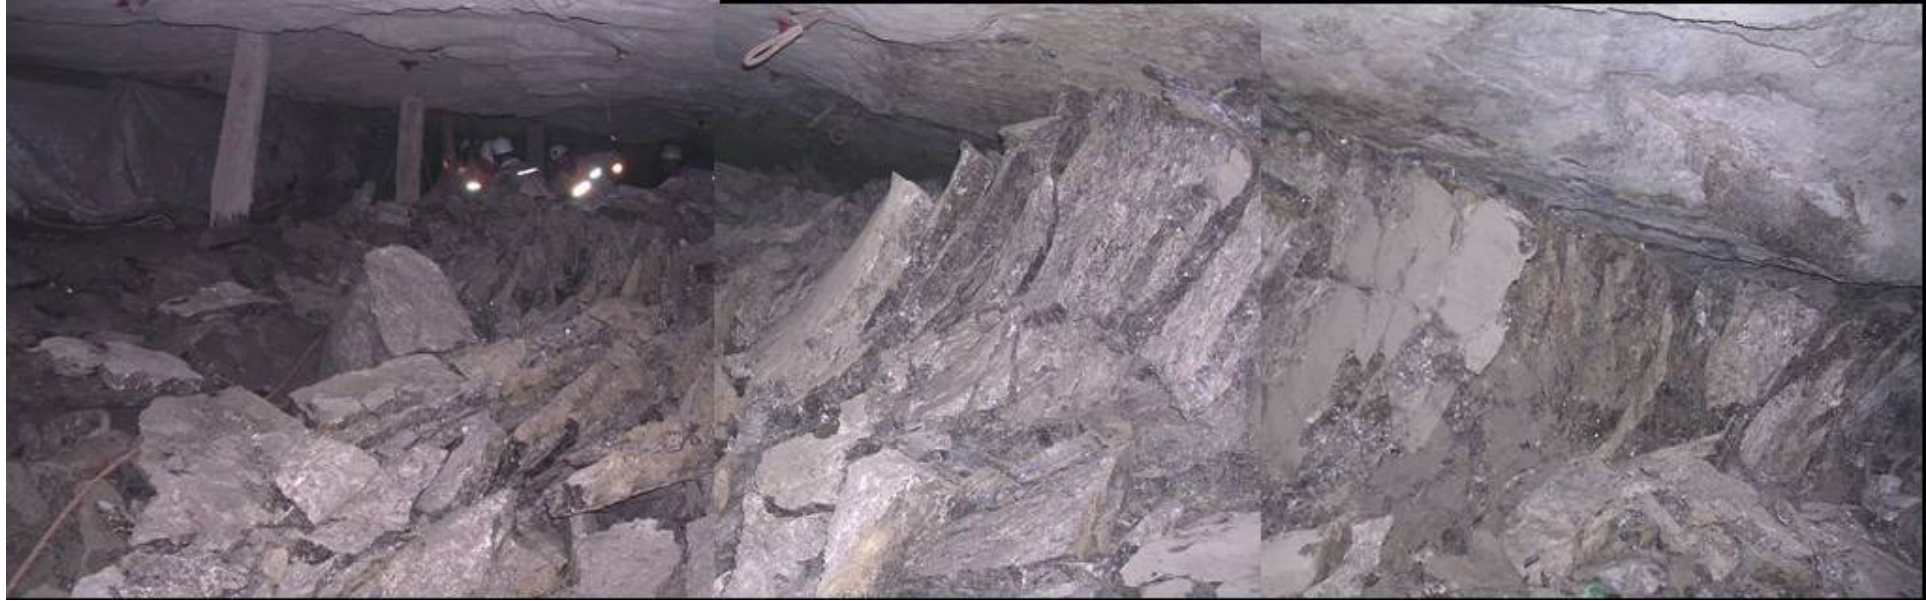
# *Pillar burst*

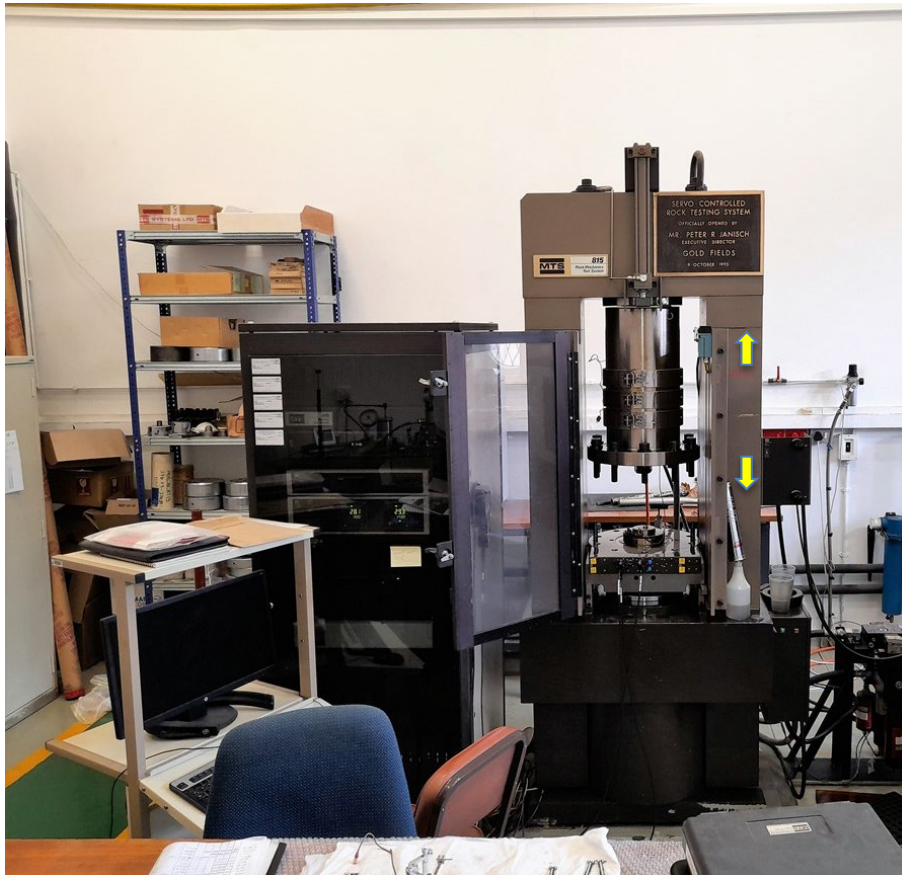
## *Stiff testing machine*

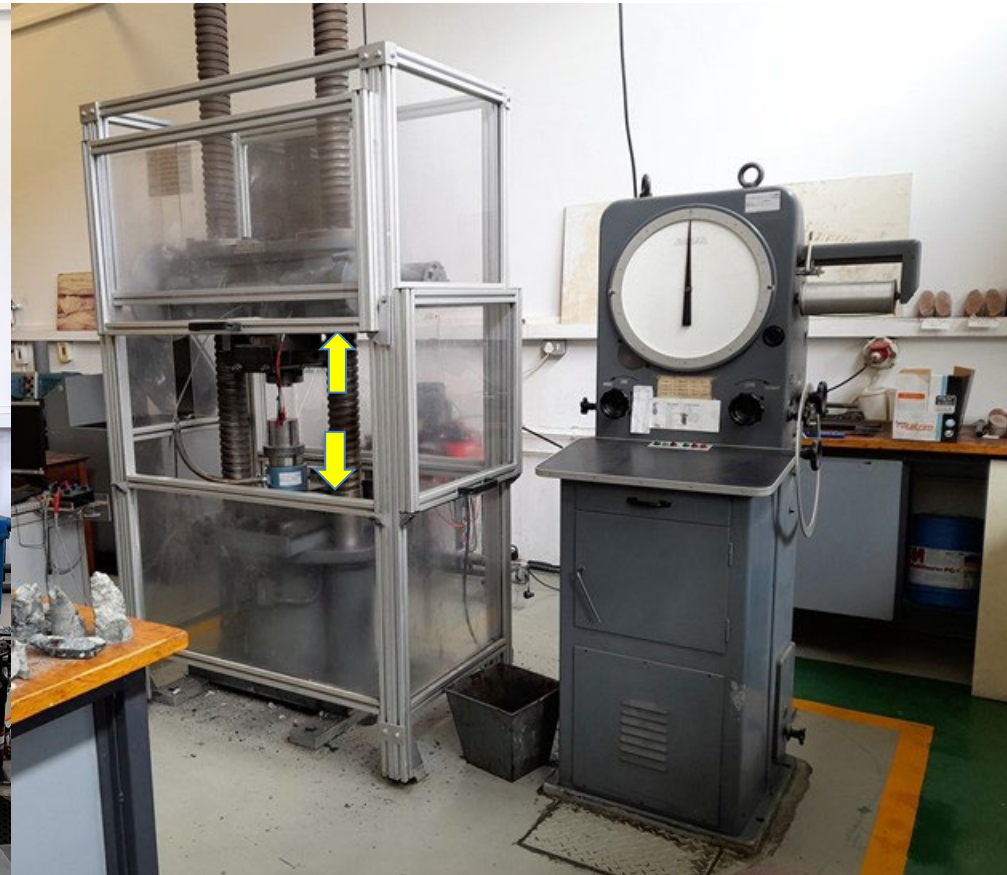
## *Soft testing machine*

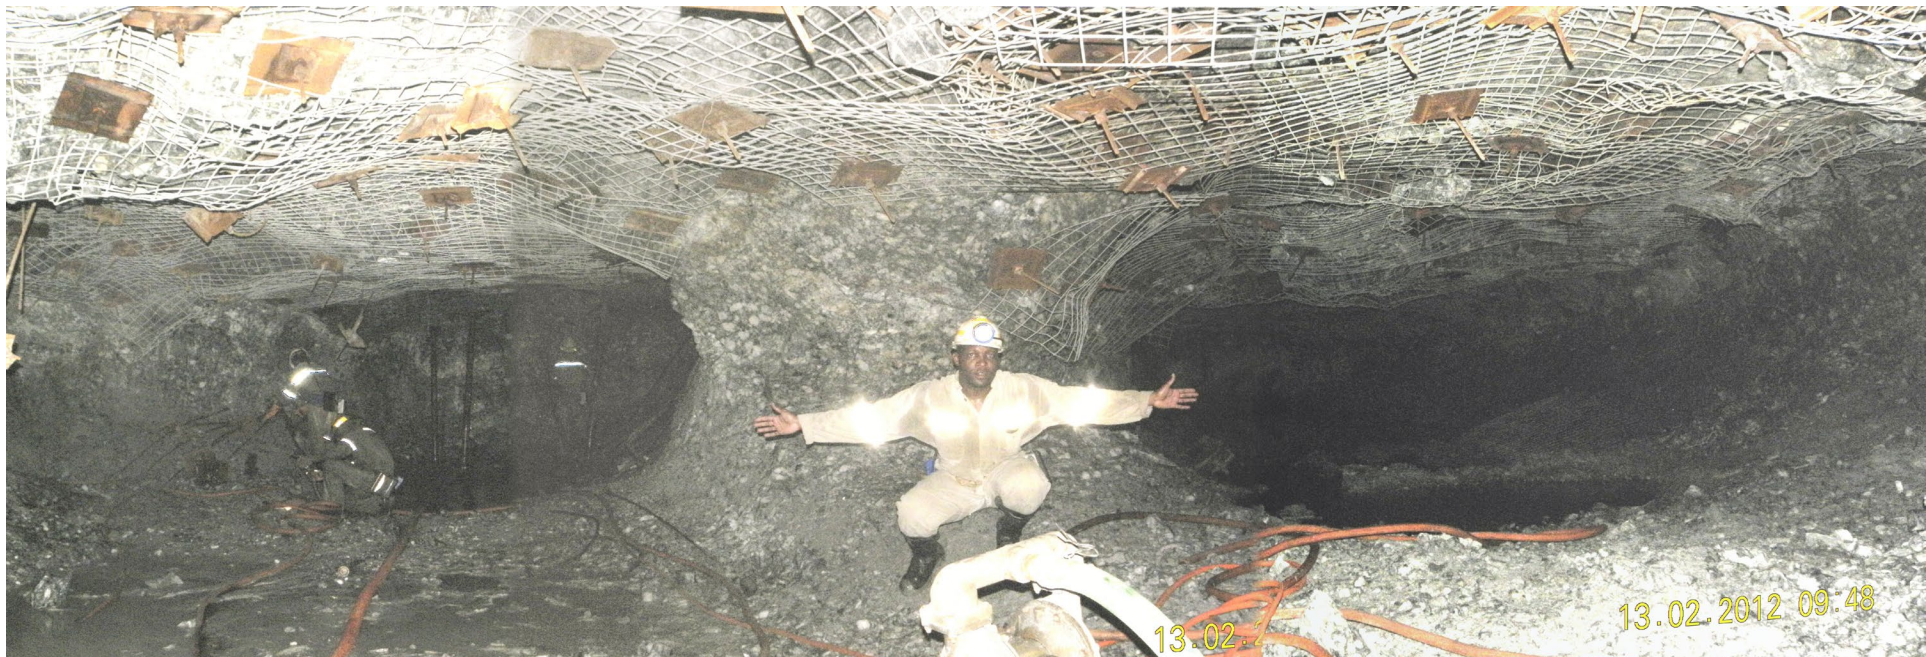
## ***Crush pillars at 3000 m below the surface***

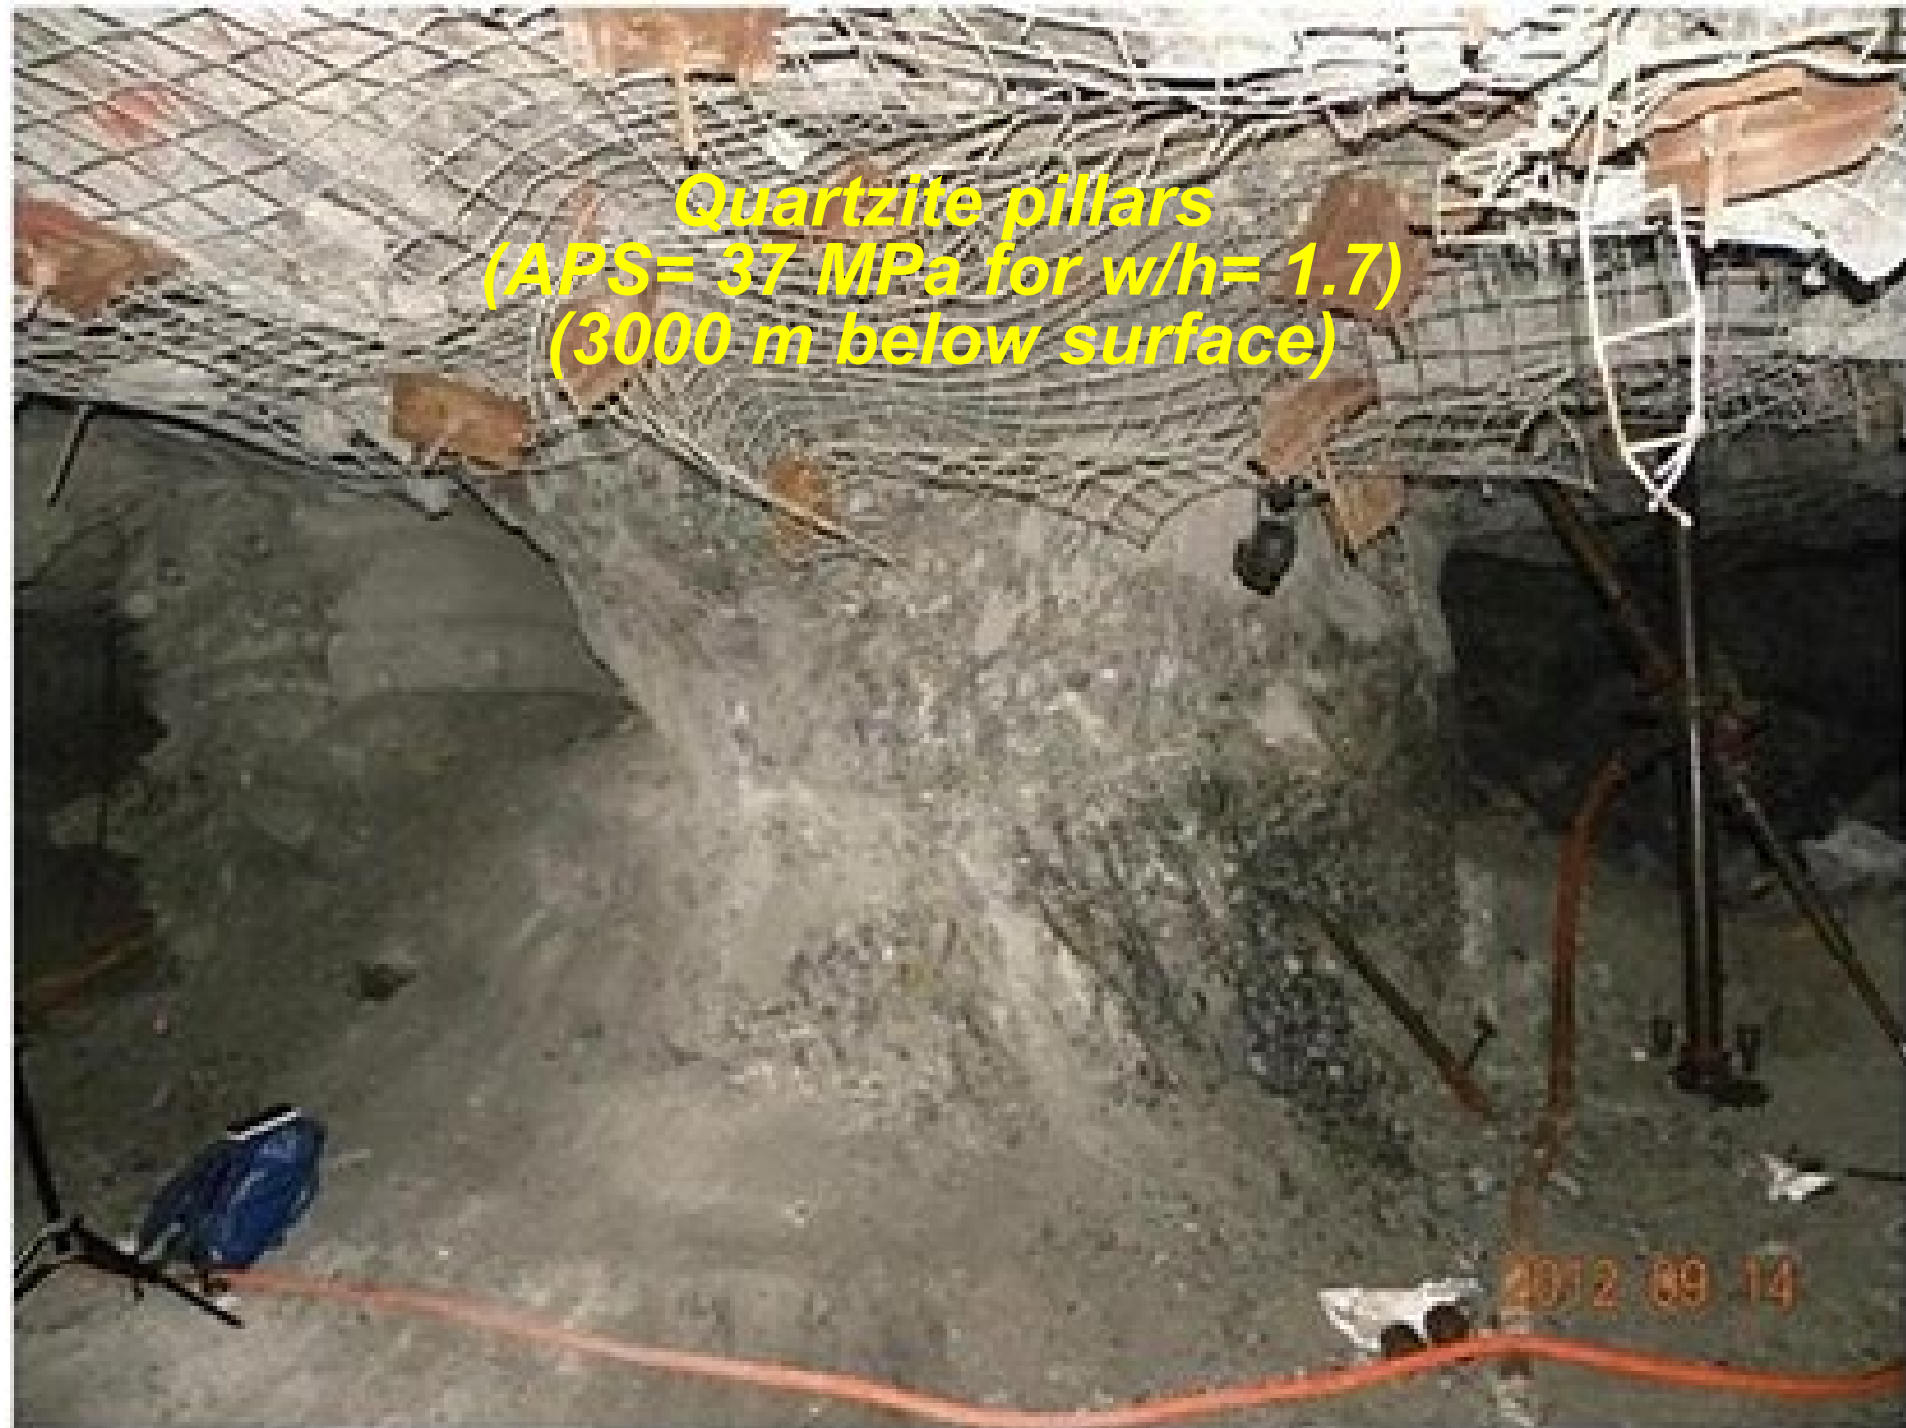
Quartzite pillars  
( $APS = 37 \text{ MPa}$  for  $w/h = 1.7$ )  
(3000 m below surface)

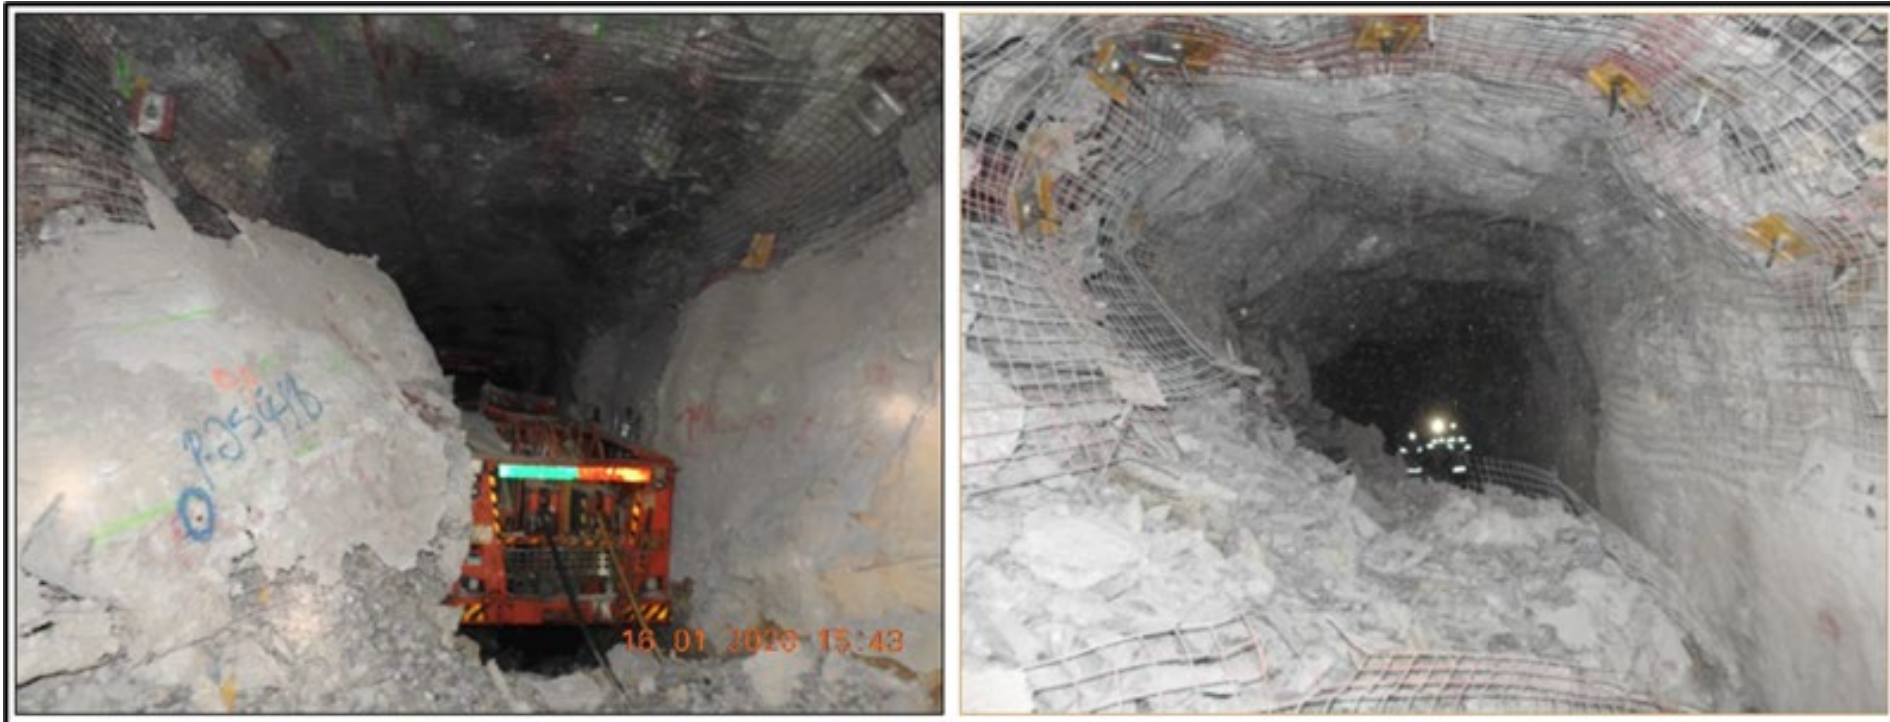
## ***Strain burst (Pillars too wide)***

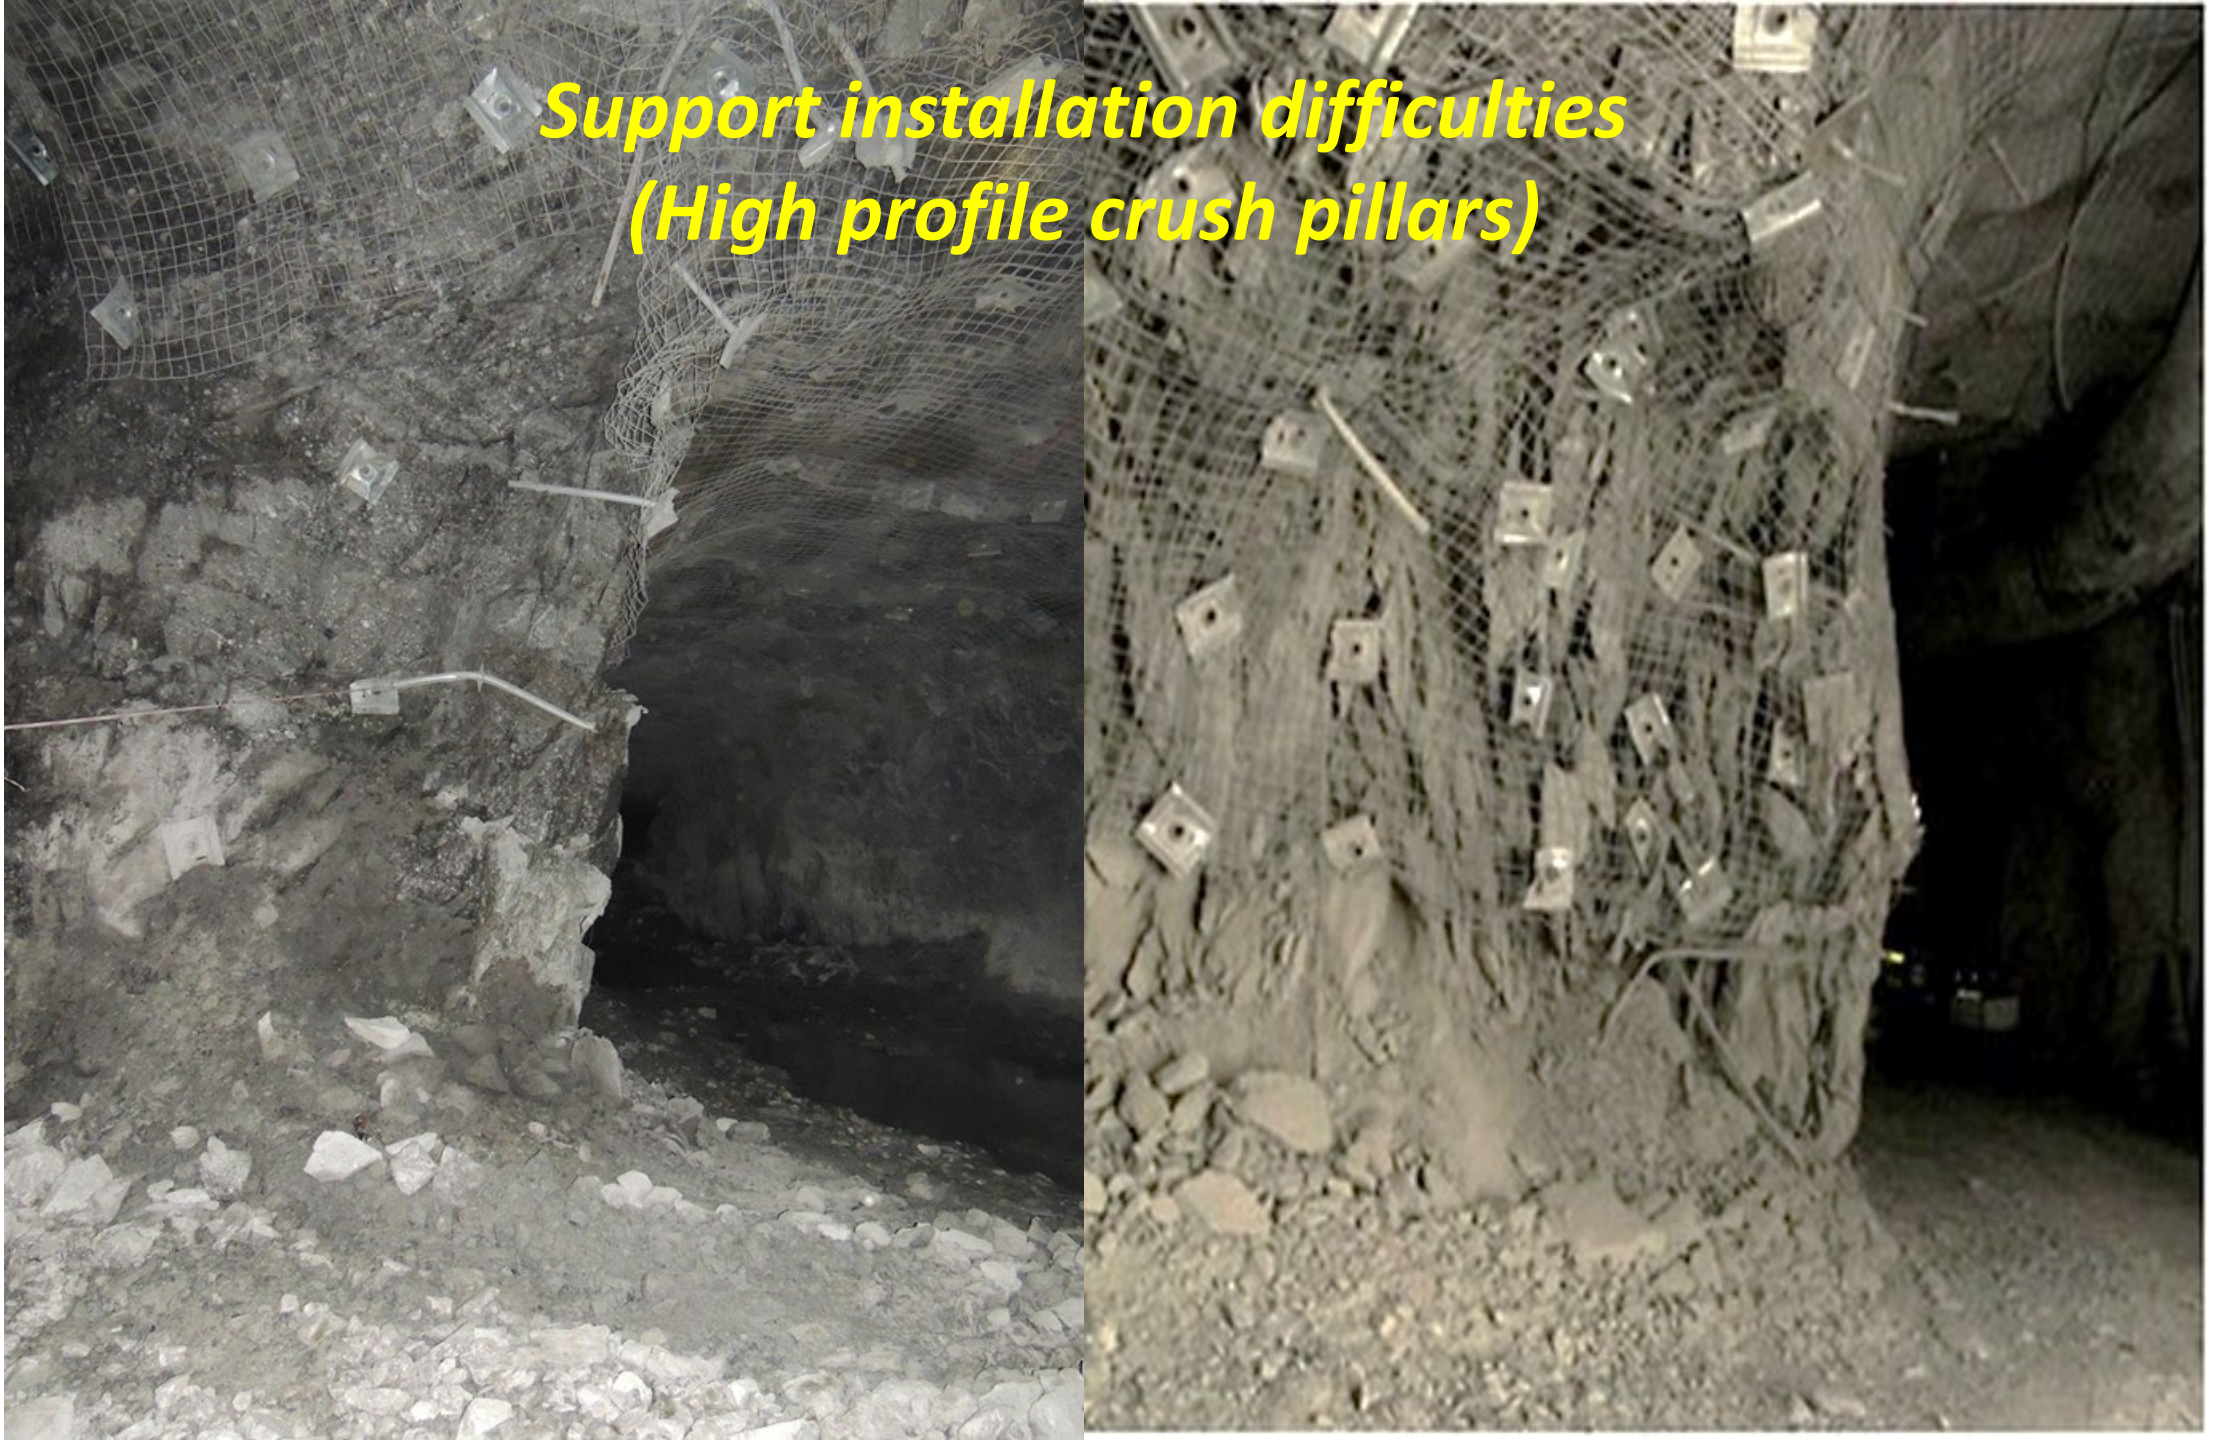
*Support installation difficulties  
(High profile crush pillars)*

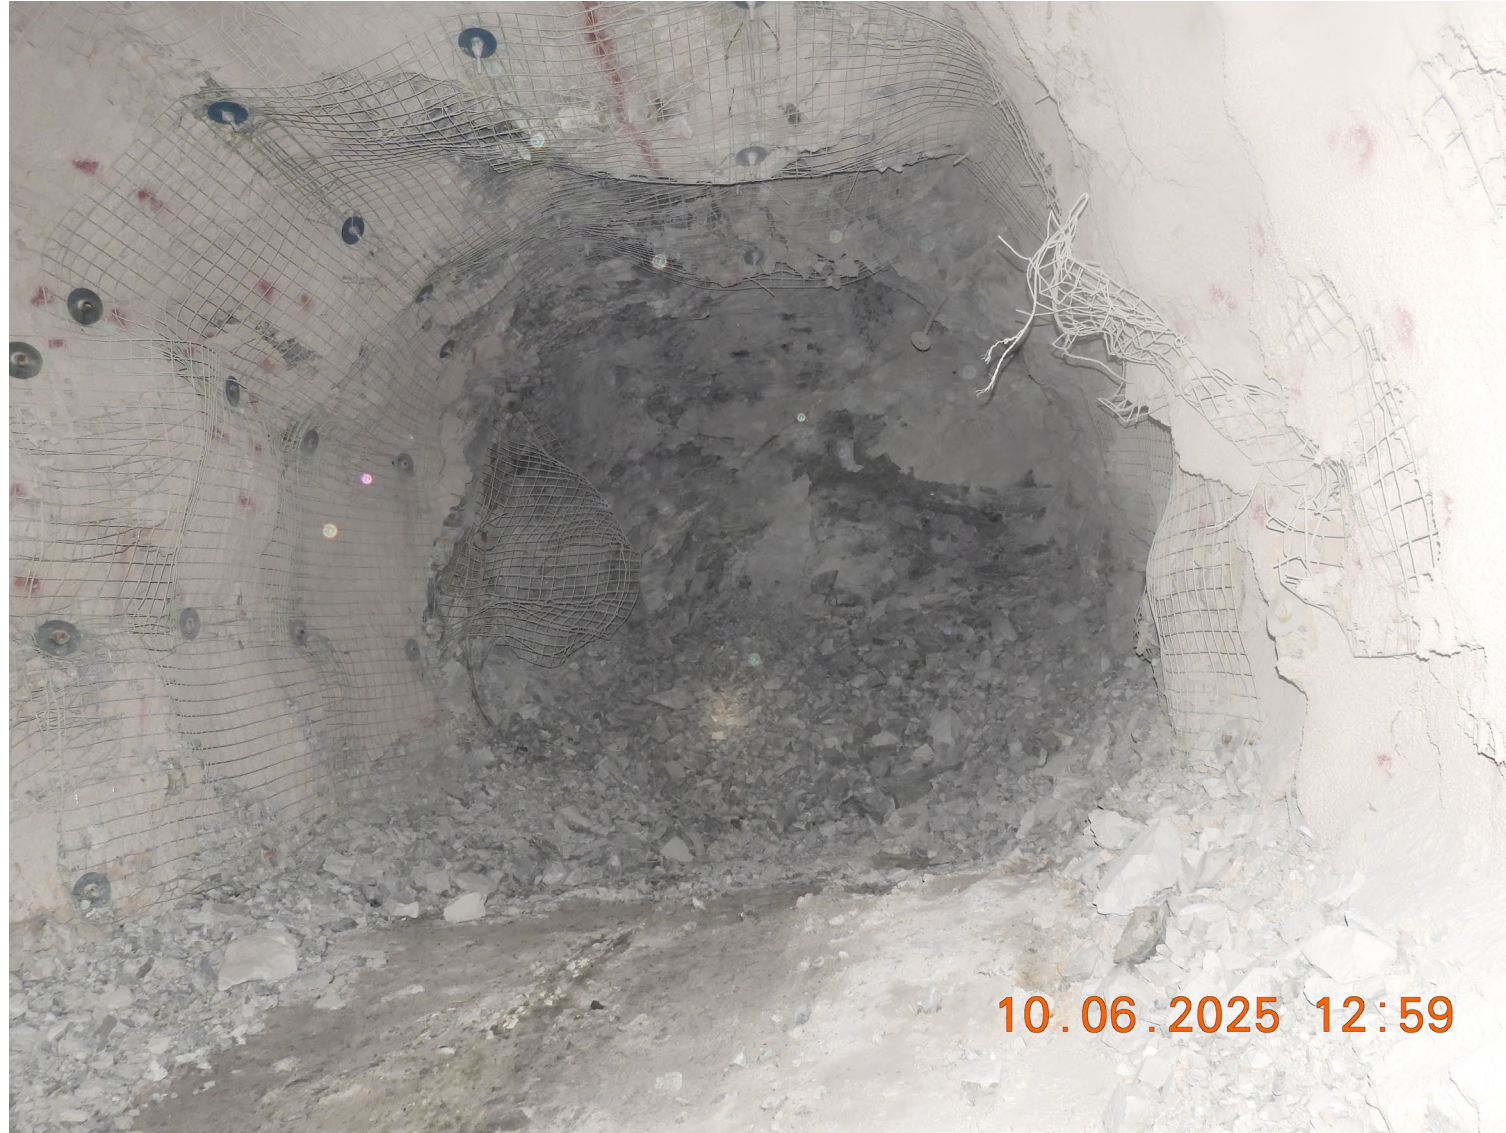
***Reduced damage  
(sufficient support & installed correctly)***
