# AFRIROCK

Monitoring Mining-Induced Subsidence and Sinkholes Using Multi-Band  
InSAR: A Case Study from Lubambe Copper Mine

P Chipola, R sililo, A Mkandla, M Douglas and M Spreafico

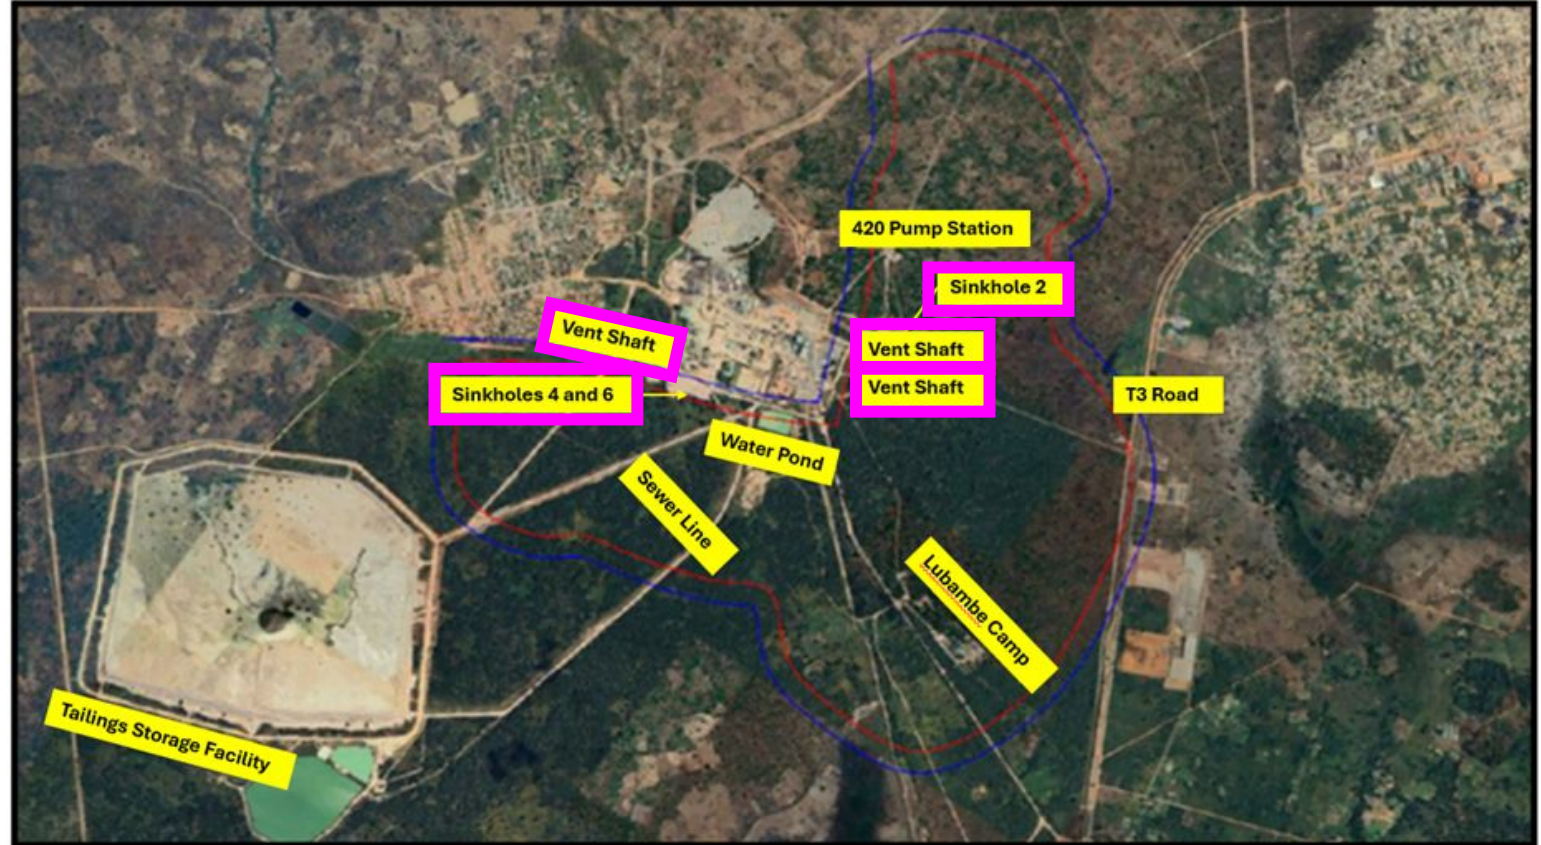
- The cave extents lines are represented in red and blue, relevant infrastructure has been labelled in yellow
- **Highest risk areas** are the Vent Shaft and Sinkholes

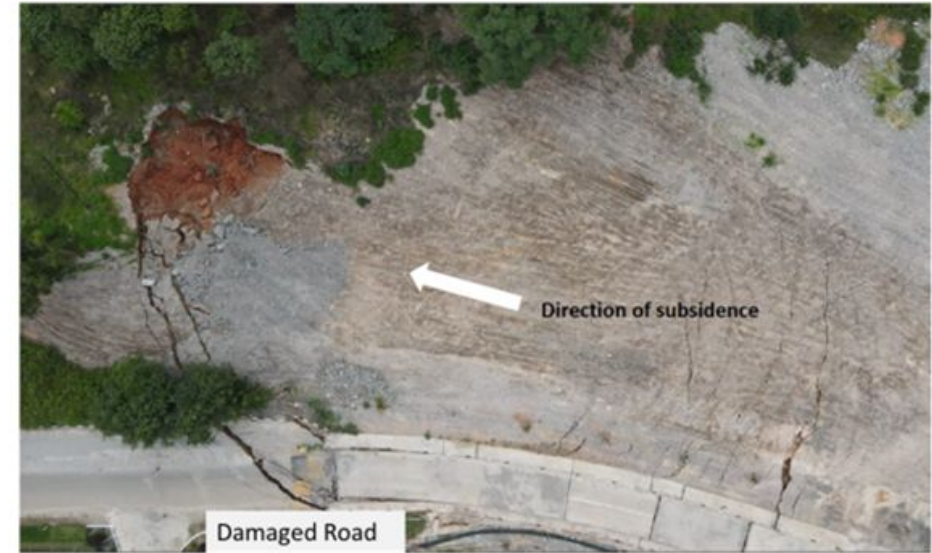
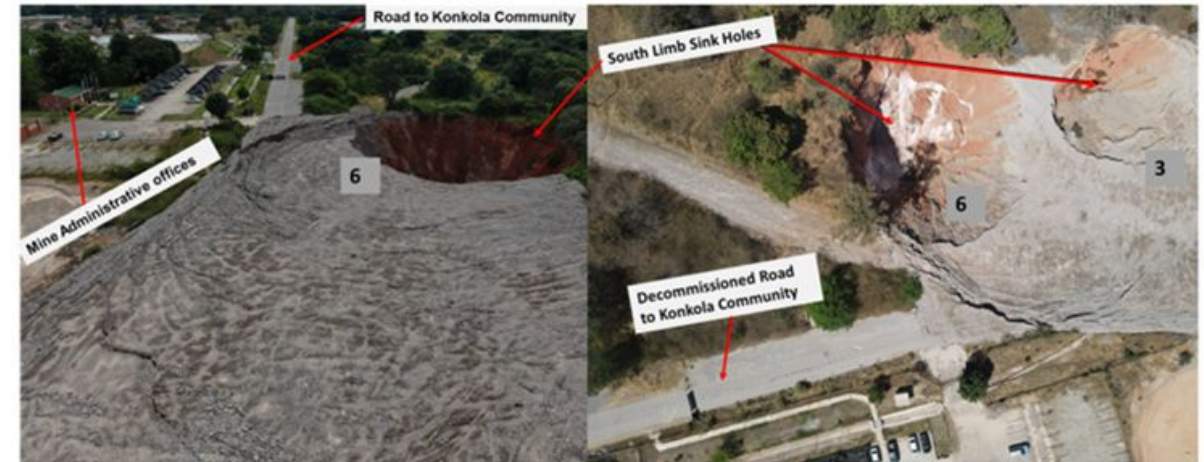
- Over the past five years **sinkholes** have been developing near infrastructures
- These have caused **closure** of main access roads and been a **risk** to administrative offices and the mine camp
- **Ground-based monitoring systems** around high-risk areas
- **InSAR monitoring** over the entire site

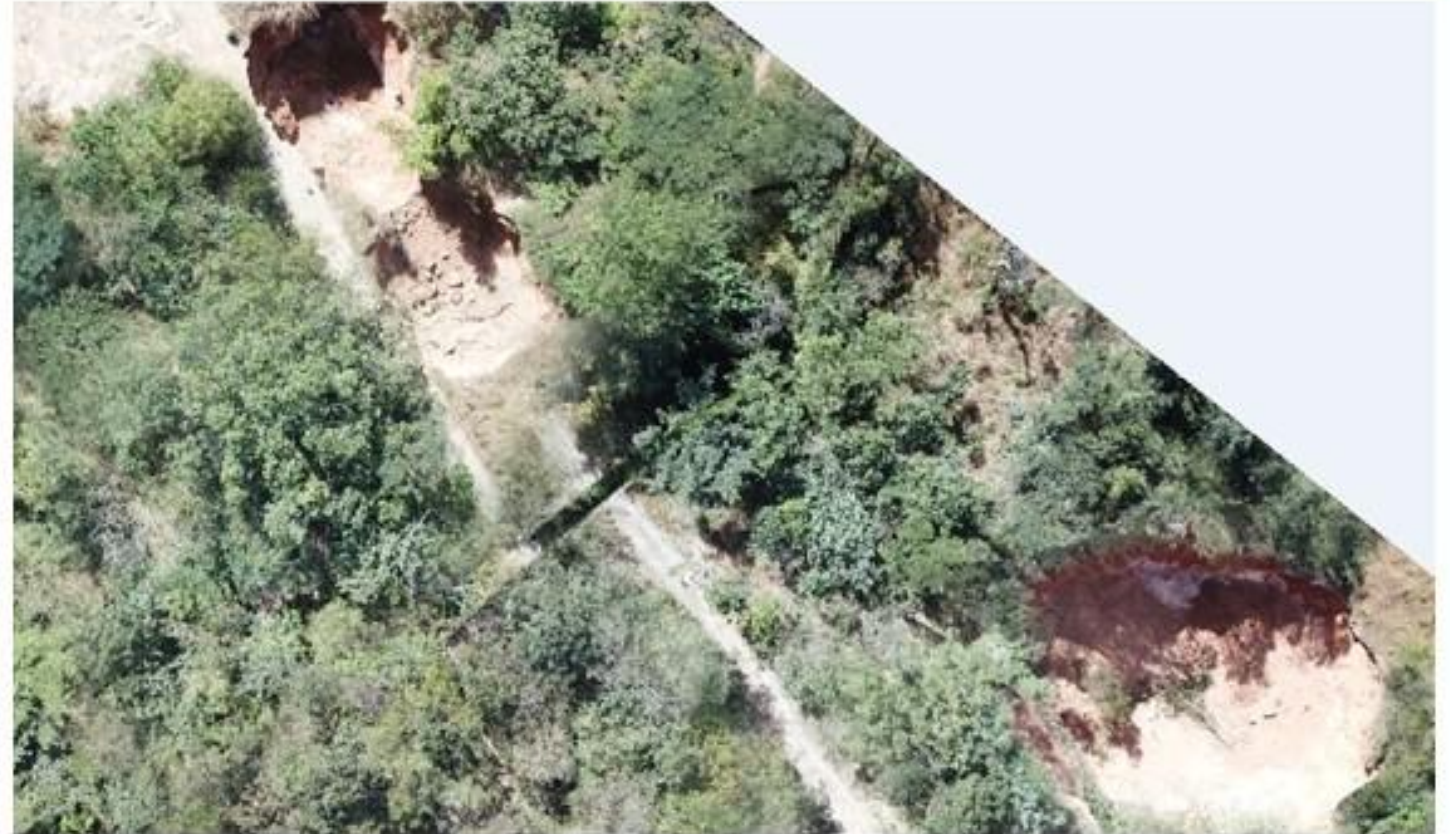
## Sinkhole 2

- **Historic open stope located 35 m below the surface and overlain by weak overburden material with high kaolinite concentrations**
- These conditions were further exacerbated by collection of **stormwater and overflows**
- Cause the eventual **collapse** in this area as seen in the photo

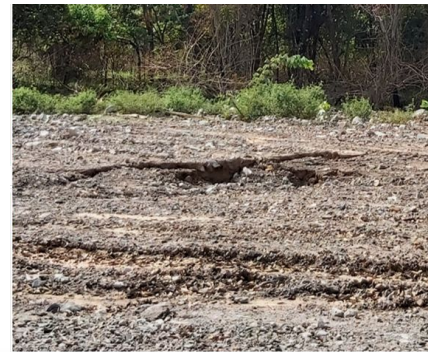
- **Historic Sinkholes** in proximity to high traffic road (profile B-B')
- **Largest deformation rates** seen close to the sinkholes (approximately -50 mm/year) and then decreasing towards the road
- ATS 6 showing approximately – 16 mm/year of settlement
- **New cracks observed** in the area of ATS 5 and ATS 6
