# Stabilisation of open pit wall movements detected by InSAR using horizontal drains

Presented by: Priyanka Narshai on behalf of the authors: Pooja Ramakrishnan<sup>1</sup>, Jacques du Toit<sup>2</sup>, Jennifer Scoular<sup>1</sup>, Pieter Bas Leezenberg<sup>1</sup> and Jason Pretorius<sup>1</sup>

Affiliations: SkyGeo Netherlands<sup>1</sup>, First Quantum Minerals Zambia<sup>2</sup>

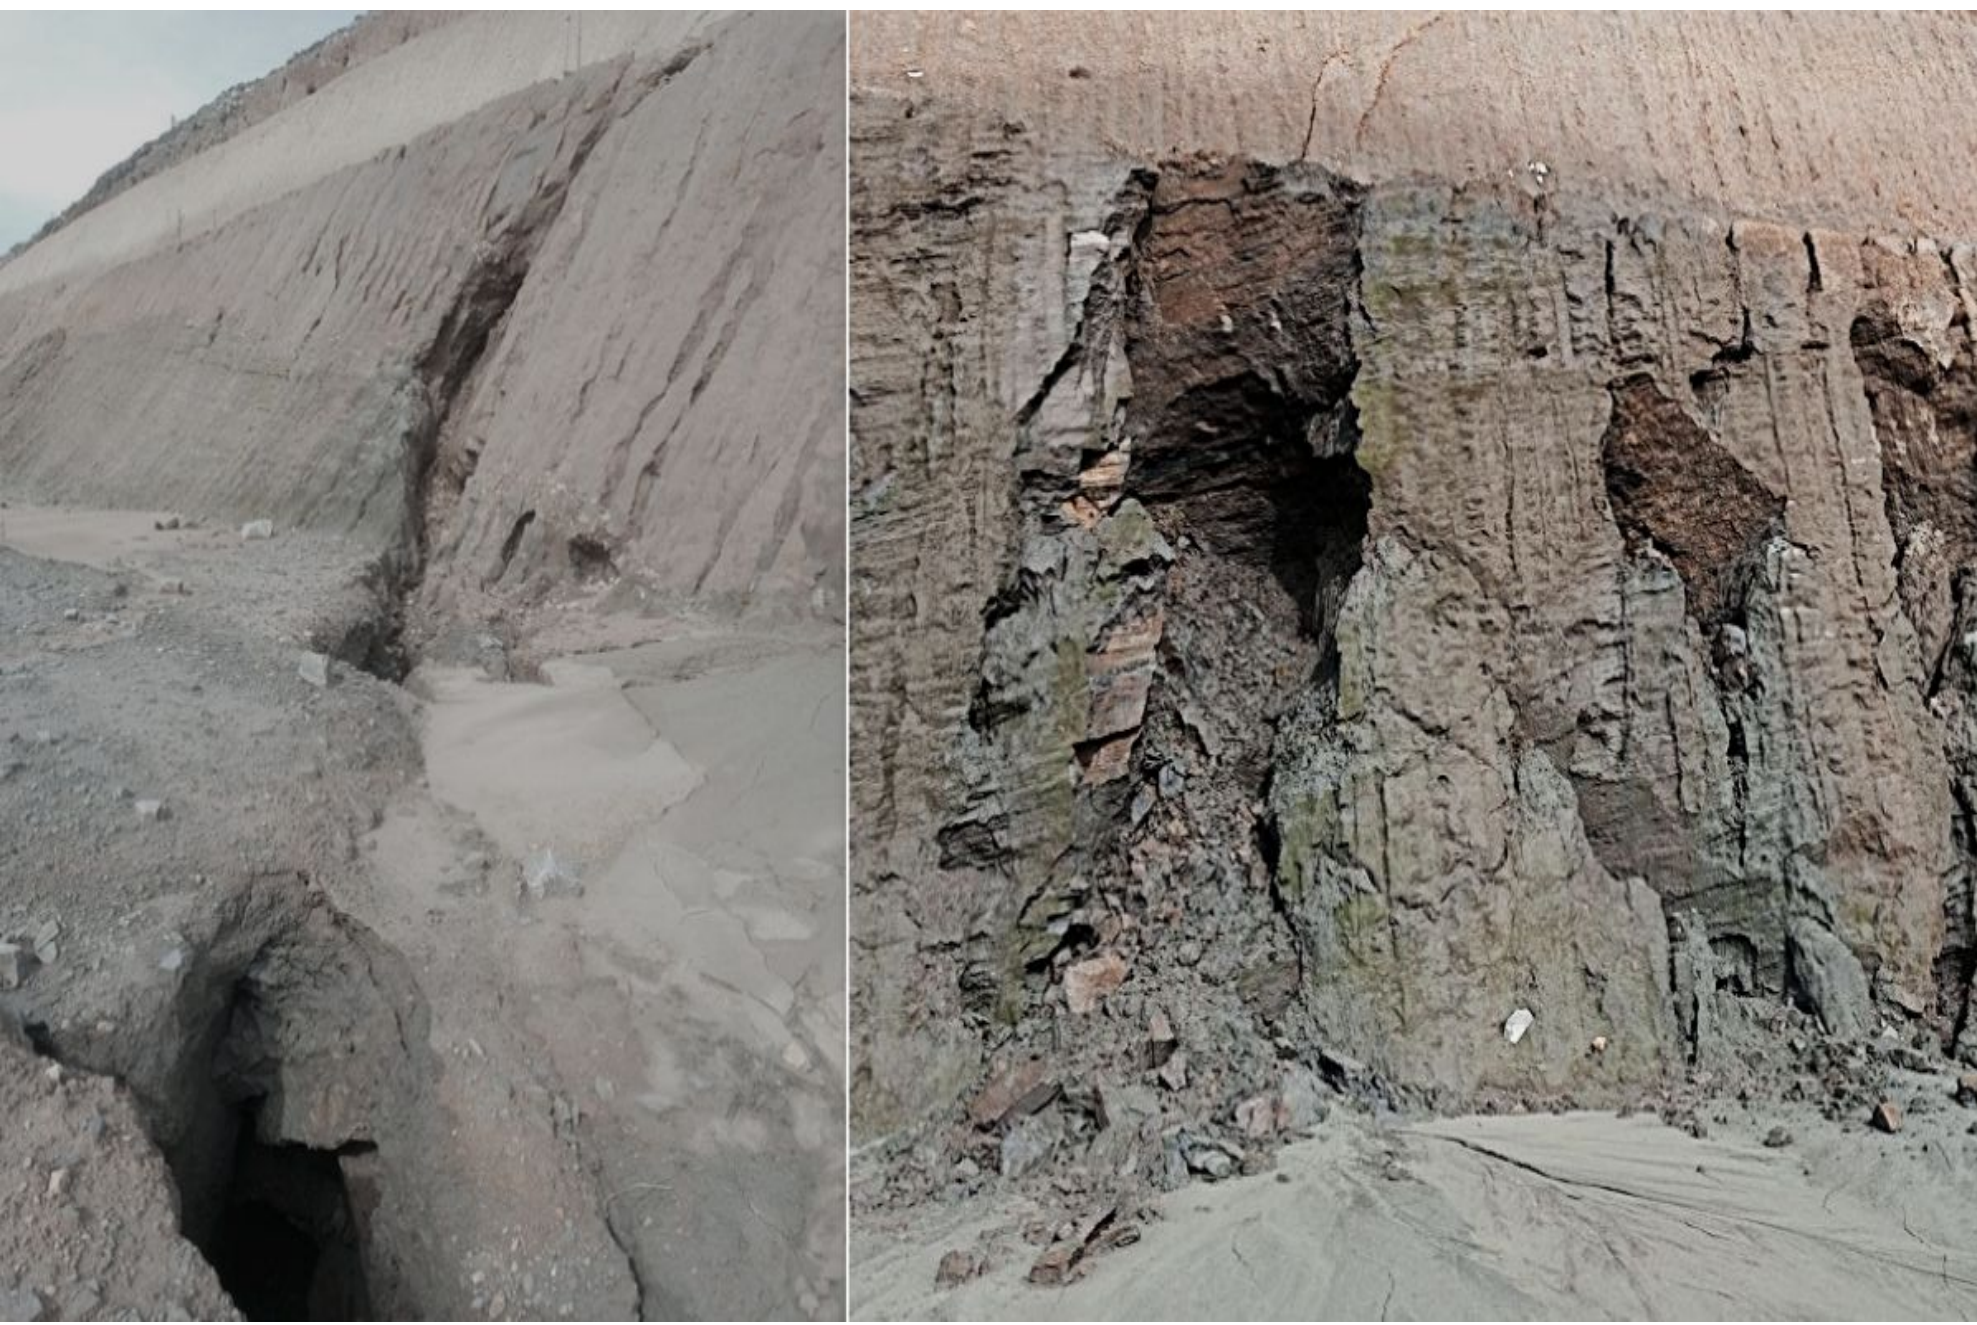
Figure 1 : Challenging geology with legacy weathering and erosion.

Slope stability is a critical concern in open-pit mining operations, where failure can cause interruptions, equipment damage, and safety risks. The Kansanshi Mine, Africa’s largest open-pit copper operation, has experienced periodic instability due to challenging geology, legacy weathering, and seasonal rainfall (Figure 1). This study focuses on the M15 west wall, an actively mined slope with a known history of elevated pore water pressure, a fault running through and structural weaknesses (Figure 2).
