# A REVIEW OF THE STOPE SUPPORT SYSTEM AT IMPALA NORTH SHAFT OWING TO STOPE CLOSURE AT SHALLOW MINING DEPTHS

North Shaft

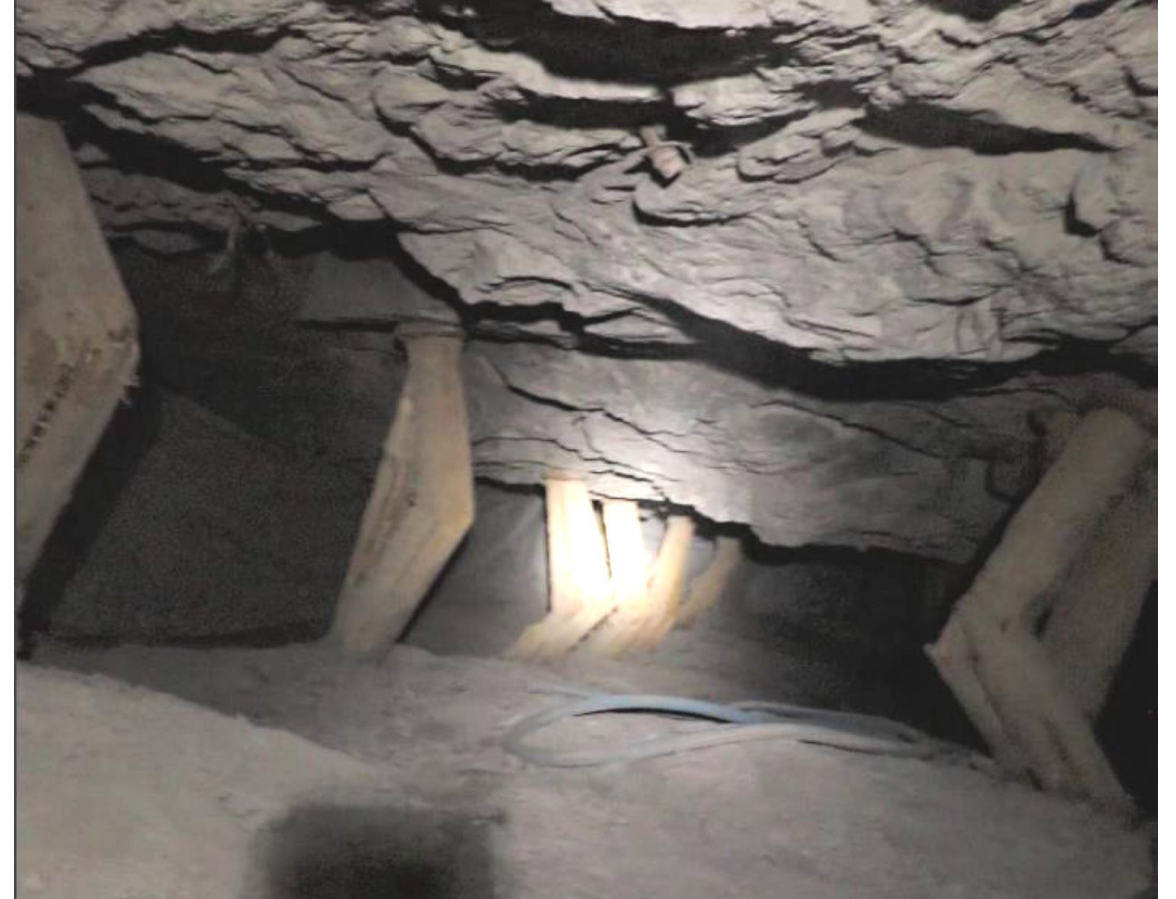
- Very little closure had been observed on the mine.
- The first raise line that was established and mined at 15 level, experienced much high closure rates which led to the failure of mine pole support units.
- The mine pole support was found to be splitting and buckling in the back areas of panels from as little as 20 m away from the face.

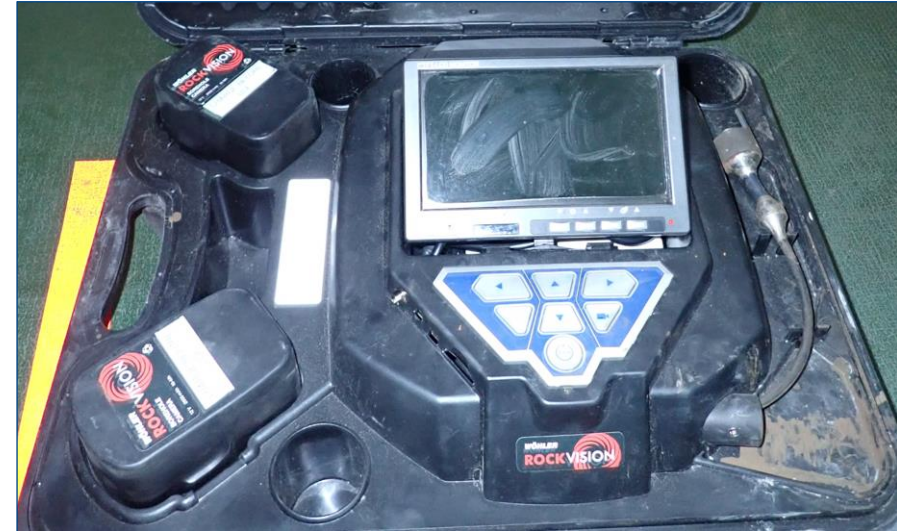
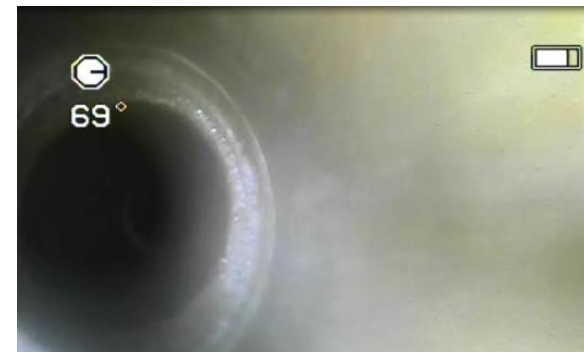
- Borehole camera investigations were conducted along the Roadways.
- The 15 m height was chosen as this was the known depth of the Bastard Reef chrome parting, the contact was examined for any signs of tensile failure.

Hanging wall pyroxenite to Norite contact

Bastard Reef contact

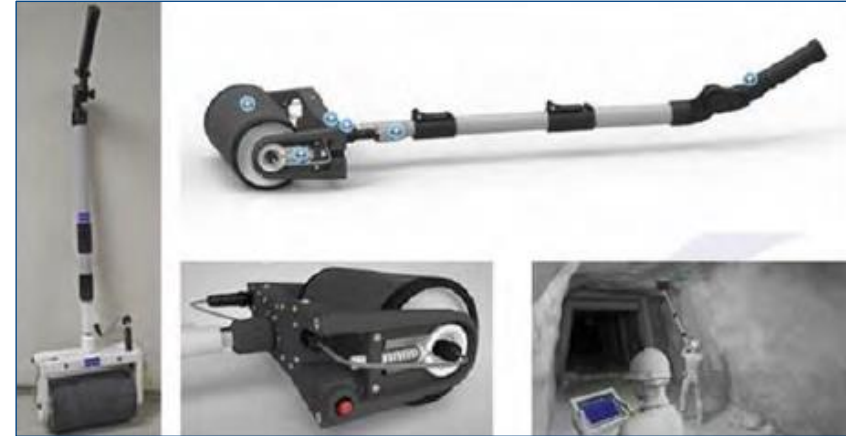
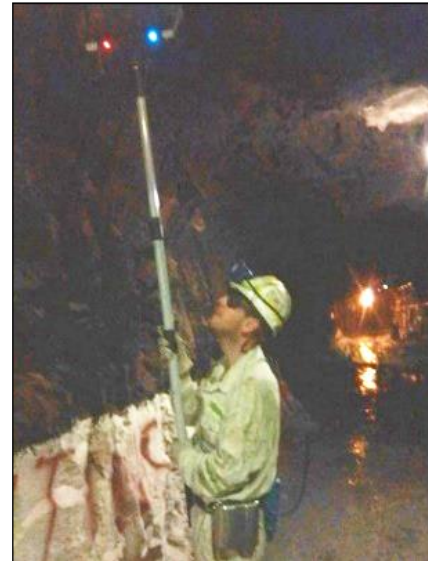
- GPR scans were conducted along the roadways and along raise lines.
- The GPR that was utilised is referred to as a Sub Surface Profiler (SSP).
- The tablet enables the user to check the scans in real time.

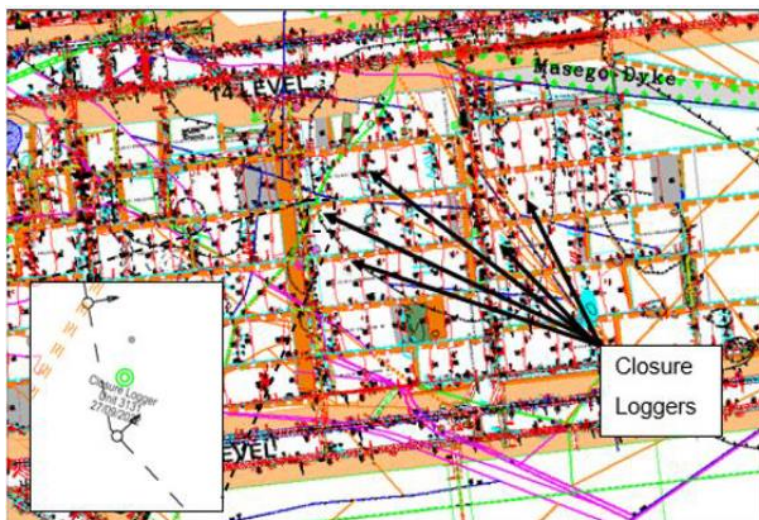
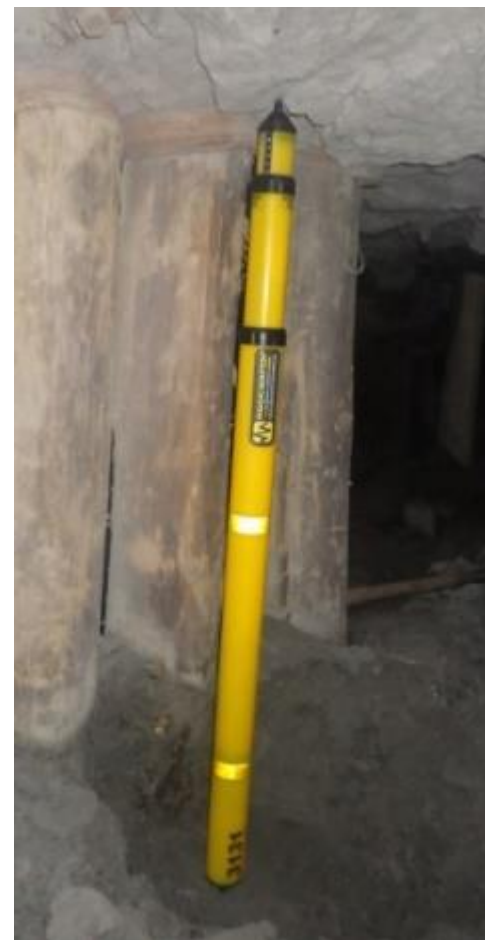
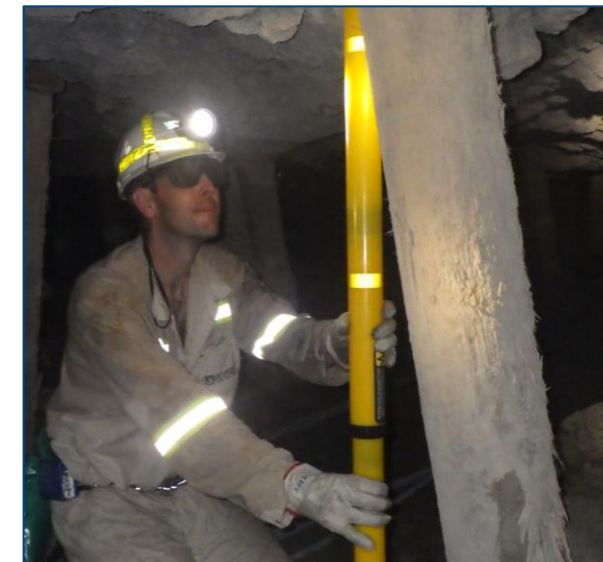
- Closure measurement data was recorded with closure loggers.
- The loggers were used to determine the rate of closure per metre of advance.

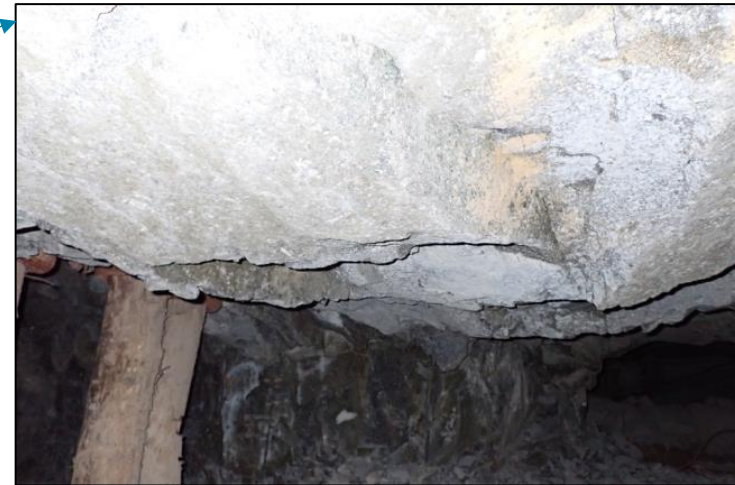
The crush pillars in the back area were inspected:

- The hanging wall around the pillar appeared to be in good condition with no sign of fractures.

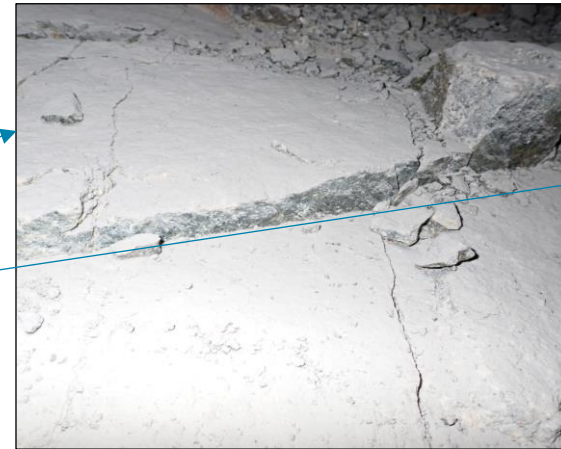
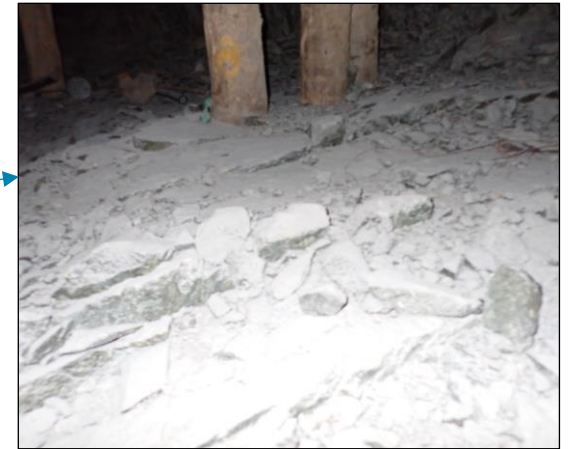
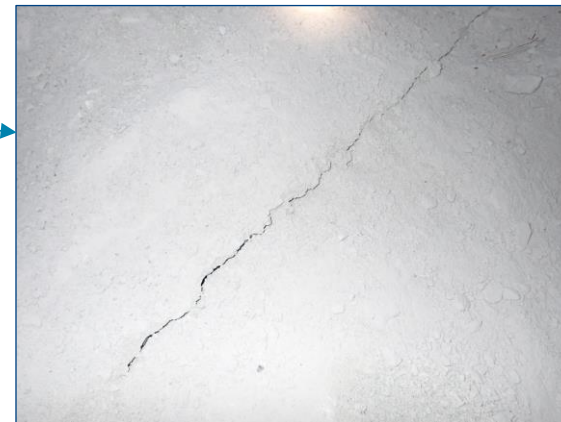
The footwall around the pillars had fractured significantly and footwall heave had taken place around the pillar. Tensile cracks were observed in the centre of the panel along the footwall.

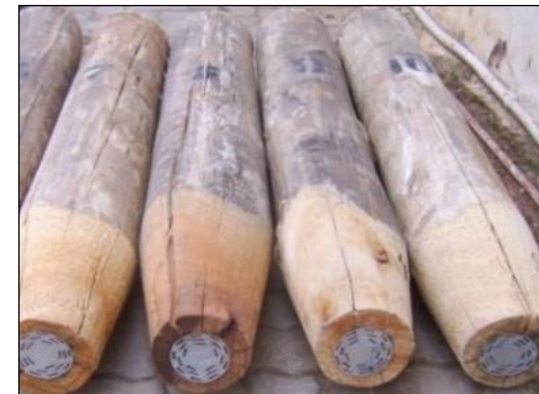
- Pencil sticks were introduced as an alternative to the mine poles.
- They provide the benefits of a stiff support system with the yielding capability required for the closure experienced.
- The profiled portion of the stick brushes/yields in a controlled manner to allow the load to be shed whilst maintaining the support resistance.

The yield capability of the pencil sticks provided suitable support for the high closure rates observed.
