# The stability of the strata overlying the mined-out areas of the central Witwatersrand

by F. G. HILL\*, Pr. Eng. B.Sc. (Min. Eng.), M.A. (Juris), Hon. Ph.D., Hon. Ll.D., Hon. F.S.A.I.M.M., Hon. F.S.A.I.P.M., M.I. Mech. E., M.I.M.M.

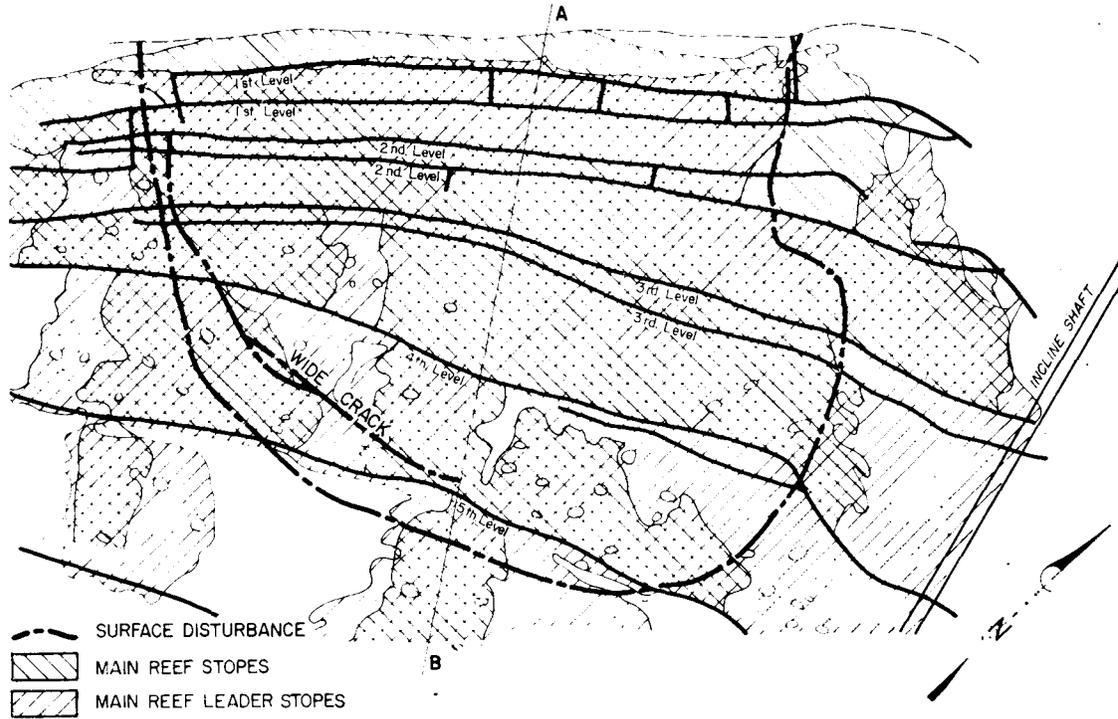
Fig. 5—Plan of a portion of the underground workings at Van Ryn Gold Mines Estate in relation to the zones of surface disturbance

*Van Ryn Gold Mines Estate.* Figs 5 and 6 show a portion of the underground workings at Van Ryn Gold Mines Estate (in the Benoni district, 30 km east of Johannesburg) in 1910. It can be seen that the disturbed surface relates strongly to the shape of the mined area. Of special interest is the following statement:

Numerous cracks were formed — one being 2 ft to 3 ft wide along a considerable portion of its length.

Here there is evidence of horizontal movement, i.e., of the surface fracturing because of tension stresses. Again to be noted is that the dip of the reef decreases with depth.

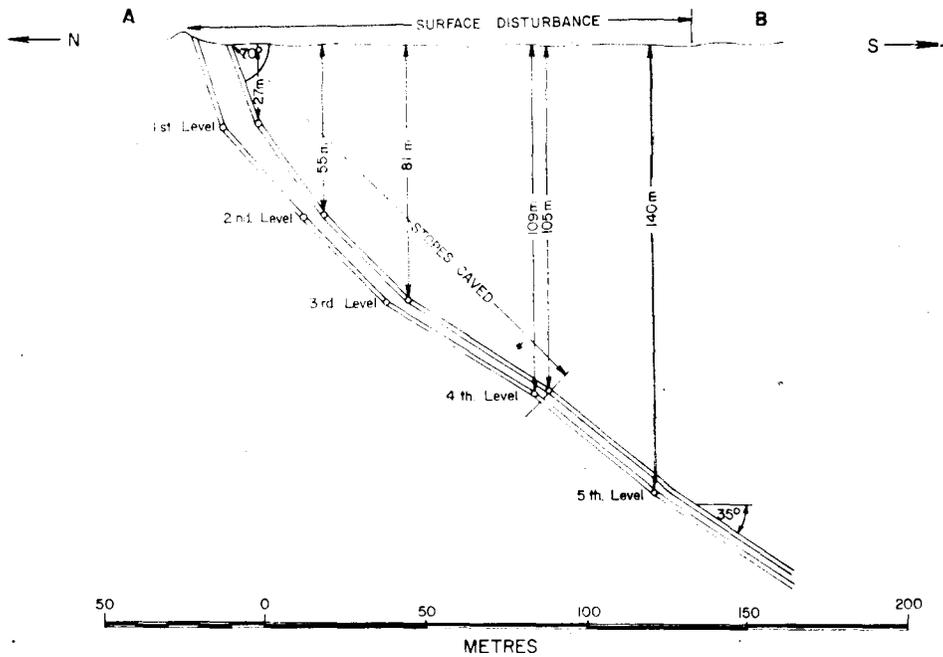
Fig. 6—Section through A-B of Fig. 5, showing the depth of the workings

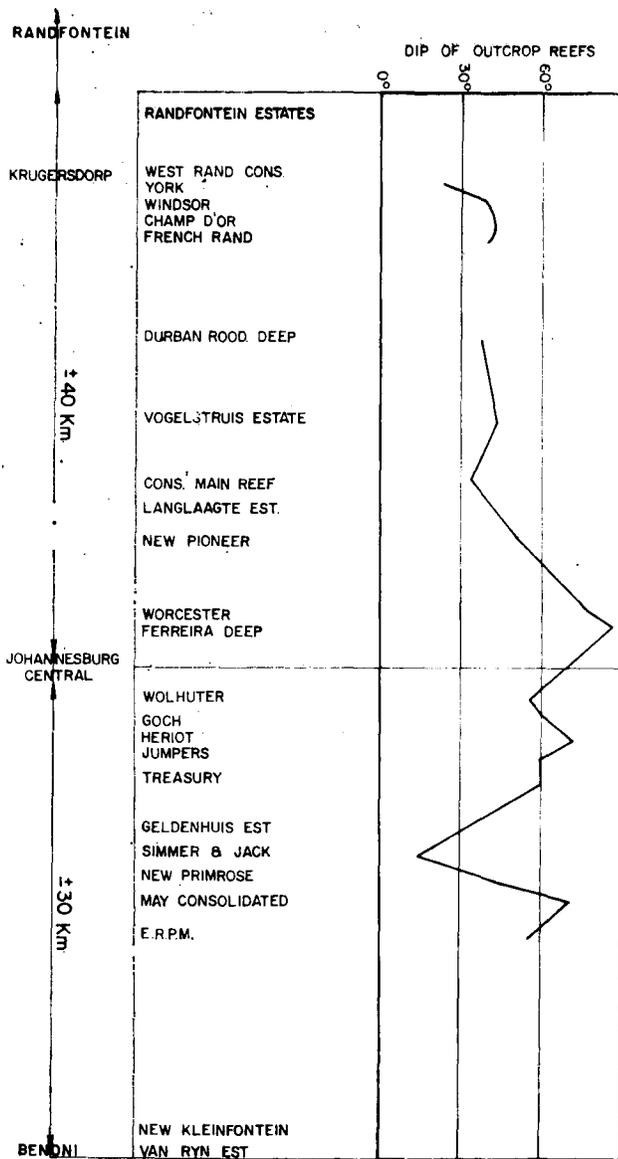
Fig. 17—Location of mines for which cracks were recorded in the annual reports of Government Mining Engineer from 1903 to 1927 (see Table II); also shown are the variations in the dip of the reefs

dip, cracks began to appear on surface in the order shown by cracks 1, 2, 3, 4, and 5, i.e., they were related to the underground fulcrum.

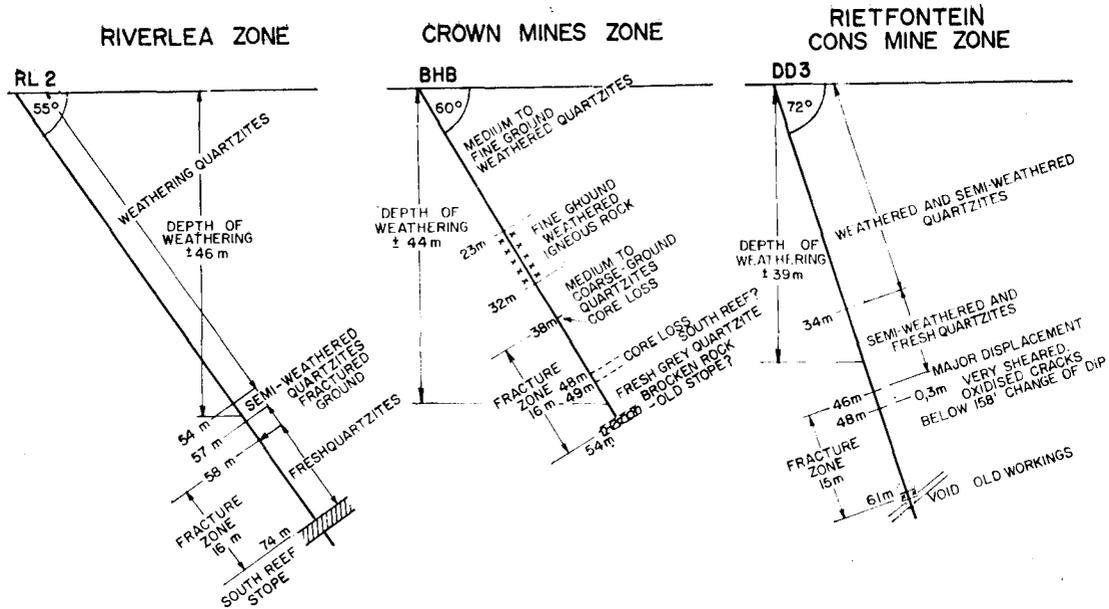
Fig. 18 gives the logs of boreholes RL2, BHB, and DD2, one borehole having been selected from the west, the centre, and the east of Johannesburg respectively (Table III). These describe broadly the nature of the strata overlying the reefs. It will be noted that, above each of the stopes intersected by the boreholes, there is a zone of rock that has been fractured; actual gaps in the hanging were not found, though these may have developed during the stoping period, only to be closed again as the main rock mass settled and compacted the fracture zone.

Fig. 18—The logs of boreholes drilled to determine the nature of the strata overlying the stopes, the depth of weathering, and the extent of the fracture zone

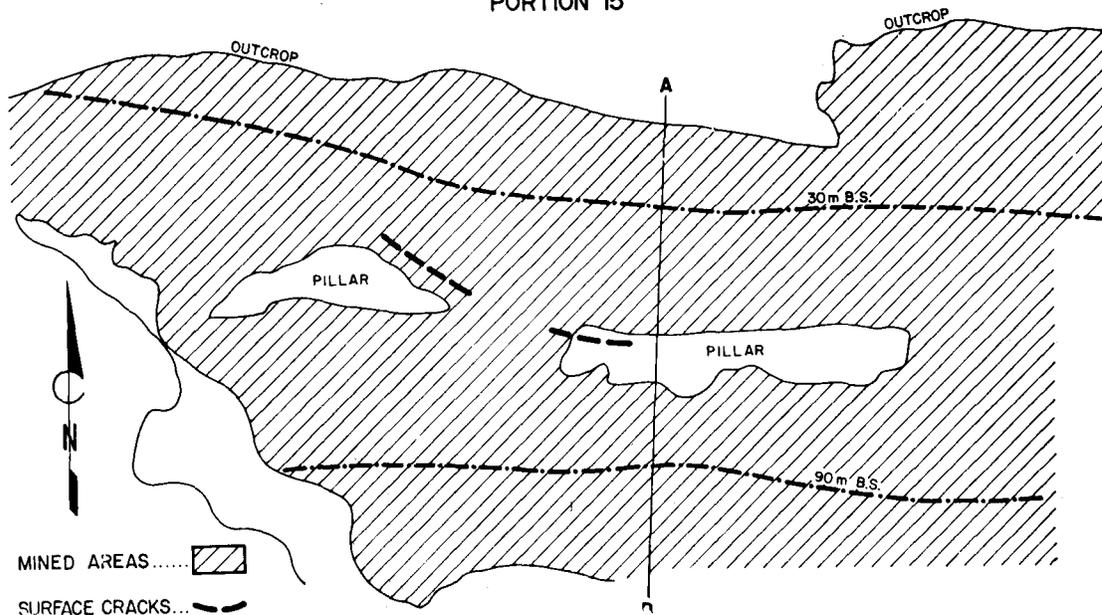
Fig. 20—Plan of Portion 15 of the underground workings, showing the surface cracks that developed on the northern edge of the pillars, Rietfontein Consolidated

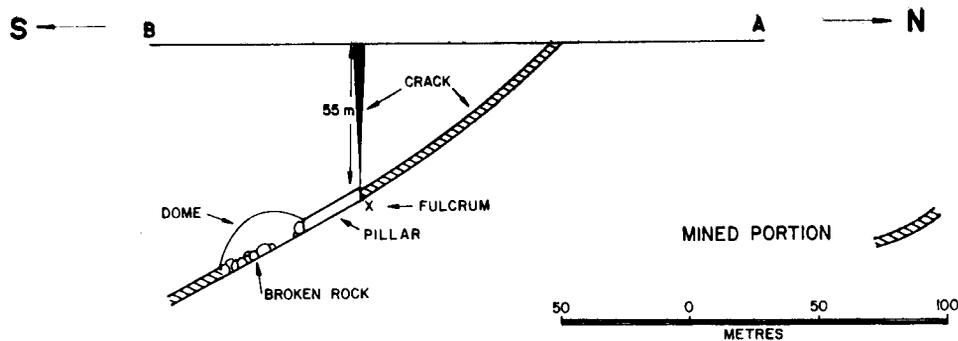
Fig. 21—Section through A-B of Fig. 20, showing a surface crack in relation to a pillar

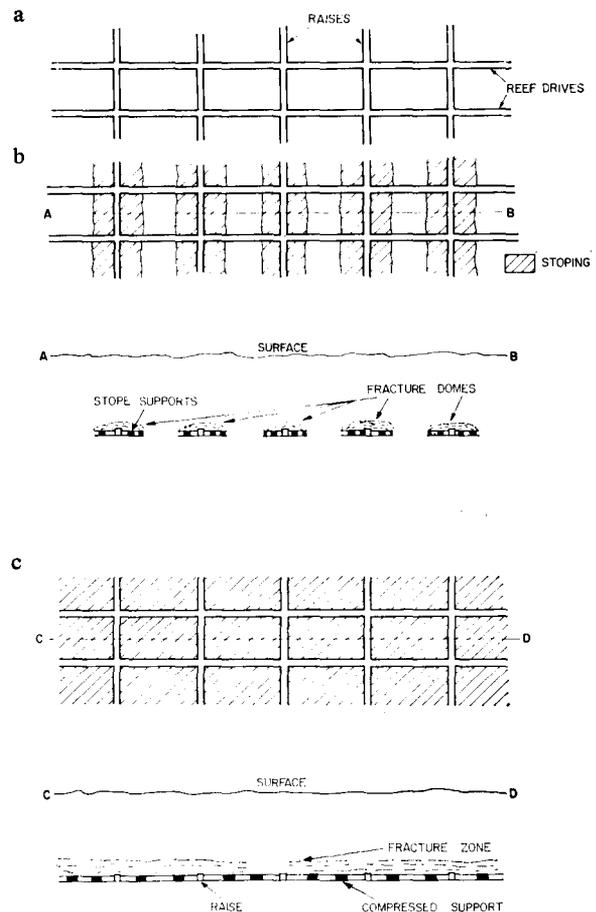
Stoping started from the raises, and, as mining progressed both east and west from each raise, supports were installed; once the stoping span exceeded, say, 30 m, the hangingwall strata would sag and settle on the supports, but this settlement would not initially have extended to surface. The phenomenon was mainly that of separation of strata along bedding planes and the formation of a dome of disturbed or fractured rock above the stopped-out area. Fig. 25b shows an 'idealized' plan and section through the stopes when the mined-out span between the stope faces had reached, say, 50 m. Particularly to be noted is the newly formed fracture zone or dome in the hangingwall of each stope. As mining progressed, the ore between the raises was completely mined out and the extent of hangingwall fracture then became that shown in Fig. 25c. The depth of fracture depends largely on the dip of the reefs: for a near-vertical reef, the depth of fracture into the sidewalls would be small because gravity plays very little part in inducing fracture; as the dip decreases, the effect of gravity becomes more pronounced and the 'fracture zone' above the stope increases. The actual depth of fracture at the shallow depths being

Fig. 25—Plans showing how, with the progress of stoping, a fracture zone develops above the stopes

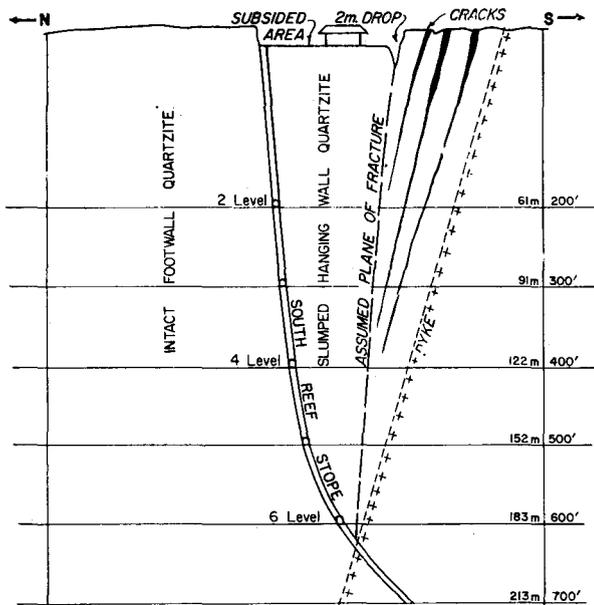
It will be seen [from Fig. 29] that the dyke dipped steeply

Fig. 29—The subsidence of a wedge of ground between a dyke in the hangingwall and a worked-out reef, Nourse Mines

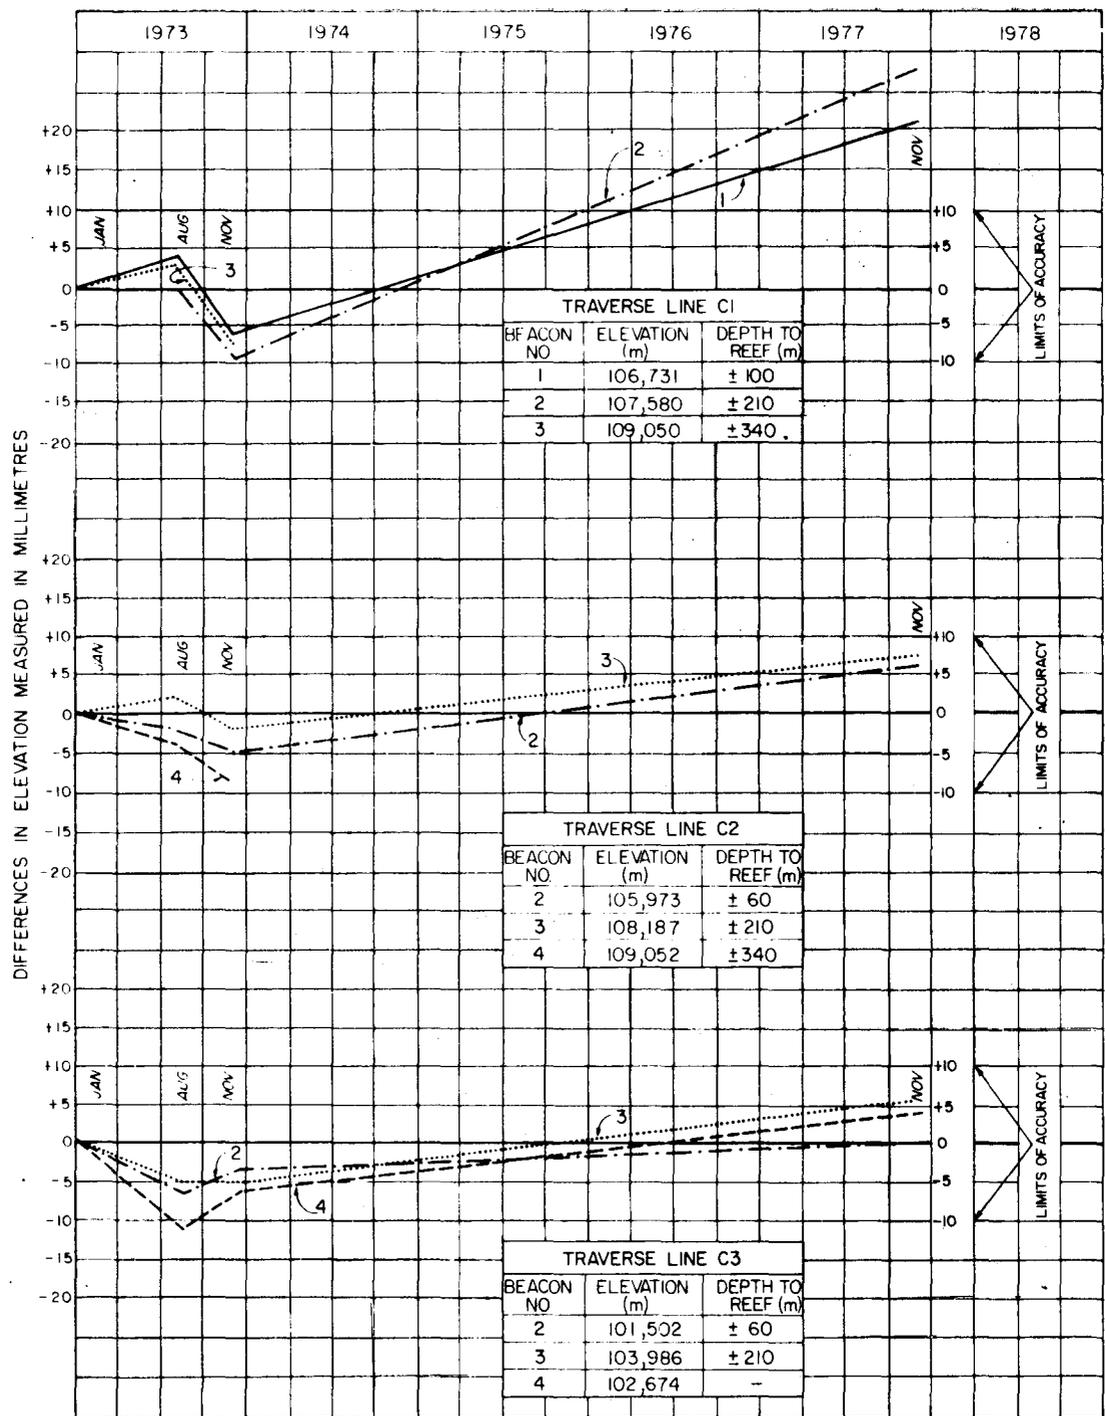
The results of these monitoring surveys are shown in Figs. 35 and 36. It will be noted that, except for beacons 1 and 2 of traverse line C1, no changes in elevation occurred outside the limits of accuracy postulated in the monitoring project. The reason for the unusual behaviour of these two beacons is probably that, as the base beacon north of the outcrop is on the edge of a main road, it was depressed by passing traffic.

Fig. 35—Graphs showing elevations of beacons along traverse lines C1 to C3, Riverlea North, zone A (assumed elevation of beacons north of the outcrop 100 m)

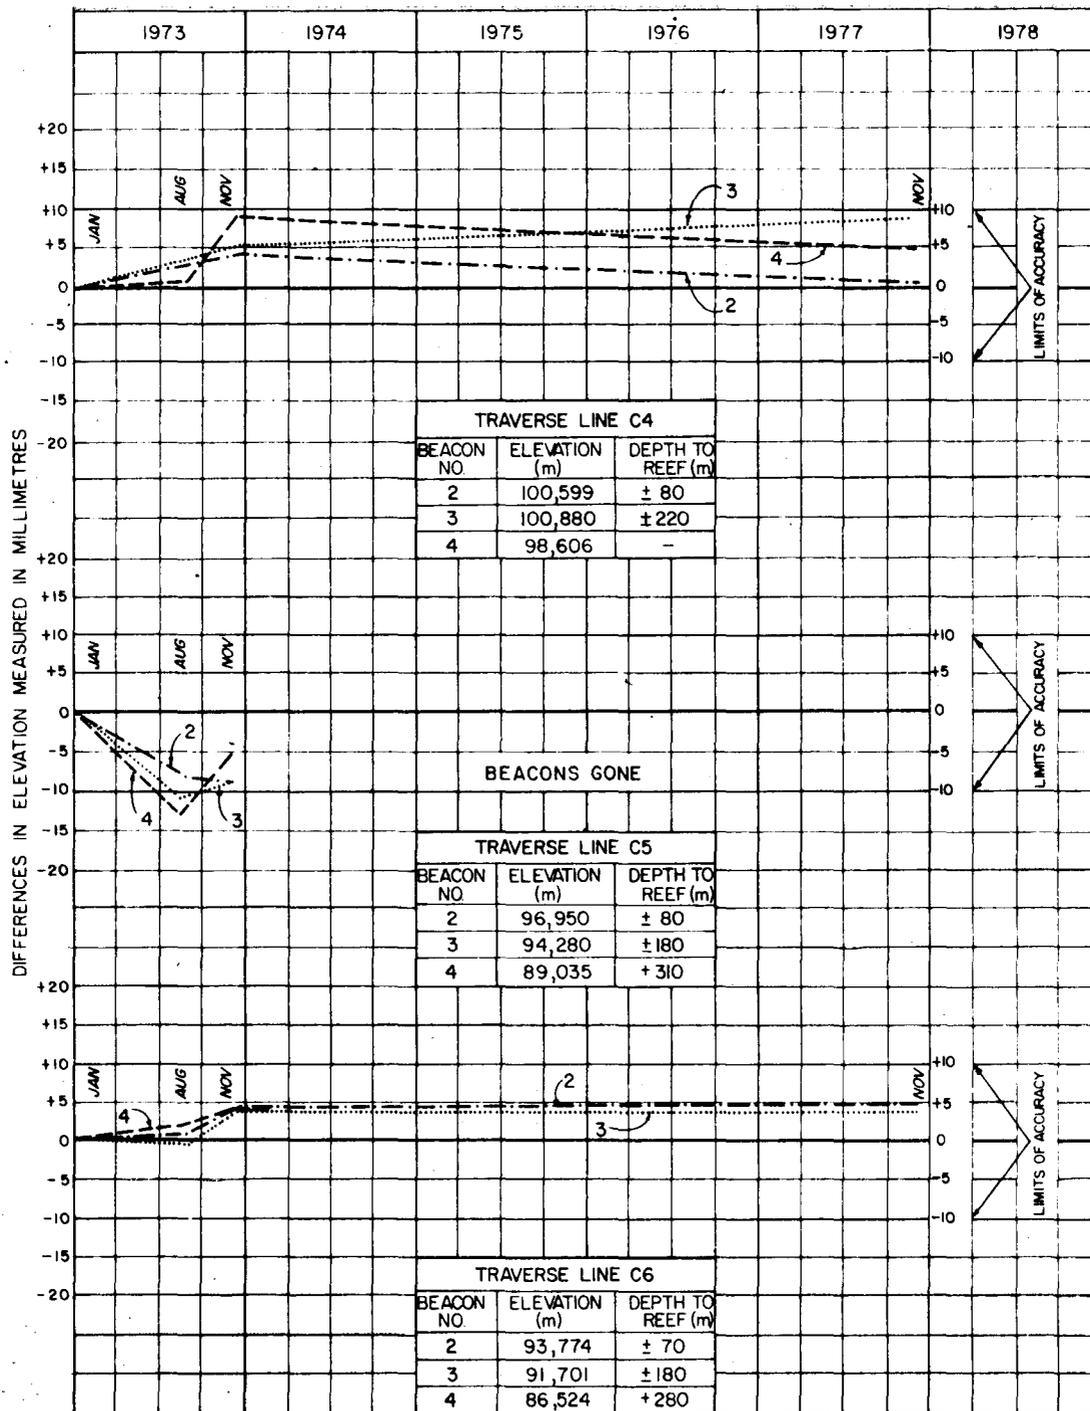
Fig. 36—Graphs showing elevations of beacons along traverse lines C4 to C6, Riverlea North, zone A (assumed elevation of beacons north of the outcrop 100 m)

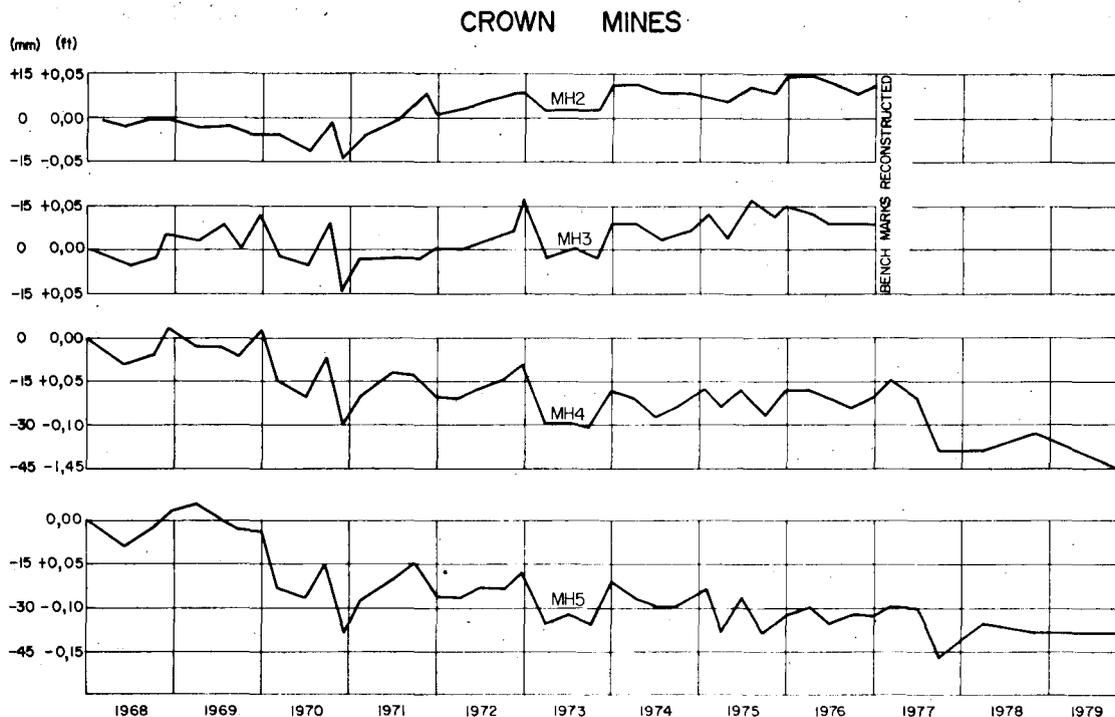
*The Sewer Traverse Line.* The beacons were established on manholes as shown in Fig. 38. The survey results for the past ten years are depicted in Fig. 39. Beacons MH2 and MH3 are situated on a large dyke and, as is to be expected, show no downward movement; beacons MH4 and MH5, on the other hand, have been subsidising very slowly, the total subsidence over twelve years being 45 mm for MH4, and 39 mm for MH5. What is remarkable about the two subsidences is their ‘parallelism’, indicating strongly that the rock mass is subsidising *en bloc*, i.e., the settlement is not differential. The measurements over the past two years suggest that further downward movement will be negligible.

**Fig. 39—Subsidence of beacons along the sewer traverse line, Crown Mines (zone B)**

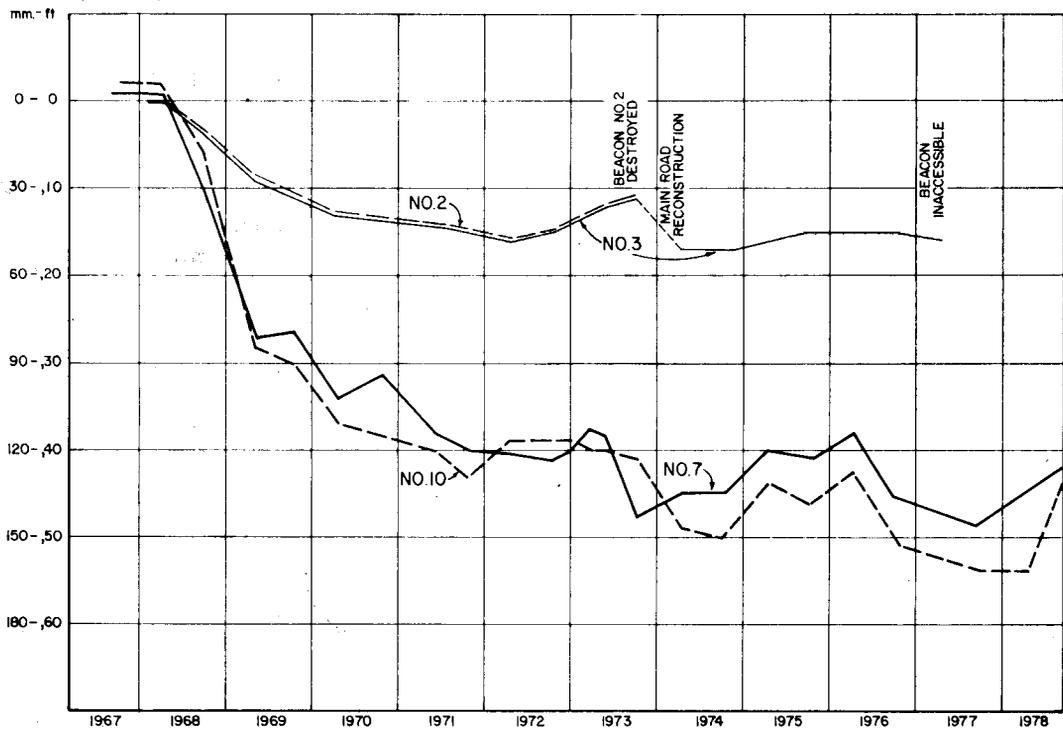
*The No. 7 Shaft Traverse Line.* The position of this traverse line in relation to the underground workings is shown in Fig. 40. The subsidences of beacons 2, 3, 7, and 10 as depicted in Fig. 41 show clearly a decreased rate of

subsidence with time until a state of zero subsidence was reached. The reason for the comparatively large subsidence of beacons 7 and 10 was the removal of No. 7 shaft pillar (Fig. 40). This renewed mining caused the surface to settle over a wide area, extending, for example, to beacons 2 and 3, which were an average distance of 300 m from the shaft. All four beacons indicated *en bloc* settlement, although beacons 7 and 10 subsided some 24 mm more than 2 and 3. This 'tilting' southwards of the surface, amounting to no more than 8 mm per 100 m, is so slight that, had there been buildings on the undermined area, they would not have been affected by the settling of the surface.

Fig. 41—Subsidence of beacons along the 7 shaft traverse line Crown Mines (zone B)

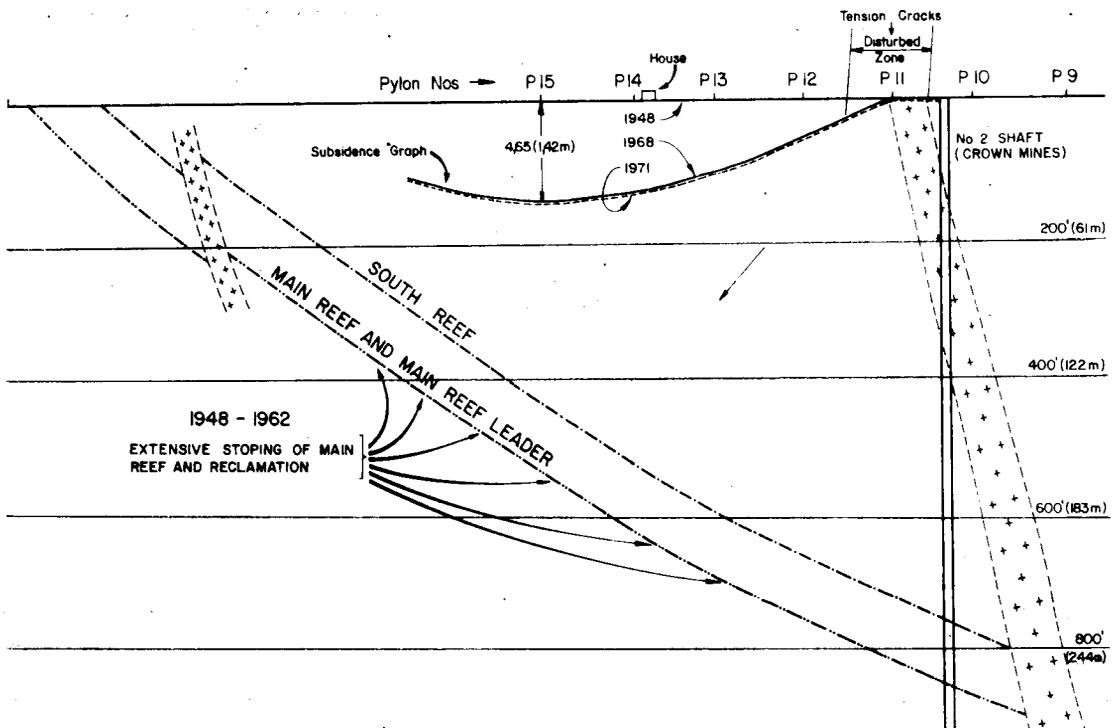
Fig. 42—Section through No. 2 shaft, Crown Mines (zone B), showing the positions of pylons P9 to P15, and the subsidence of pylons P11 to P15, between 1948 and 1971

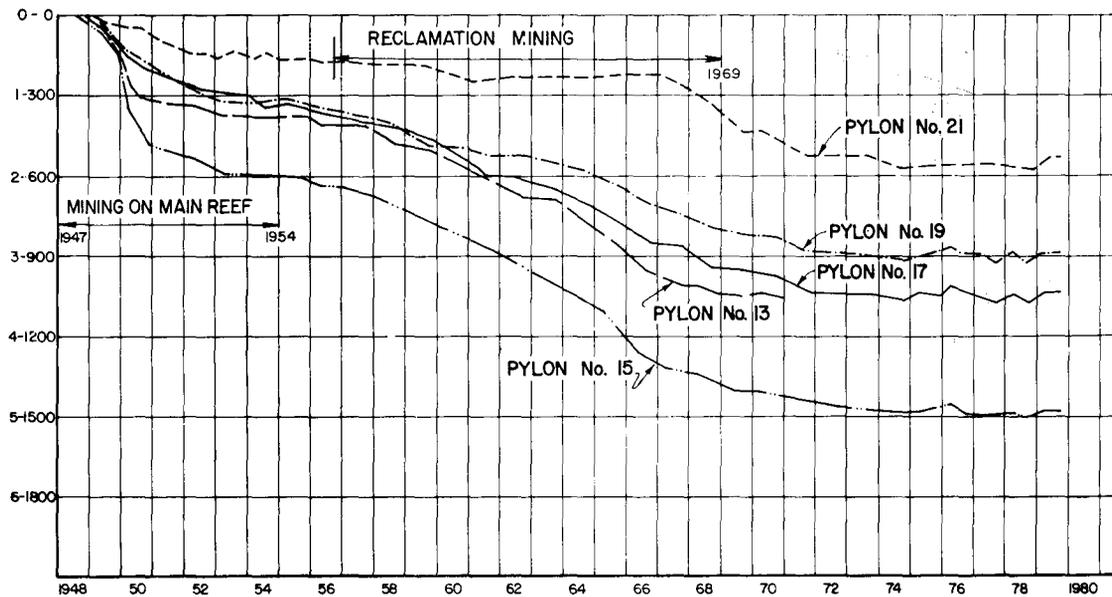
**Fig. 43—Subsidence of beacons on the pylons traverse line, Crown Mines (zone B)**

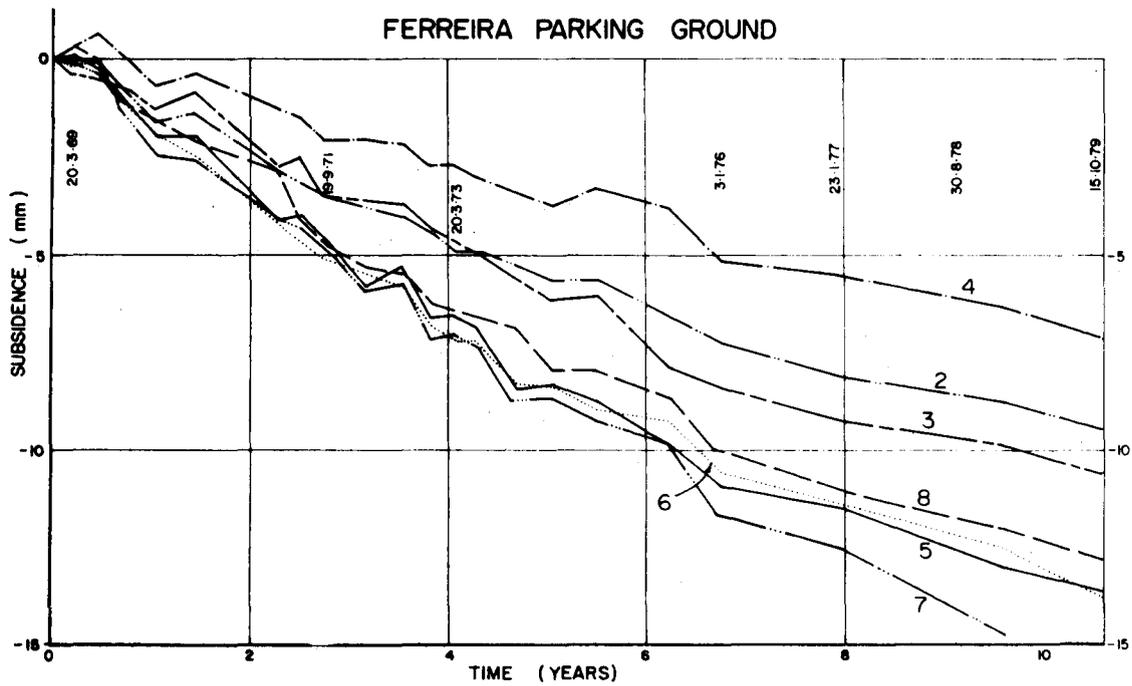
Fig. 46—Graphs showing subsidences of beacons during the period 1969 to 1979, Ferreira parking ground (zone C)

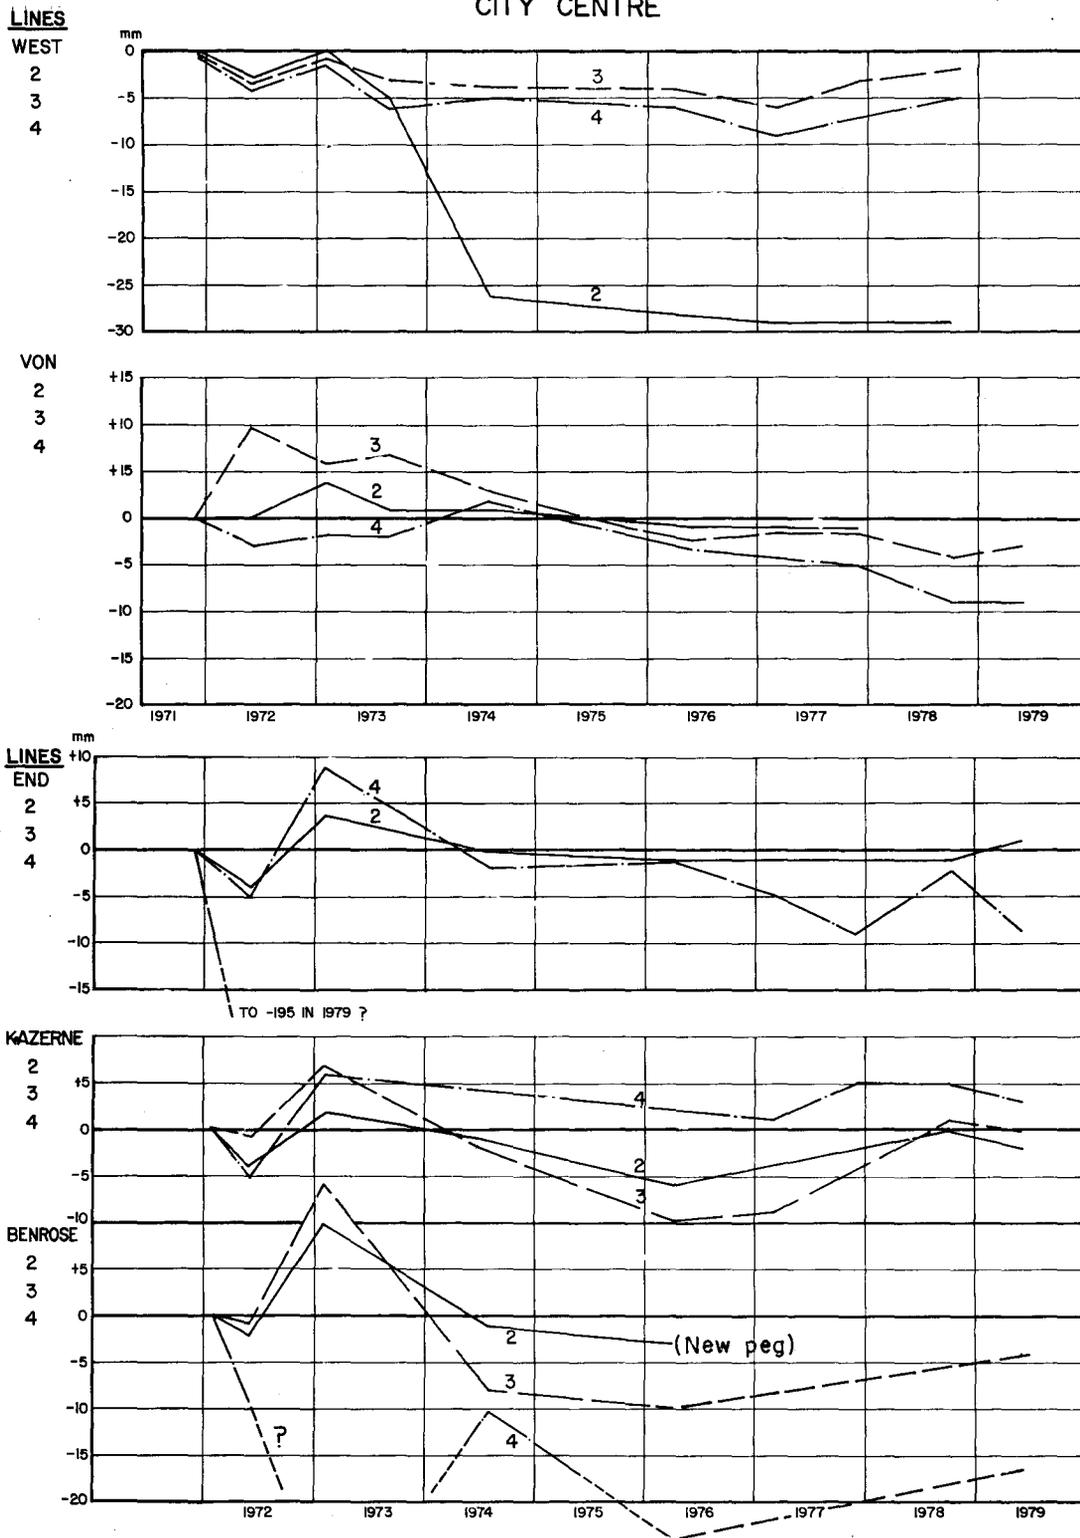
**Fig. 48—Subsidence of beacons along five of the traverse lines established in the City Centre (zone D)**

Current measurements reflect remarkable stability in the vicinity of benchmarks 1, 2, 3, 4, 8, and 9, where the observed subsidence is of the order of the accuracy of the measurements themselves. Benchmarks 7 and 11 show downward movements of 1.2 and 3.0 mm with respect to the initial survey. One may therefore conclude that minimal surface subsidence has occurred over the period of the observation.

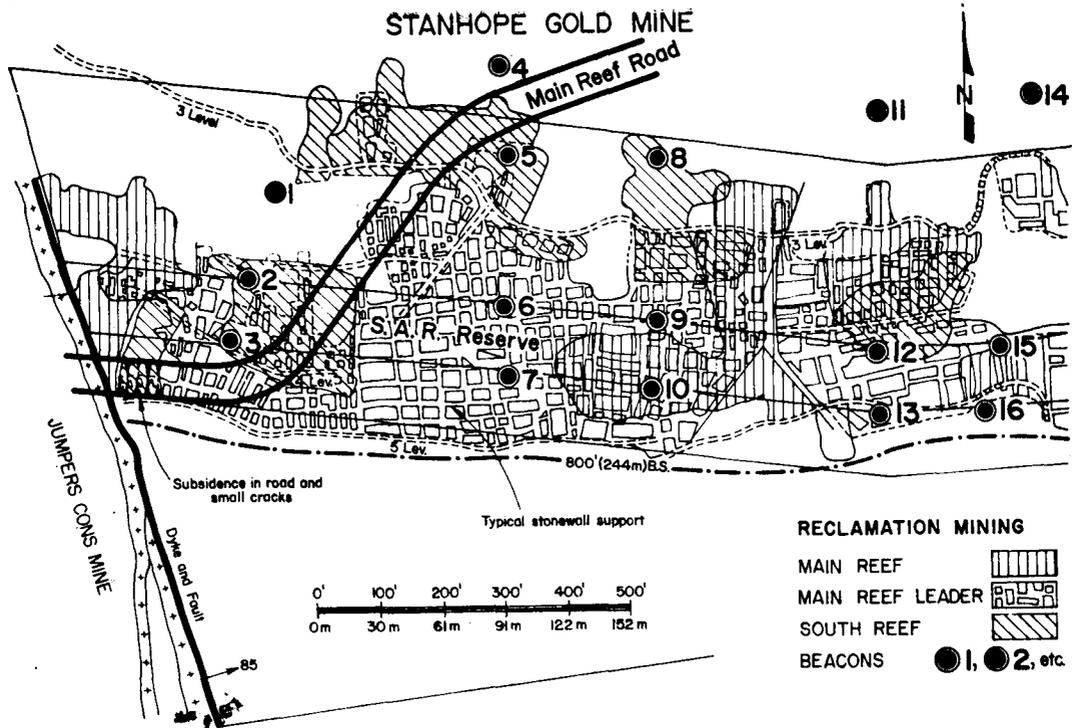
Fig. 53—Plan of Stanhope Gold Mine (zone F), showing beacons in relation to the South African Railways Reserve, the Main Reef Road, and the reclamation mining that has taken place during the past ten years

It will be noted that, during the first four years of the survey (from March 1975 to January 1979), surface movement was minimal. This was followed by a spell of relatively rapid but non-violent subsidence of all the beacons, showing that a large area had started settling. Before an explanation can be offered for the resumption of surface subsidence, consideration must be given to the physical condition of the hangingwall strata in the area, and the conditions in the mined-out stopes prior to reclamation.

years, and which, for the past five years, has been close to the dyke shown in Fig. 53. This diagram gives a clear picture of the extent of reclamation mining below the Main Reef Road and the railway line on the South Reef, the Main Reef Leader, and the Main Reef. The reclamation consisted, *inter alia*, not only in the removal of pillars here and there, but also in the stripping of reef bands left in hangingwall or footwall, and blasting out or breaking of rock to retrieve the fines, e.g., where hangingwall and footwall met. The effect of these operations has been to reduce the effective overall support in the area; small wonder, then, that the hangingwall mass was once more set in motion, resulting in renewed subsidence on surface as well as downward movement of the hangingwall in the stopes. The differential settlement to be seen on the Main Reef Road (Fig. 53) is not unexpected since it took place on the edge of a dyke.

The strata east of the dyke will probably continue to subside while mining is in progress. However, this is no cause for concern since the Stanhope Mine is providing stonewall support in 60 to 70 per cent of the reclaimed areas. The rate of subsidence will thus be so steady and slow that neither the railway nor the road authorities will have to contend with a problem more serious than that of adding extra ballast under the railway line or levelling out any dip in the road with road-surfacing material.

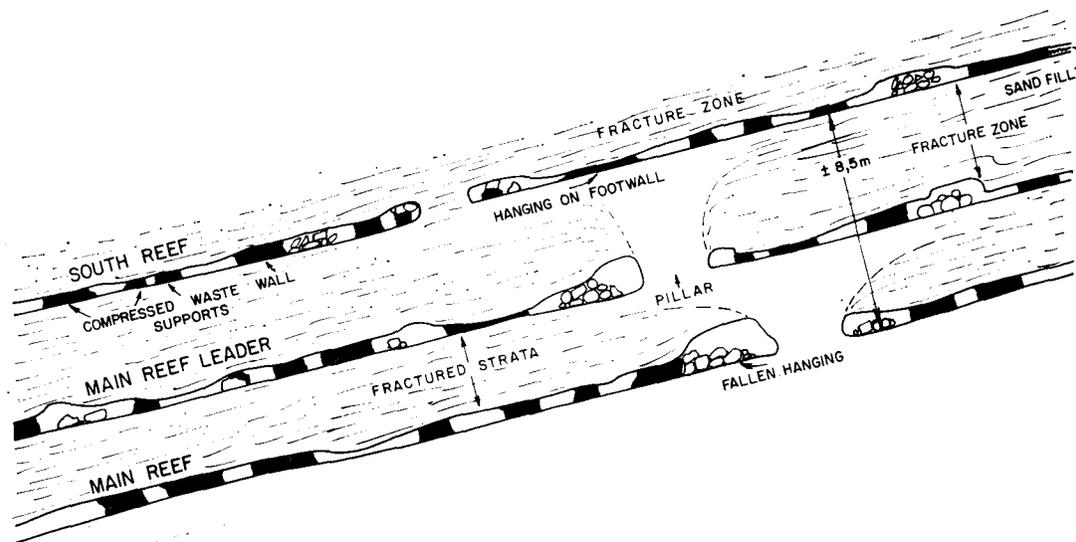
*Conditions in the Stopes Prior to Reclamation.* In May 1980 the writer went underground at the Stanhope Mine to examine the areas where reclamation work was in progress. He found them much as he had expected: compressed supports, low reef drives, pillars here and there, falls of hanging in open stopes, and every evidence of subsidence, including places where the hangingwall was resting on the footwall. Fig. 54 shows the virgin reefs, and Fig. 55 reflects the underground situation in the stopes at the time of inspection. The closure of the stopes resulted from mining in the pre-1925 era. As mining progressed, the hanging above the stopes subsided and fractured, and this continued long after mining had ceased. In the process, the stonewall supports and falls of hanging were compressed, and in some stopes the hangingwall reached the footwall; with the passage of time, the fracture zones above the stopes were also compacted and the multitude of diverse supports became more and more compressed until a state of equilibrium was reached. This was not an uneasy state: it was permanent and stable because of the widespread nature of the supports, which consisted mainly of stonewalls and sandfilling. This judgment is based, not only on the observations at Stanhope, but also on the data collected from zones A to I, which show convincingly that, when mining ceases, subsidence slows down until a state of permanent stability is reached. Conversely, if mining is resumed, subsidence may well occur, as shown by the records from Crown Mines.

Fig. 55—Present conditions in the stopes of the mined-out reefs shown in Fig. 54; the initial mining took place before 1925

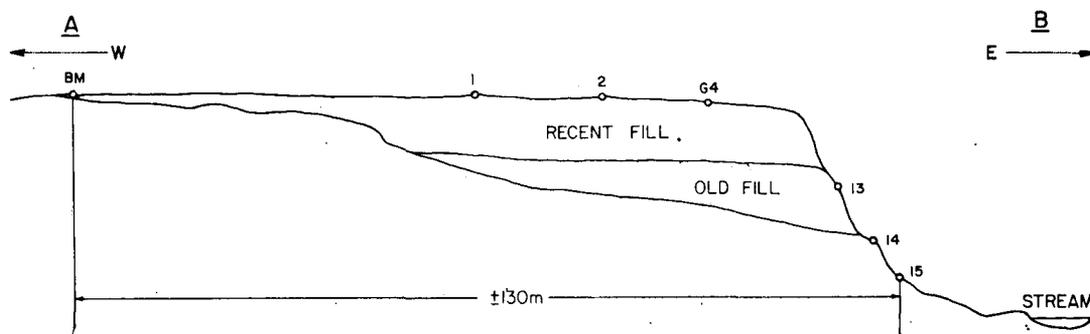
The unexpectedly high subsidences of Table XIII are attributable to gradual compaction of the soil and are, in the writer's view, unrelated to mining. The Germiston Municipality dumped material on the site about nine years ago, and it is the gradual compaction of this material that has caused the subsidence of the benchmarks (Fig. 58). Points 1, 2, and G4 subsided an average of 32 mm, whereas the average for BM13, 14, and 15 was only 1 mm. This seems clear evidence that the recently dumped material is still compacting, while the main rock mass is stable.

Fig. 58—Section through A-B of Fig. 58 (Geldenhuis Estates, zone H), showing beacons that have subsided on ground where there has been a 'fill' of soil and rock

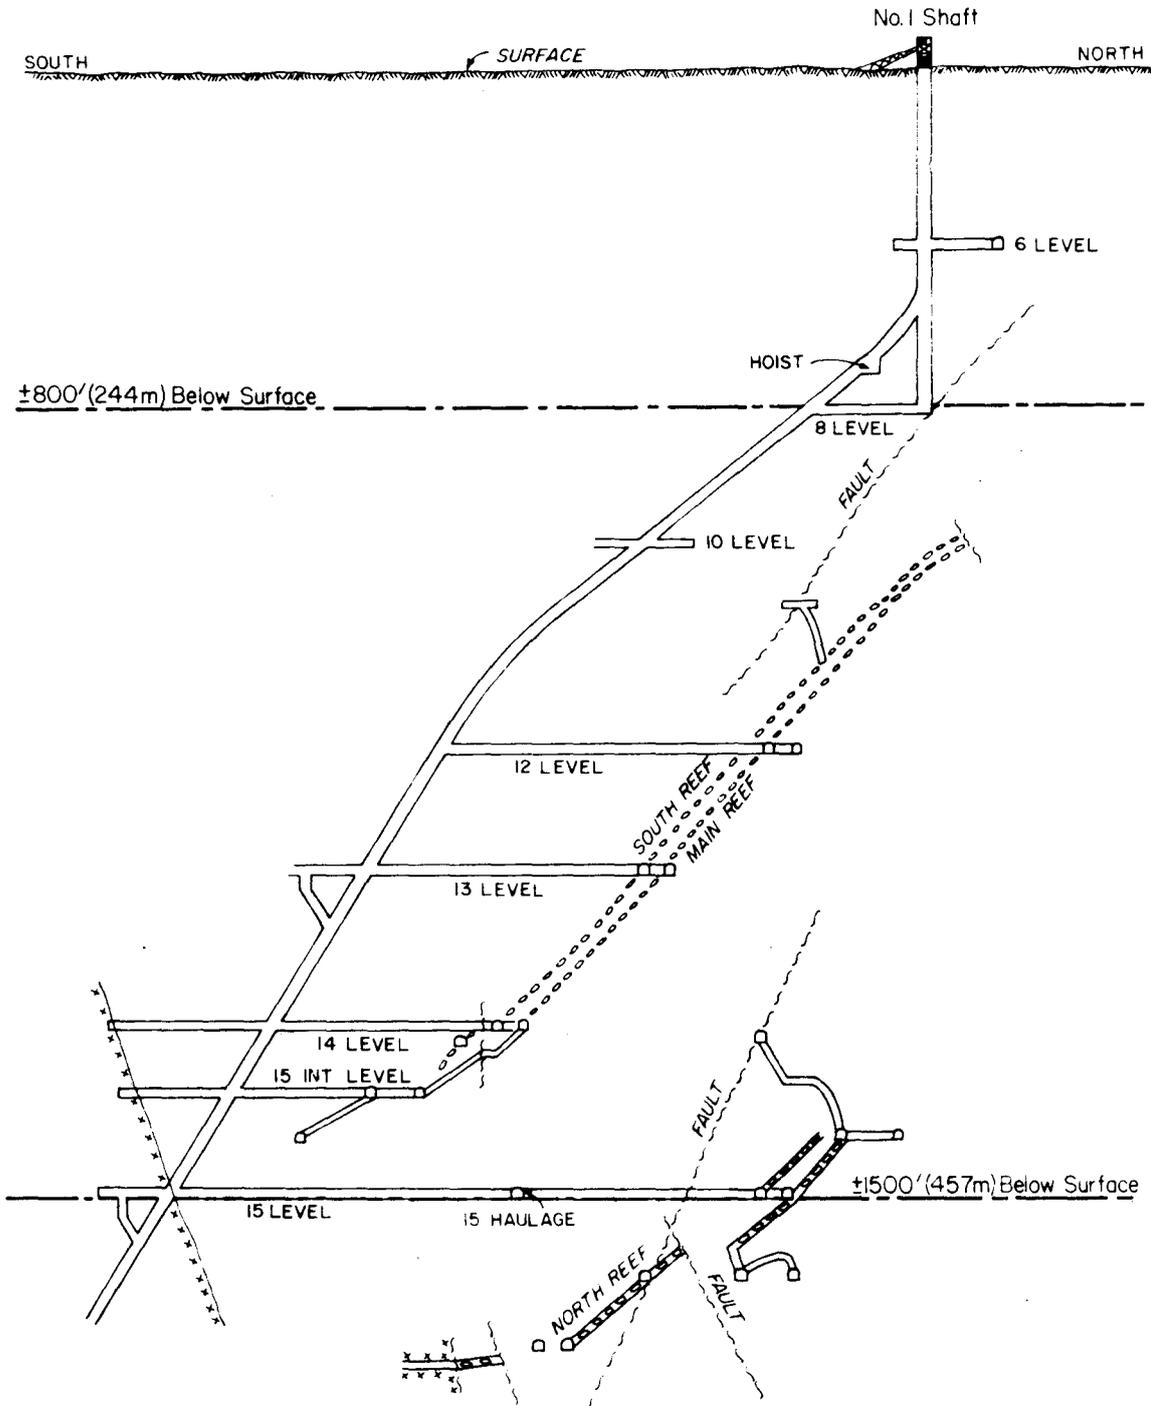
all four portions and do the subsequent survey work. *Portion 20*. Fig. 60 shows the locations of the beacons, which for all these portions consisted of a steel bar projecting from a concrete block embedded to a depth of about 1 m into the soil. Monitoring conducted over a period of six months gave the results listed in Table XIV. It will be seen that the whole of portion 20, whether the depths of undermining are shallow or deep, is completely stable. The few beacons that show differences in elevation of 3 mm are not significant; such small differences are more attributable to soil conditions than to strata movement. Further strong evidence of the hangingwall stability and its *en masse* movement is the fact that No. 1 shaft (Fig. 61), despite being above the mined reefs, was not distorted or in any way adversely affected by move-

Fig. 61—An incline shaft that was unaffected by the South Reef stopping below, Rietfontein (zone I)

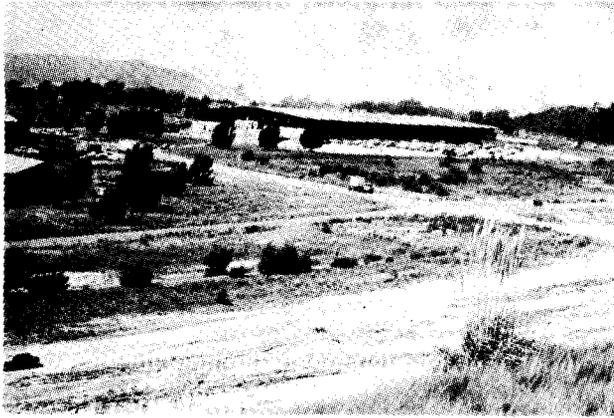
Fig. 64—The warehouse on the old Mayfair Mine

Fig. 64 is a photograph of the wholesale store, and Fig. 65 shows its position in relation to the underground workings. The outcrop area had been treated as follows before the warehouse was erected. All the rubble and loose material were removed from the throat of the outcrop, and the *in situ* quartzites on the hangingwall and footwall sites were located. The cleared-out area was then backfilled with selected material and compacted. Cables treated with bitumen were next installed to straddle the

sandfilled stopes, and these cables, in turn, were covered with soil to the required levels. The safe-guarding against collapse was carried out so well that the building could have straddled the outcrops without fear of the structure being damaged by any form of subsidence.

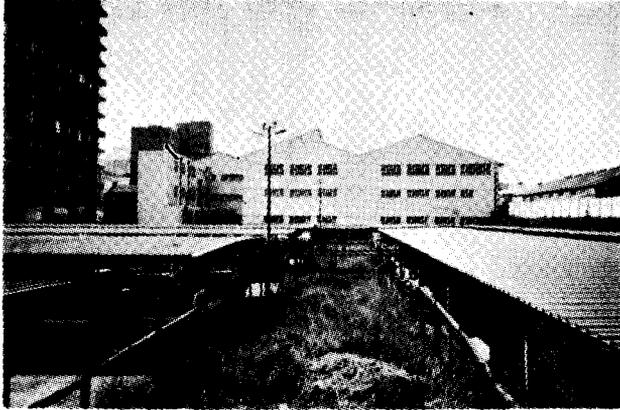
Fig. 67—The fenced-off area next to the building (building B in Fig. 69) marks the strike of the South Reef

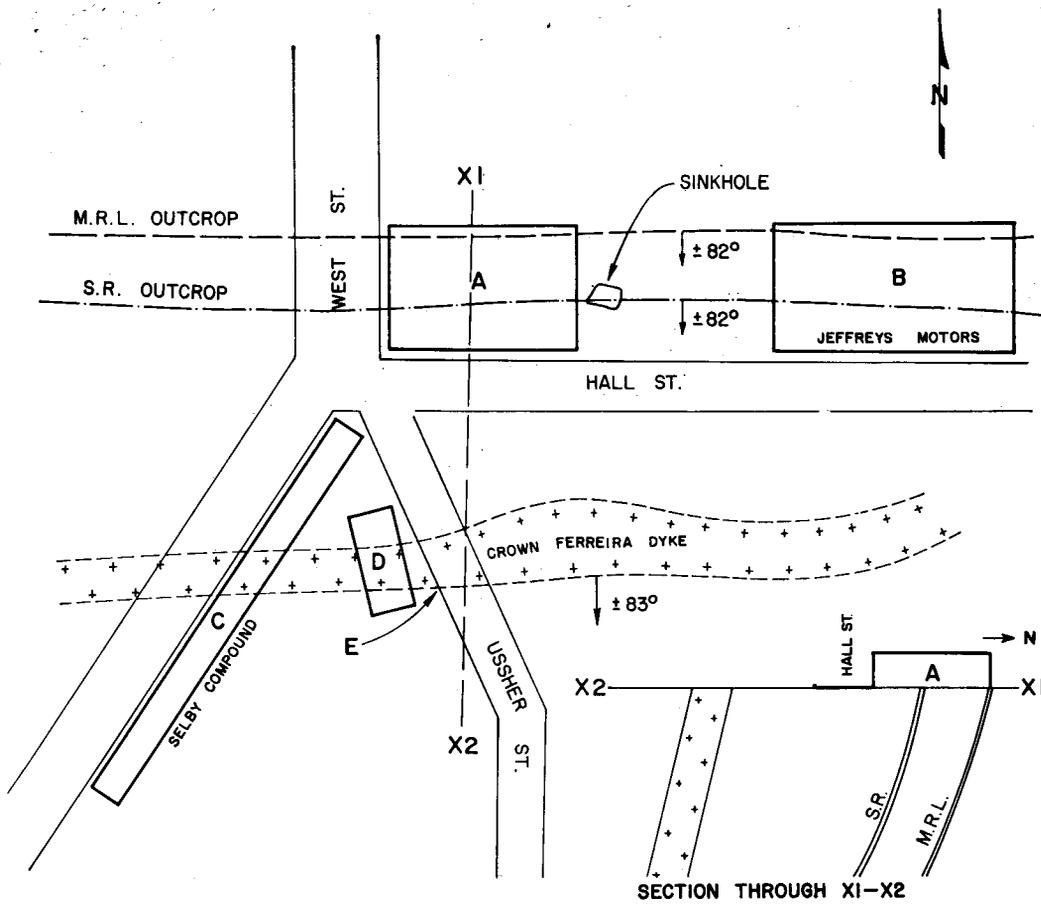
Fig. 68—Despite straddling the Crown Ferreira dyke, these buildings (C and D in Fig. 69), which were erected over 40 years ago, have been unaffected by differential movement of the surface

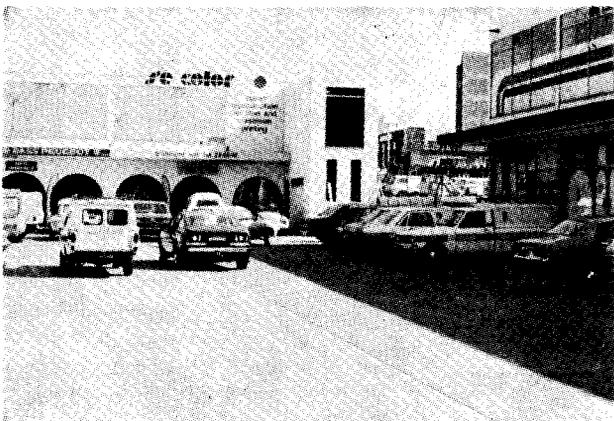
The two shops of Fig. 70, which were completed in 1975, were erected on ground overlying the outcropping South Reef and Main Reef Leader respectively; they, too, have been unaffected by differential movement of strata, for the reason that the strata have reached a state of rest. Figs. 71 and 72 show the positions of these shops

Fig. 70—Photographs, looking west, of shops A and B in End Street (Fig. 71), which were erected in 1975 on undermined ground

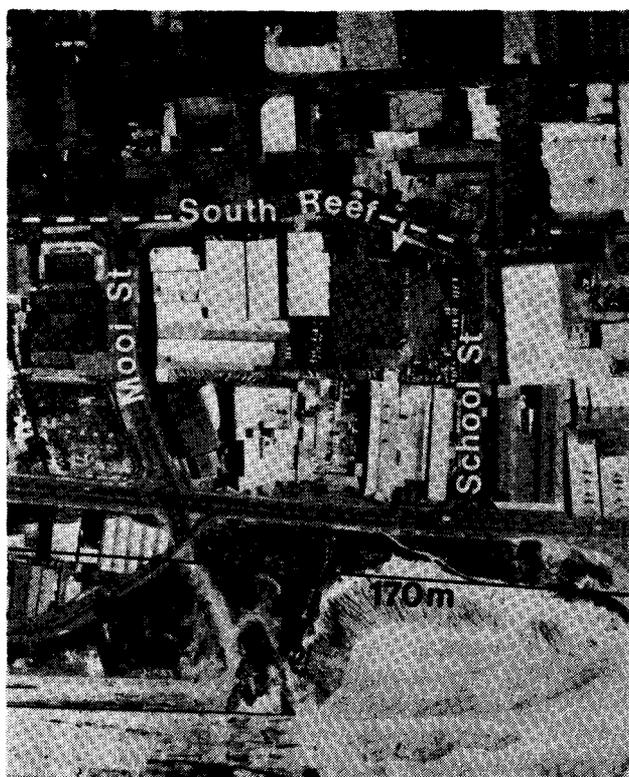
The South Reef outcrop (and the 170 m depth contour) is shown in Fig. 73. To be noted are the large number of buildings in this 'restricted' zone. Inspection of the buildings has confirmed the absence of damage due to undermining.

Fig. 73—A large number of buildings where the depths of undermining range from 10 to 170 m
