Davidsen, J.E. and Honstad, M. Tap-hole maintenance and management on furnace 10 at Eramet Norway Porsgrunn The Southern African Insitute of Mining and Metallurgy

Synopsis

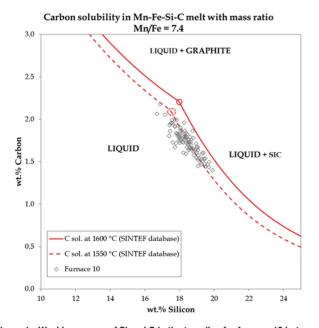
As shown in Figure 1, the composition of the tapped alloy from furnace 10 is located mainly to the right of the coexistence point for C/SiC, indicating that SiC should be the stable form of carbon. The points are located around the solubility limit at 1550°C. Knowing from experience that the metal temperature is generally lower than the slag temperature, which averages around 1586°C, this seems like a reasonable fit. About half the points in Figure 1 are situated below the curve and thus indicate an alloy unsaturated in carbon. Such an alloys has the potential to dissolve carbon from the graphite tap-hole block, but would be less likely to dissolve a SiC block. As the tap-hole blocks in the present lining on furnace 10 are made out of graphite, chemical attack by the metal on the tap-hole block can be assumed a plausible wear mechanism.

Figure 1—Weekly average of Si and C in the tap alloy for furnace 10 between July 2016 and February 2018. Calculated carbon solubility curves at 1550°C and 1600°C are plotted in the same graph, with the point of coexistence between C and SiC marked by larger circles. The red lines are calculated with ThermoCalc using the SINTEF database

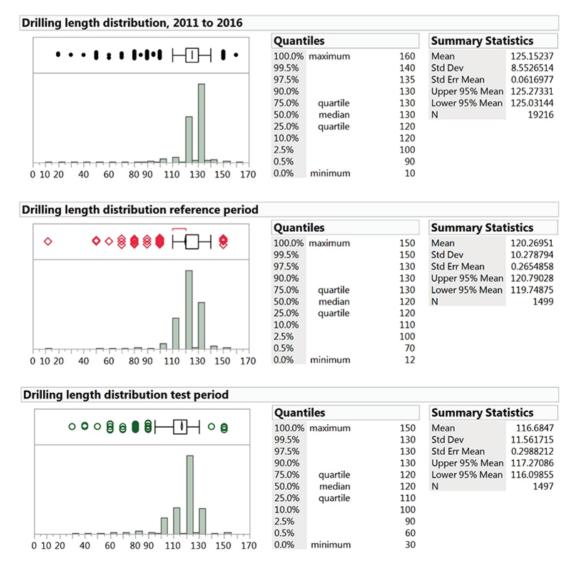
Figure 4—Distribution of the drilling length (in centimetres) for the period of 2011 to 2016 (top), reference period (middle), and the test period with CTP-free paste (bottom)

As can be seen, the drilling length decreased for each of the periods, with averages of 125 cm, 120 cm, and 117 cm for 2011–2016, the reference period, and the test period, respectively. A t-test was run to compare the drilling length distribution during the reference and test periods. The test returned a P-value smaller than 0.0001, indicating that the shorter drilling length during the test period is in fact statistically significantly.

Some wear of the lining in the tap-hole area is to be expected during full operation for over 7 years. However, the decrease from the historical data to the reference period and then to the test period indicates an accelerated decrease in length. Some of this decrease can most likely be attributed to an increase in the number of taps with oxygen lancing. Figure 5 shows the percentage of taps with lancing per month from 2011 to February 2018. The test period and reference period are shown by light grey and striped black bars, respectively. As the graph shows, there seems to be an increased incidence of O₂ lancing from the end of 2015.

The increase in O₂ lancing is most likely the main cause contributing to the shortened drilling length for the test period. The fact that the average drilling length stabilized, although on a slightly lower level, is interpreted as an indication that the CTP-free paste works well for maintaining the tapping channel.

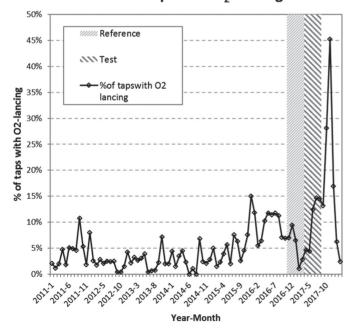
Percent of taps with O₂-lancing

Figure 5—Percentage of taps with O₂ lancing in the period between January 2011 and February 2018. The reference and test periods are marked with light and dark grey bars, respectively
