Investigation of the mechanism for fire-side corrosion in coal-fired boilers in South Africa

Furnace wall tubes from 600 MW subcritical boilers at three coal-fired power stations were sampled and the fireside deposits examined to determine the mechanism of fireside corrosion. This involved an in-depth investigation into the morphology and composition of the fireside deposits and the conditions of the furnace that enable this type of attack. SEM-EDS analysis revealed high concentrations of oxygen, iron, and sulphur, QEMSCAN and XRD analyses identified the presence of Fe_3O_4 , Fe_2O_3 , FeS , and FeS_2 . Differential thermal analysis showed thermal activities at temperatures of 500–600°C, 900–1100°C, and 1100–1250°C, which are associated, respectively, with FeS_2 oxidation to FeS and Fe_2O_3 , at 475–525°C, formation of aluminosilicates at 925–1100°C, and melting of FeS around 1190°C. The absence of sodium and potassium eliminates the contribution of molten alkali sulphates to the corrosion. The consistent coexistence of iron sulphide and iron oxide is indicative of the substoichiometric conditions in the furnace, while the detection of pyrite suggests that the coal is not complete

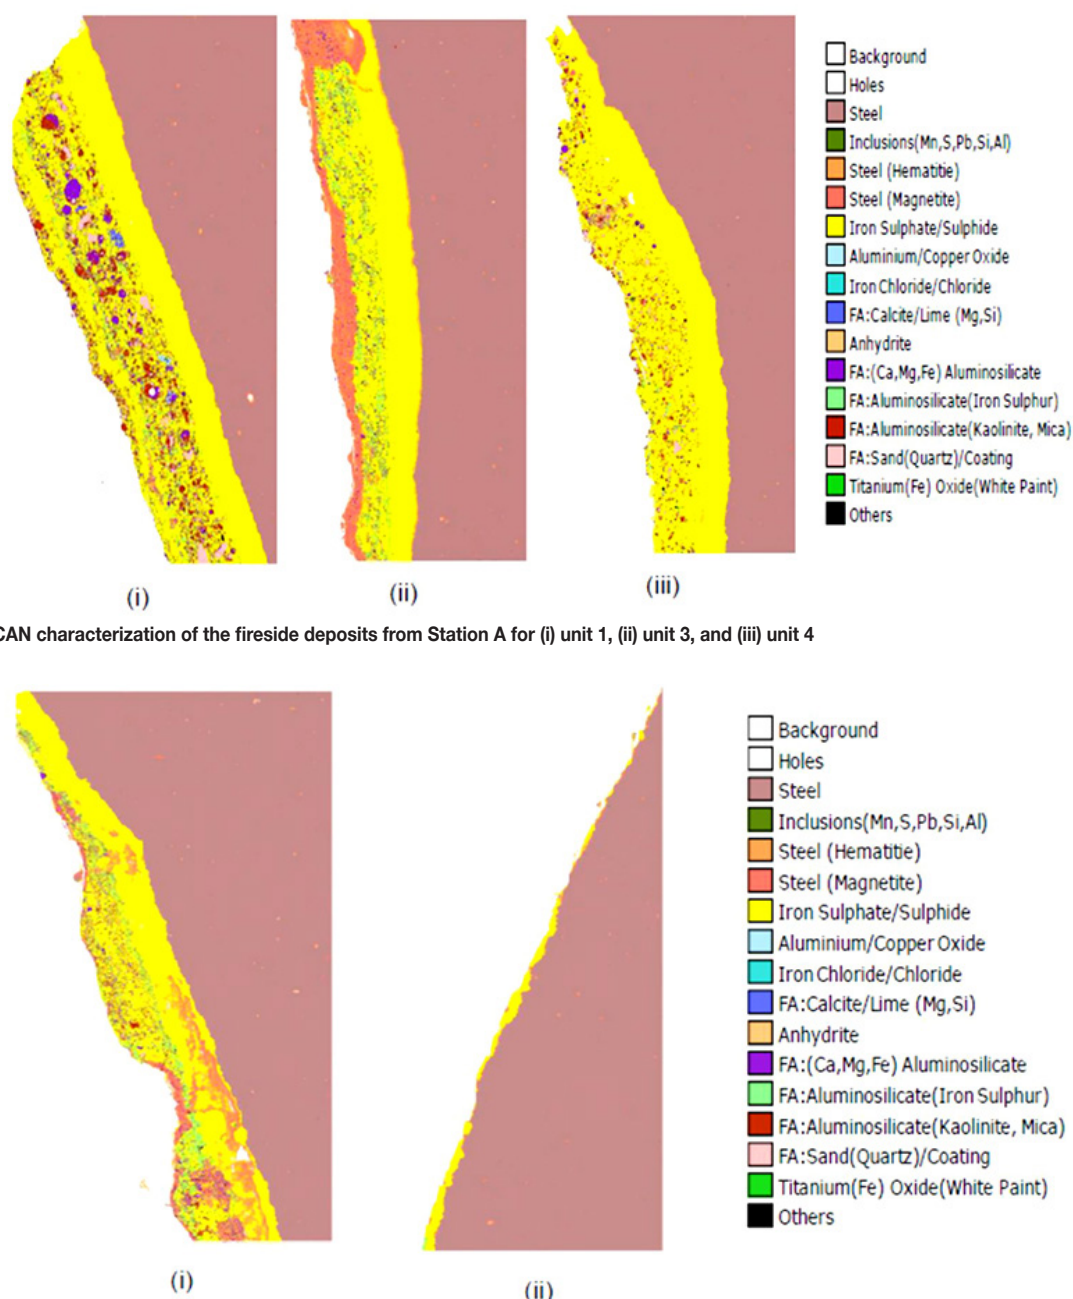
QEMSCAN analysis was performed on the fireside of the tubes from stations A and C. Due to the lack of samples from Station B during this analysis, the mineralogy of Station B tubes was analysed with XRD only. A similar morphology was observed on the fireside deposits from stations A and C. As shown in Figures 16 and 17 respectively, a three-layered deposit with a consistent band of Fe-sulphide rich phase was observed on the interface to the steel extending to the middle section. The outer layer was predominantly iron oxide with fly ash particles: quartz (SiO_2), kaolinite ($\text{Al}_2\text{O}_3 \cdot 2\text{SiO}_2 \cdot 2\text{H}_2\text{O}$), Ca/Mg aluminosilicate, and pyrite

Figure 16—QEMSCAN characterization of the fireside deposits from Station A for (i) unit 1, (ii) unit 3, and (iii) unit 4

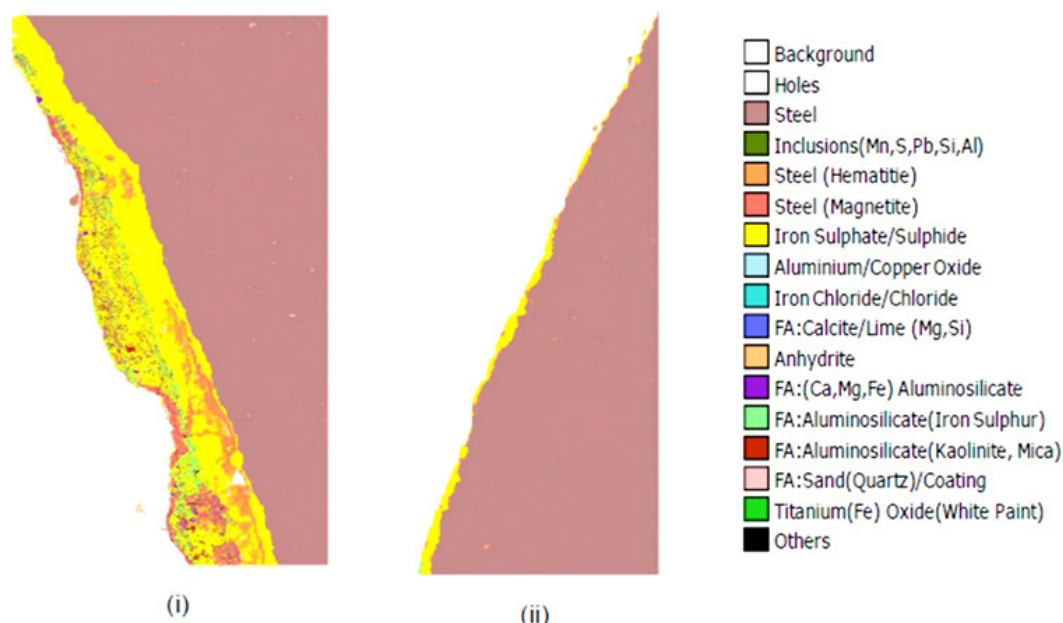
Figure 17—QEMSCAN characterization of the fireside deposits from Station C for (i) unit 4 and (ii) unit 6

Station C: The fireside deposit on the tubes from both units of Station C showed high levels of pyrrhotite. Differences were seen in the concentrations of magnetite; the fireside deposit from unit 6 had higher concentrations than unit 4. The difference in the morphology of unit 4 and unit 6 fireside deposits may be indicative of the different furnace environments. The high concentration of pyrrhotite and iron oxide phases in unit 6 samples suggests the existence of alternating oxidizing and reducing conditions, whereas in unit 4 it appears that conditions were reducing for a longer time, which resulted in the formation of pyrrhotite and minimal iron oxide phases.

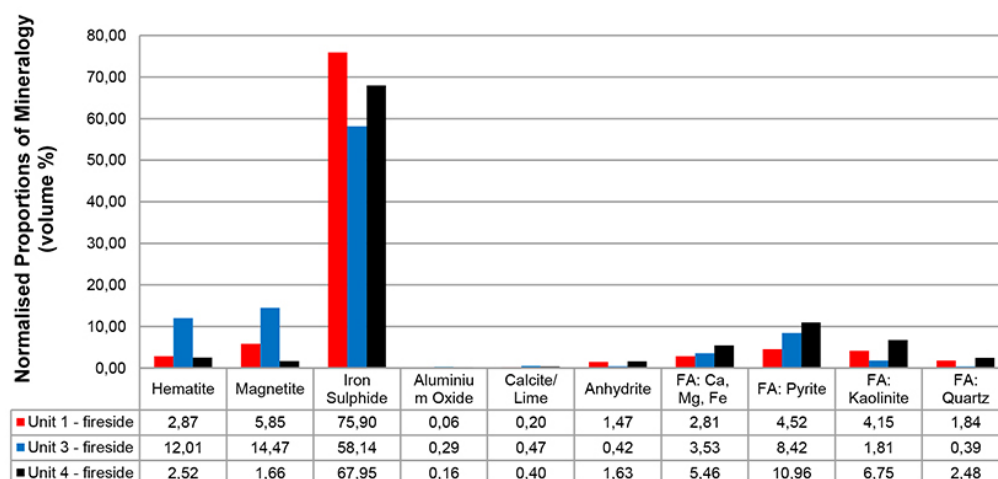
(FeS_2). These results correlate with the high iron and sulphur concentrations in the middle and innermost layers detected by SEM-EDS. Figure 18 and 19 give the mineralogical composition of the fireside deposits from stations A and C respectively. The fireside deposit thickness was measured at a maximum of 1.2 mm for Station A and 0.53 mm for Station C.

There was no evidence of sodium or potassium associated with the sulphur in any of the samples from stations A and C. The presence of sulphide phases coexisting with iron oxide is indicative of substoichiometric conditions in the furnace and/or on the tube surfaces.

Figure 18—Quantitative mineralogy estimates of the fireside deposits for Station A

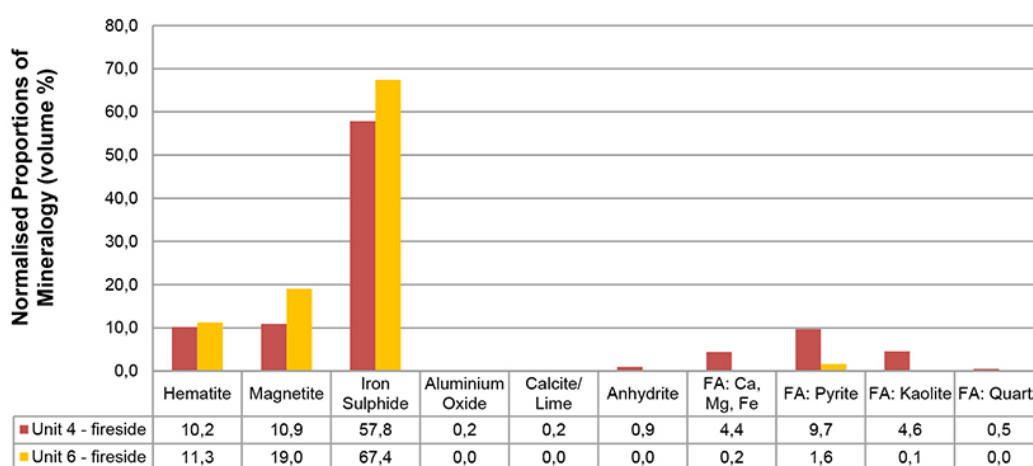
Figure 19—Quantitative mineralogy estimates of the fireside deposits for Station C

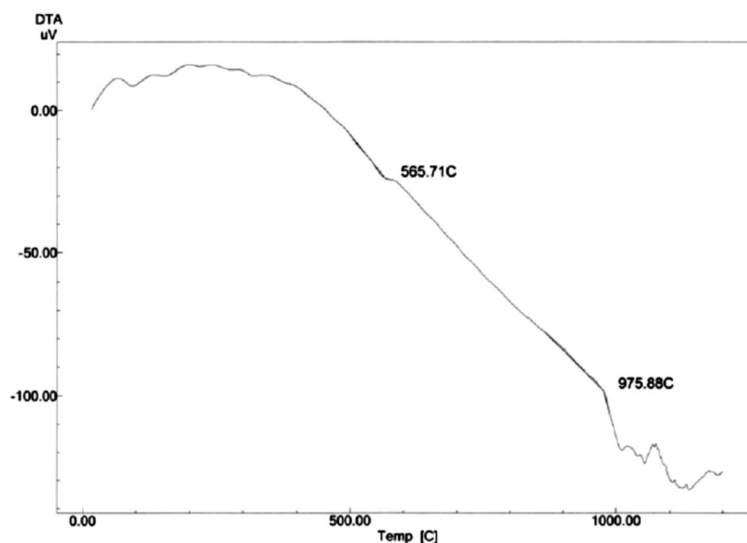
DTA results for stations A and B revealed similar thermal behaviour. Peaks were generally measured at temperatures from 950 to 1250°C. On isolated samples from stations A and B, lower temperature activities were indicated at 565°C and 541°C respectively, as shown in Figures 20 and 21. These thermal activities seem to correlate with a survey reported by Bryers (1995) on the thermal behaviour of minerals commonly found in coal. Bryers showed that kaolinite transforms into metakaolinite at temperatures around 500°C, which further transforms into other forms of aluminosilicate at around 925°C and 1100°C. At

Figure 20—Thermal behaviour of the fireside deposit on Station A tubing sample

i.e. metakaolinite, into mullite, were detected consistently at temperatures in the range 950–1250°C, which concurs with thermal behaviour described by Bryers (1995). Lower temperature peaks were measured between 500 and 600°C, indicating pyrite (FeS_2) transformation to FeS, $\text{Fe}_2(\text{SO}_4)_2$, and FeO (Corey, 1964). The coexistence of high levels of pyrrhotite with iron oxide and the presence of pyrite in the fireside deposit is indicative of reducing conditions in the furnace as well as on the surface of the boiler tubes.

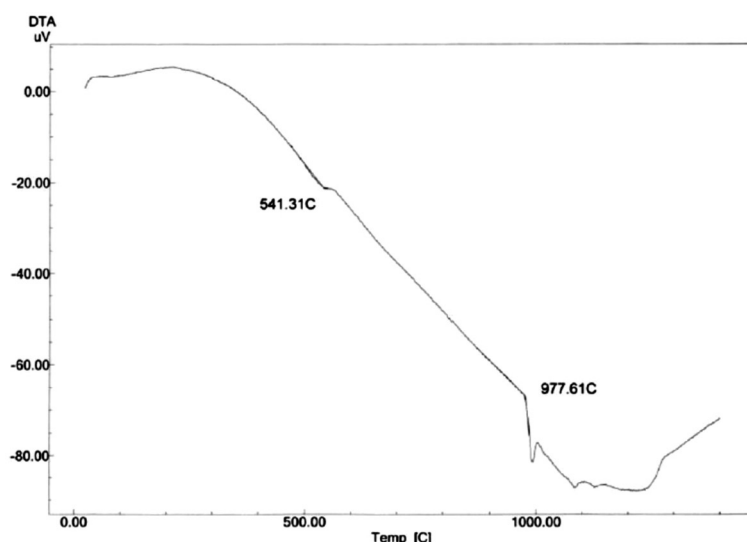
Figure 21—Thermal behaviour of the fireside deposit on Station B tubing sample
