# Stabilisation of Highwall Instability Using Numerical Modelling and Statistical Analysis for Open Pit Mining

**Middindi Consulting (Pty) Ltd**  
Rock Engineering Geotechnics Geology

Rising concerns after highwall failure led to an urgent detailed assessment as increasing fractures and block movement developed at the failed highwalls crest and is close to a public road, approximately 100m.

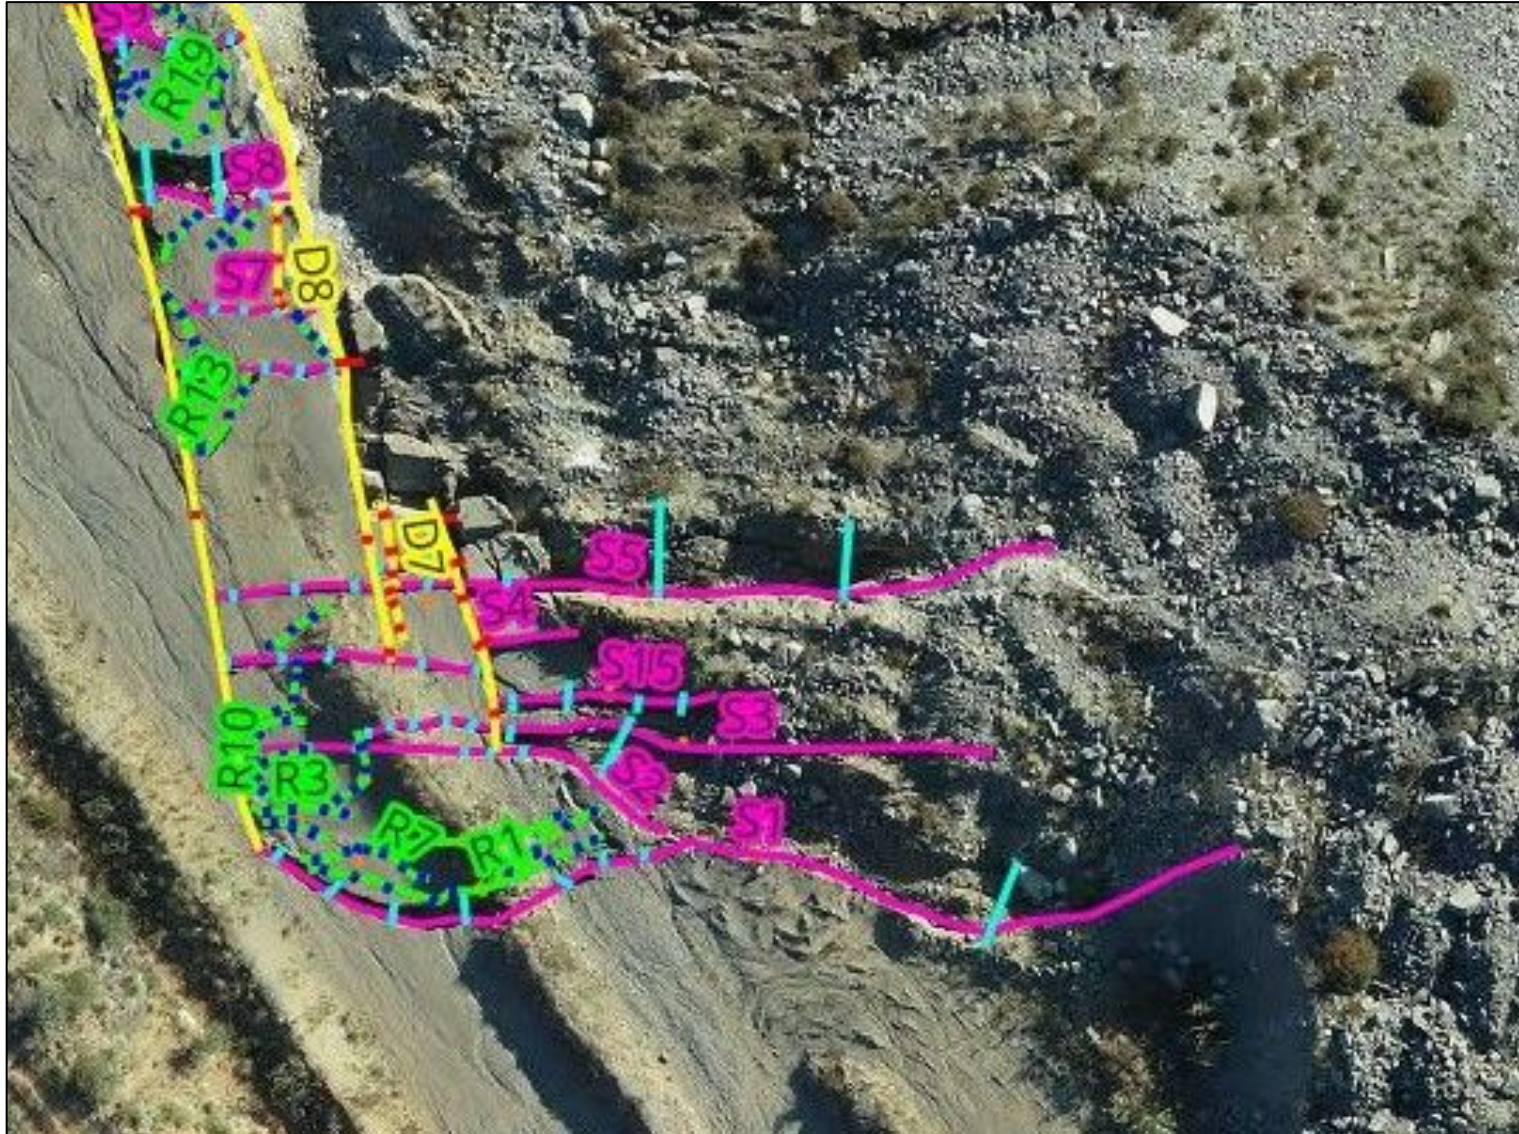
# Fracture Analysis

To better understand the progression of the fractures:

- Fracture propagation analysis using aerial photographs captured over a six month period.
- A total of 10 Dip fractures, 15 strike fractures, and 28 radial fractures were observed and analysed using QGIS.
