# Application of ecosystem function analysis (EFA) in assessing mine tailings rehabilitation: an example from the Mhangura Copper Mine tailings, Zimbabwe

by G.M. Dowo\*, S. Kativu\*, and D.J. Tongway†

## Synopsis

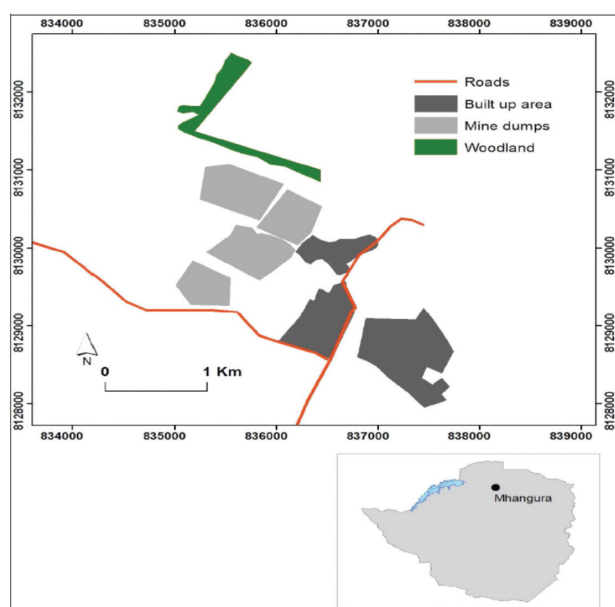
Figure 1—Map of Mhangura Mine showing the location of the slimes dams (grey shade). Map units are in metres, Universal Transverse Mercator (UTM) zone 36 South based on WGS 1984 spheroid

Mhangura Copper Mine lies approximately 186 km northwest of the city of Harare. It is located in the Mashonaland West Province of Zimbabwe, at approximately 16°53'S and 30°09'E (Figure 1). The mine area is surrounded by farmland that is used mainly for maize cultivation and, to a lesser extent, livestock grazing. Mhangura lies in Natural (Agro-climatic) Region II (Vincent and Thomas, 1960), which is characterized by high rainfall (750–1000 mm a<sup>-1</sup>) and intensive farming. This includes a dry, cool season from May to September when very little rain falls. The wet season is usually characterized by heavy rainfall from November to March. Geologically, Mhangura is one of the largest stratabound copper occurrences within the Proterozoic metasediments of the Lomagundi Basin (Mhangura Copper

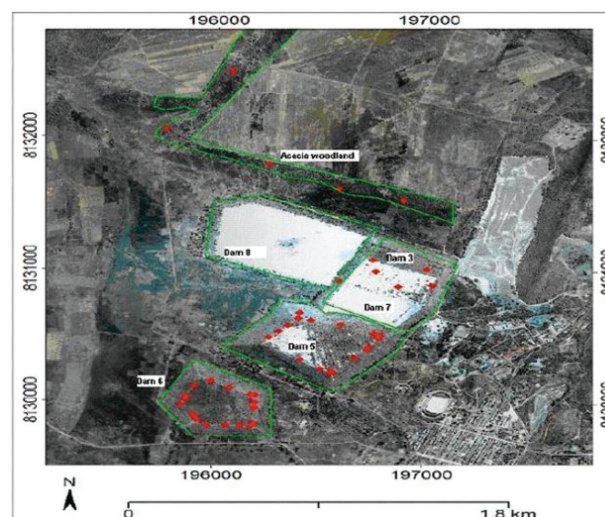
Figure 2—Google Earth® satellite image showing sampling sites (dots) on the slimes dams and in the acacia woodland

functional ecosystem (Figure 2). Reference sites are supposed to occur in similar biotic zones, in close proximity to the rehabilitated site, and exposed to similar natural disturbances (Society for Ecological Restoration International, 2004). Although the site was flat, and did not have similar topography to the slimes dams, it served in providing the biogeochemical potential for rehabilitation. It was also important to compare the rehabilitated sites with a site representing a dysfunctional ecosystem. For this purpose, the top of Dam 7 (also flat) was used (Figure 2). This dam was constructed in the late 1980s as an infill between Dams 3 and 5. The mine closed before Dam 7 was fully rehabilitated.

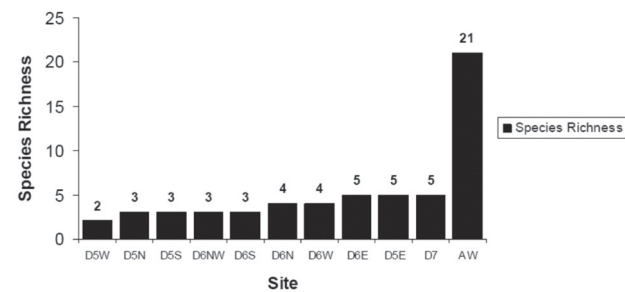
There was an evident difference in species richness between the dam sites and the acacia woodland reference site (Figure 3). For Dam 5, the lowest species richness occurred on the western aspect with only two species, whereas for Dam 6, it was on north-western and southern aspects, with three species each. On both of these dams, the highest species richness was on the eastern aspects with five species apiece. In total, 27 species were recorded from 14 families. Twenty-one of them occurred in the acacia woodland, and

Figure 3—Species richness on the aspect stratified dam sites and the acacia woodland reference site

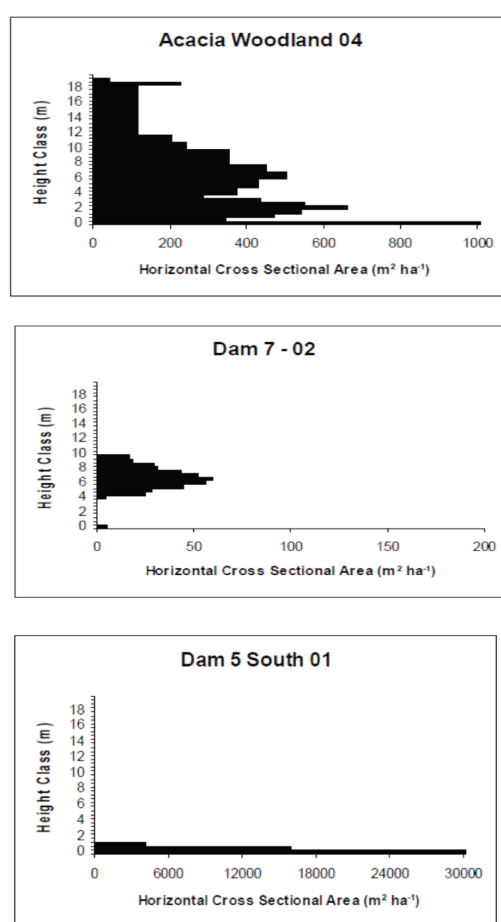
In the acacia woodland reference site, all life forms were represented, i.e. grasses, shrubs, and trees (Figure 4). There was good ground cover in the 0–0.5 m height class, with the layer attaining a cover of around 900 m<sup>2</sup> ha<sup>-1</sup>. Woody species' canopy cover was most prominent in the 4–8 m height layer. In contrast, the Dam 7 reference site lacked a viable ground cover, with the grass layer covering less than 100 m<sup>2</sup> ha<sup>-1</sup>. On Dam 7, there was also no shrub layer. Although present, the tree layer also had a canopy cover of less than 100 m<sup>2</sup> ha<sup>-1</sup> (Figure 4). The slimes dams, on the other hand, had considerable ground cover. Most extensive was the 0–0.5 m layer, which reached ground cover values of 30 000 m<sup>2</sup> ha<sup>-1</sup>. There was also good ground cover in the height classes between 0.5–2 m on Dam 5 (Figure 4). Even though there was an extensive ground cover in the 0–0.5 m layer on Dam 6, there was not as much cover between 0.52 m as on Dam 5. Nevertheless, the ground cover was greater than that of the acacia woodland. The tree canopy cover on the slimes dams was very low when compared to the grass layer (Figure 4). Tree cover on slimes dams was also much lower than that of the acacia woodland.

Figure 4—Vegetation horizontal cross-sectional area of sample sites from the acacia woodland, Dam 7, and Dam 5

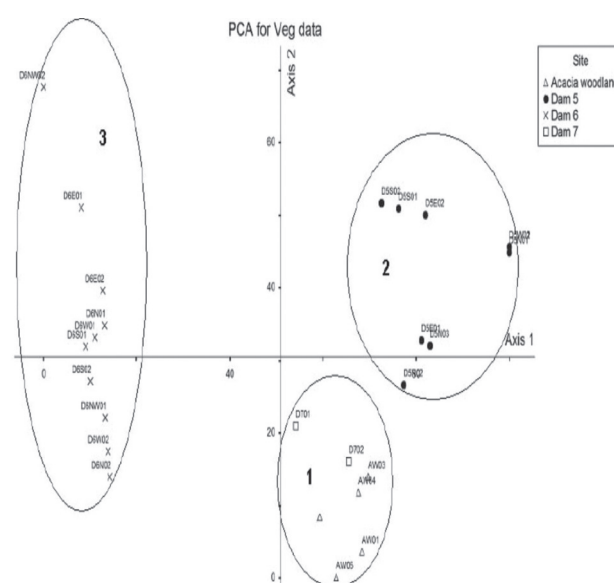
The vegetation data was tested for normality using the Shapiro-Wilks normality test. The data was not normally distributed according to the test ( $p < 0.05$ ), and was thus log-transformed then re-tested for normality, but again failed the test ( $p < 0.05$ ). To test for significant differences between sites on the basis of species composition (richness and abundance), a non-parametric Kruskal-Wallis test was therefore carried out. There were significant differences ( $p < 0.05$ ) between the sites in terms of species abundance ( $p = 0.0107$ ). A similar result of significant differences between the sites ( $p = 0.0018$ ) was obtained for species richness ( $p < 0.05$ ). These differences were also illustrated in principal component analysis (PCA). With an eigenvalue of 1390.44, Component 1 explained about 71.19% of the variance, whereas Component 2 (with an eigenvalue of 329.007) explained 16.85% of the variance. The PCA produced three separate groups (Figure 5). The first group consisted of Dam 7 (reference sites) together with all sites from the acacia woodland. The second group consisted of all sites from Dam 5, and the third group was made up of sites from Dam 6.

Figure 5—Principal component analysis of vegetation data. Numbers refer to clusters of related sites

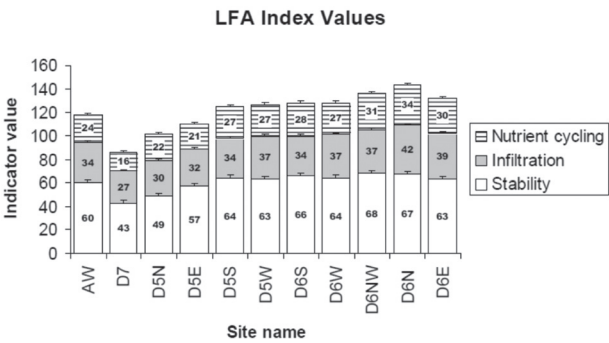
The values of the three main LFA indices (nutrient cycling, stability, and infiltration) were combined in order to graphically illustrate the difference in functionality between sites on the basis of all three indices. The sites were grouped on the basis of aspect for the slimes dams, and each reference site was made into a single group. The Dam 7 reference site is the least functional of all sites (Figure 6). The most functional site is D6N (Dam 6 northern aspect). On the slimes dams (excluding the reference dam) the least functional site was D5N (Dam 5, northern aspect). The stability index contributed the most to functionality on all sites.

Figure 6—Landscape functionality of sites based on the three LFA indices (stability, infiltration, and nutrient cycling). The reference sites (Dam 7 (D7)) and the acacia woodland (AW) are on the left side of the graph

Dam 6 sites are the most functional among all the sites sampled. This is due to their high values for the landscape organization index (LOI), stability, infiltration, and nutrient cycling indices (Figure 6). The LOI is related to the number and size of patches. This essentially means that Dam 6 sites have the greatest patch area. This may be attributed to the grass species *Imperata cylindrica*, which occurs mostly in uniform swards over the dam due to its rhizomatous habit. Therefore, this indicates a high retention capacity with respect to these sites. On the other hand, Dam 5 sites (most of which have a higher functionality than those from the acacia woodland) have a poorer landscape organization compared to Dam 6 sites. *Hyparrhenia sp.* is the dominant grass on Dam 5. It is a tussock grass that does not form uniform swards as does *I. cylindrica*. The grass layer in the acacia woodland is not as effective in retaining resources as on the slimes dams, due mainly to the reasons discussed above. The poorest landscape organization is that of Dam 7. There is virtually no grass layer, and the only protection is from sparsely distributed trees. Therefore, most resources are lost via wind and water, resulting in the creation of rills and gullies.

The high functionality of Dam 6 sites is also evidenced by their high stability index values (Figure 6). This indicates that there is good soil and litter cover on these sites. Cryptogamic vegetation that functions in stabilizing soil is well developed on Dam 6 sites. The surface has an intact crust, thus there are no loose soil particles available for erosion. The surface is resistant to disturbances, thus indicating the difficulty of releasing soil in an erosion event. High stability also means that the soil maintains its cohesion even when wet, thus preventing erosion. On the contrary, Dam 7 sites with the lowest stability values have poor cover. They are also characterized by an absence of cryptogams. The sites have severe rills and gullies, which indicates that there has been much soil loss. Acacia woodland sites have a lower stability, possibly due to the reduced grass cover and the trampling effect of grazing cattle. Dam 5 sites have lower stability values than those of Dam 6 due to their lack of cryptogam cover and lesser efficiency in erosion prevention by the tussock grass *Hyparrhenia sp.*

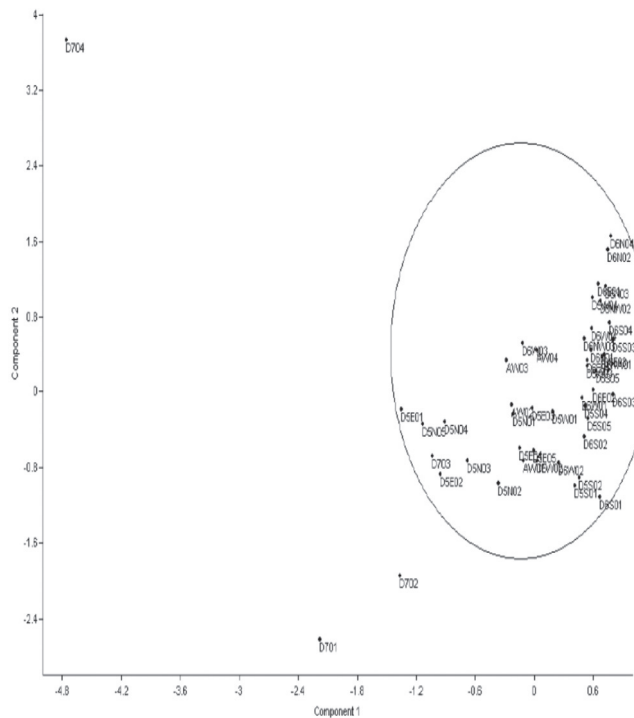
All LFA data was first log-transformed, and a Shapiro-Wilks normality test was carried out on the data. The data was normally distributed ( $p > 0.05$ ). Thus, a one-way analysis of variance (ANOVA) was carried out to test for any significant differences among the sites. There were significant differences among sites ( $p < 0.05$ ). To further explore the relationships among the sites in terms of functionality based on the LFA indices, a principal component analysis (PCA) was carried out on the data. With an eigenvalue of 0.0884, Component 1 explained 90.96% of the variation and Component 2, with an eigenvalue of 0.0069, explained 7.07% of the variation. These two components were used to illustrate the relationships between the sites. The PCA showed close relationships in functionality between slimes dams and the acacia woodland reference site (Figure 7). However, three sites from Dam 7 reference site clustered

further from the other sites. Site D704 (Dam 7, LFA transect 4) was the most deviant.

Figure 7—Principal component analysis (PCA) plot of the LFA data. The numbers indicate clusters of related sites
